ARCHITECTURAL CONSERVATION ASSESSMENT

August 1, 2011

1790 WESTFORD ACADEMY

TOWN OF WESTFORD & WESTFORD HISTORIC SOCIETY

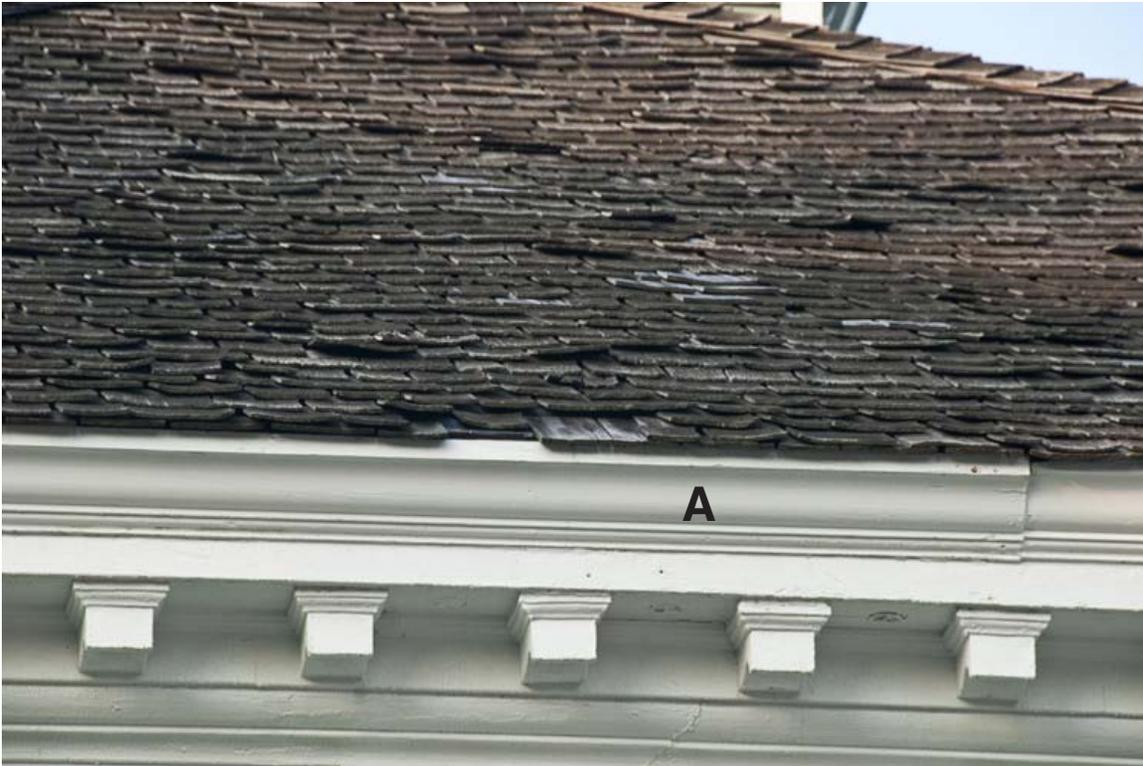
The roof shingles are currently at the end of their useful service life and in very poor condition. A number of individual shingles have recently slipped out of place and been replaced with new shingles, presumably due to their fasteners corroding. Many of the shingles are curling badly. Based on several samples in the museum office, their exposed surface has become deeply eroded from ultra-violet sunlight. “Red Label” shingles are the #2 shingles in the four tier grading system of the shingle industry. They are permitted to have some knots in the upper portion of the shingles along with a limited amount of sapwood and/or flat sawn wood. The shingles in the office were vertically grained heartwood without knots, and would conform #1 “blue label” standards. “Blue label” shingles are the standard product used on roofs in quality work.

The installation of the shingles has a number of problems. In addition to the poor choice of fasteners, the staples were placed an inch or two higher up on the shingles than the normal placement, which contributes to the curling problem. The shingles are also spaced about 1/2” apart, which is wider than normal. Installing the shingles directly over felt paper without any provisions for air circulation beneath them to dry out moisture often causes premature deterioration from the underside of the shingles. The plywood deck further aggravates this problem.

7: Wood shingles installed in 1992 show excessive curling and area of missing shingles at eaves. The crown molding (A) was installed c. 1980 to reproduce the original. The rest of the cornice elements are original and in good condition.

*Replace the roof within the next year using “blue label” #1 “perfection” (i.e., 18” long) red cedar shingles incorporating provisions for ventilation under the shingles and with proper nailing. ****

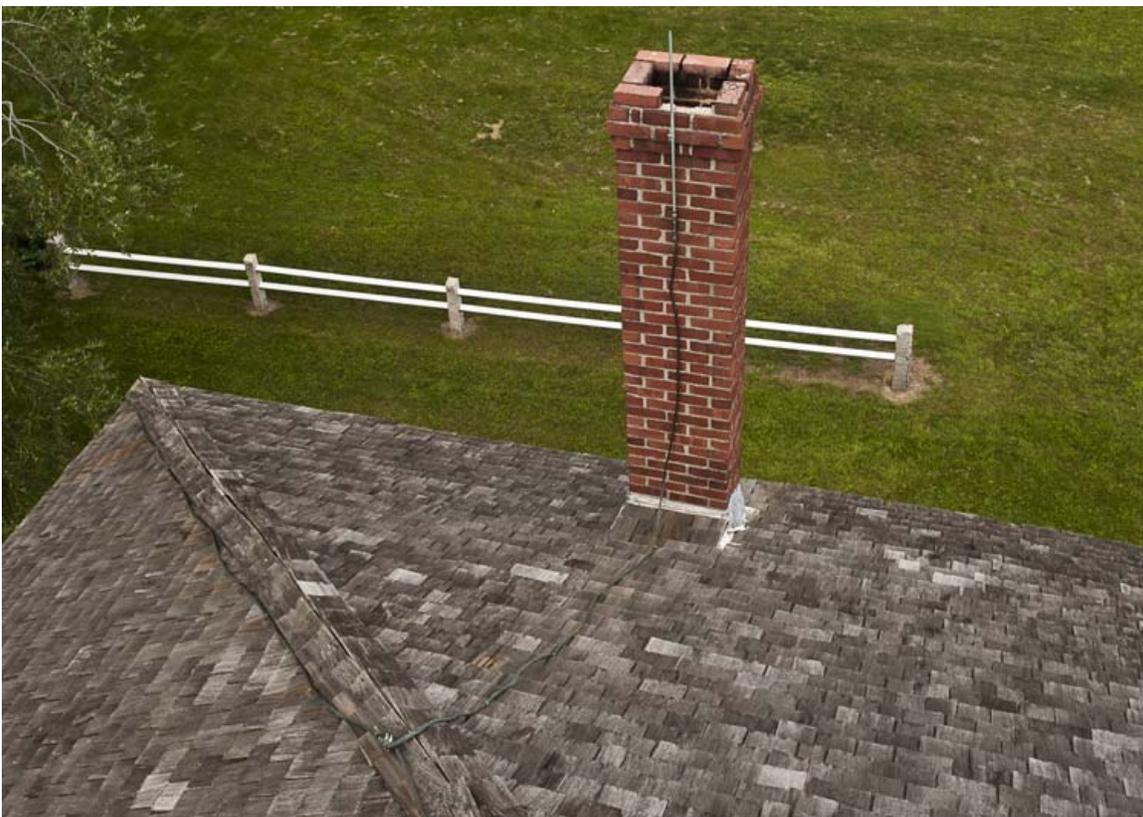
The top courses of brick are loose. As previously noted its flashing is defective.

8: Wood shingles installed in 1992 are in poor condition. The top of the chimney is missing a brick and the top 4-5 courses need to be rebuilt. The flashing and detailing of the cricket at the back of the chimney may be a problem.

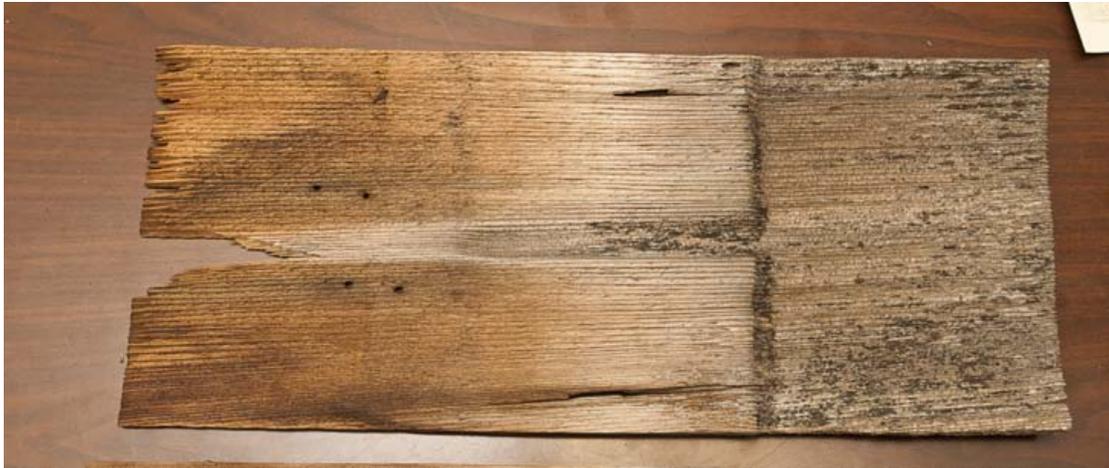
9: Front face of wood shingle from the roof showing its exposed heavily eroded from UV exposure to become very thin. This shingle is clear and straight grained red cedar, although the “Red Label” grade used on this roof would allow some defects in the top portion of the shingle and some shingles with flat sawn grain.

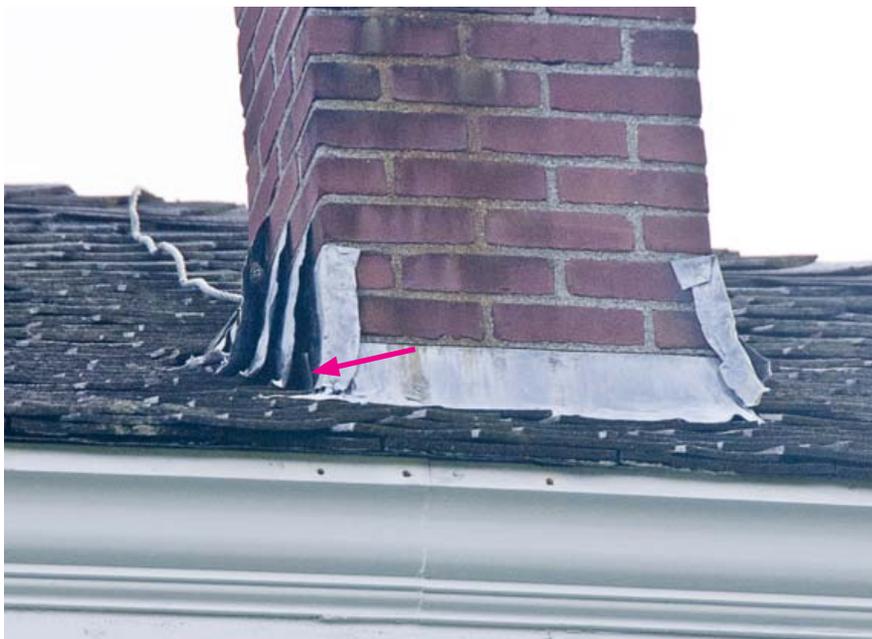
There are currently active leaks at the second floor ceiling at the rear chimney due to defective flashings. The cap flashings at the rear chimney are not properly dressed down tight to the chimney (they are literally flapping in the breeze), and allow wind driven rain to run over the tops of the base flashing. Whether there are other problems with the flashings is not known (i.e., wear) as they were not examined hands-on. According to staff they are to be repaired in the near future to stop the leaks. This repair will probably involve dressing down and/or replacing some of the cap flashings, but will not completely replace the flashings.

10: Cap flashings at rear chimney are not tightly dressed down over the base flashings. Arrow points to the upstand of a sheet of base flashings where wind driven rain could blow under the cap flashing and run down behind the base flashing. The mortar pointing looks to be tight and sound in this area.

Chimney Flashings: *Replace the both cap and base flashings in conjunction with the replacement the wood shingle roof. The base flashings should be 16 oz. lead coated or red copper. The cap flashings can be 4lb. lead ,or 16 oz. lead coated, or red copper. ****

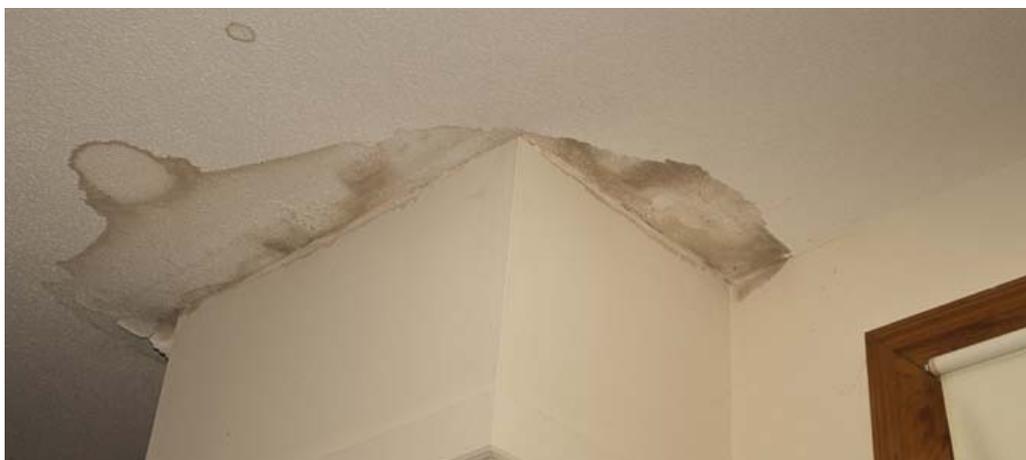
11: Water stains around chimney at second floor from active leaks at chimney flashing.

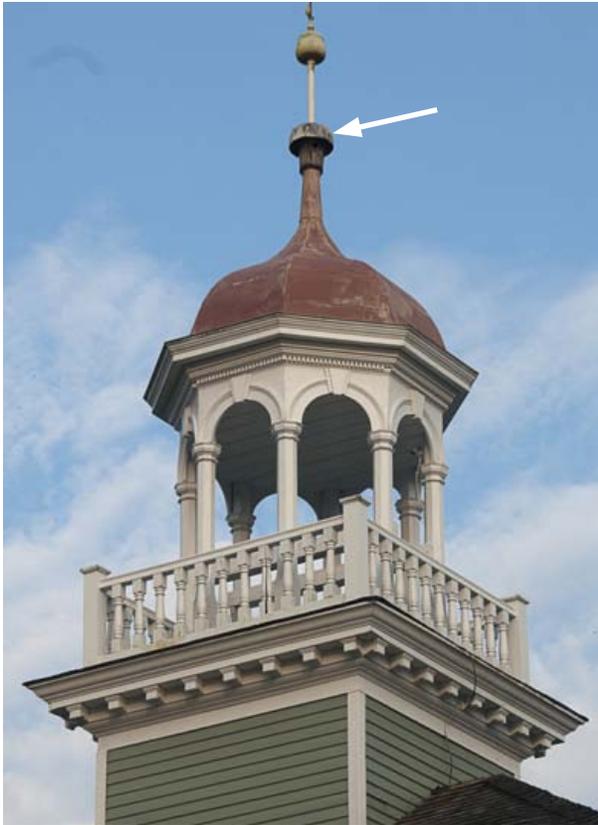
The sheet metal cupola roof appears to remain in serviceable condition. It was not examined “hands on”, but there was no evidence of current leaking from the roofing or the cupola shaft on the ceiling boards of the cupola. The painted surface of the metal roofing exhibits some wear with its primer showing through in some places. It was not clear if the roof cap is clad with sheet metal over wood, or is painted wood without a cover. It shows some wear and likely needs substantial repair or replacement, but its condition needs to be more fully assessed next time the cupola roof is painted.

12: Current appearance of cupola as repaired c. 1980. Note paint on metal roofing has areas of wear as does the cap at its top (arrow).

*The cupola roof should be repainted within the next 1-3 years, at which time the condition of the cap below the weathervane should be checked. Ideally this should be done in conjunction with repairs to the cupola wood trim.***

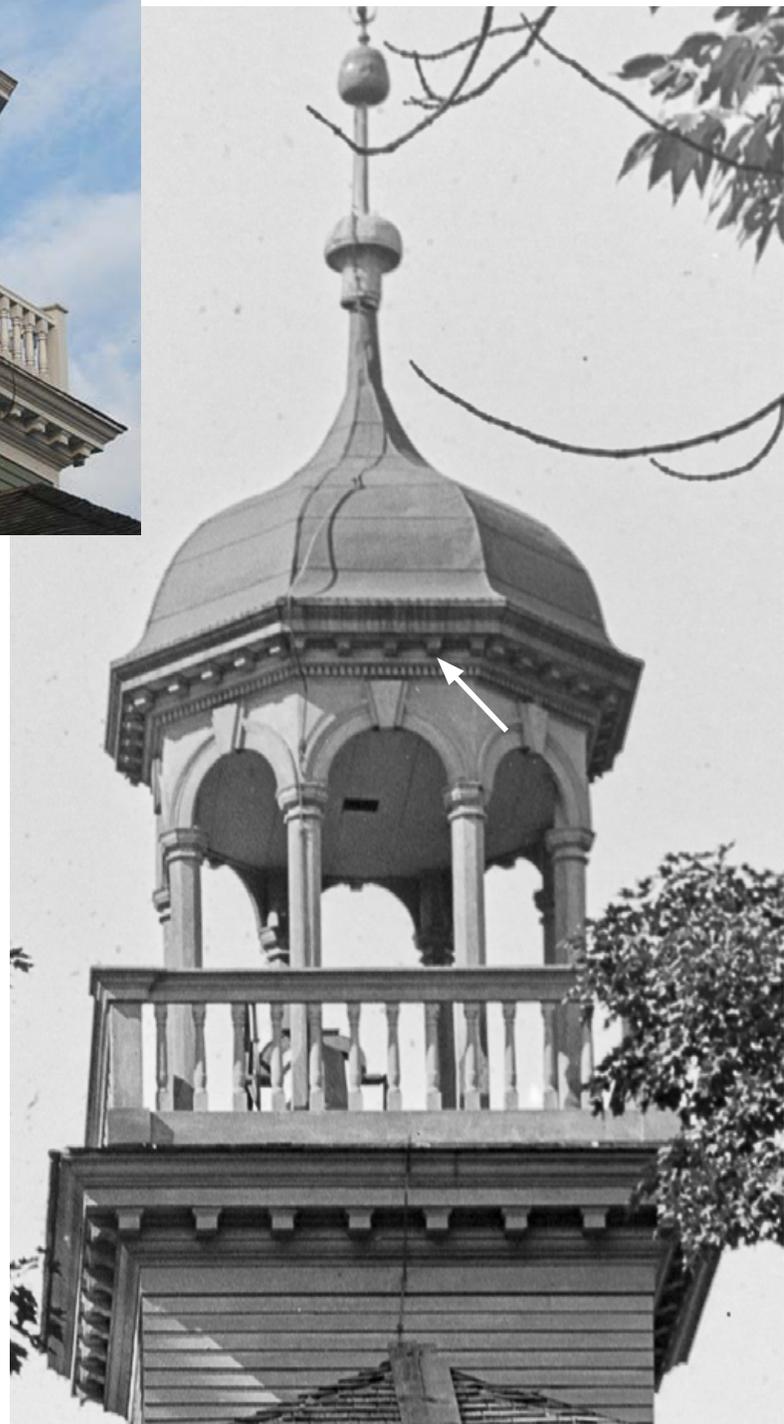
13: Detail of cupola from Photo 6 showing original detailing. Note that the modillion blocks (arrow) were not reproduced in the c. 1982 restoration work.

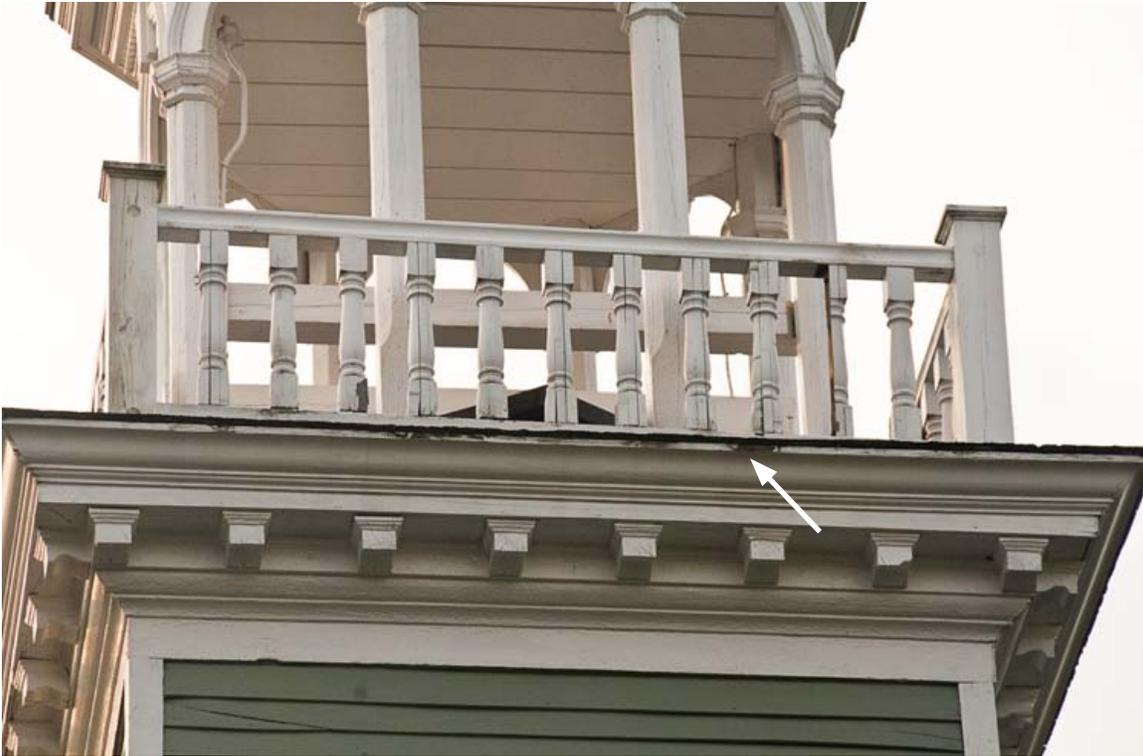
14: Current view of cupola balustrade and cornice showing that the balusters, railing, and posts do not match the ones in the late 19th century photo below. Also note the balusters are splitting apart, and the top of the crown molding (which was installed in 1982) is rotting (arrow). The fascia, modillion blocks, and bed molding below the crown molding are original to 1794. The ends of the modillion blocks on the cornice show weather checking.

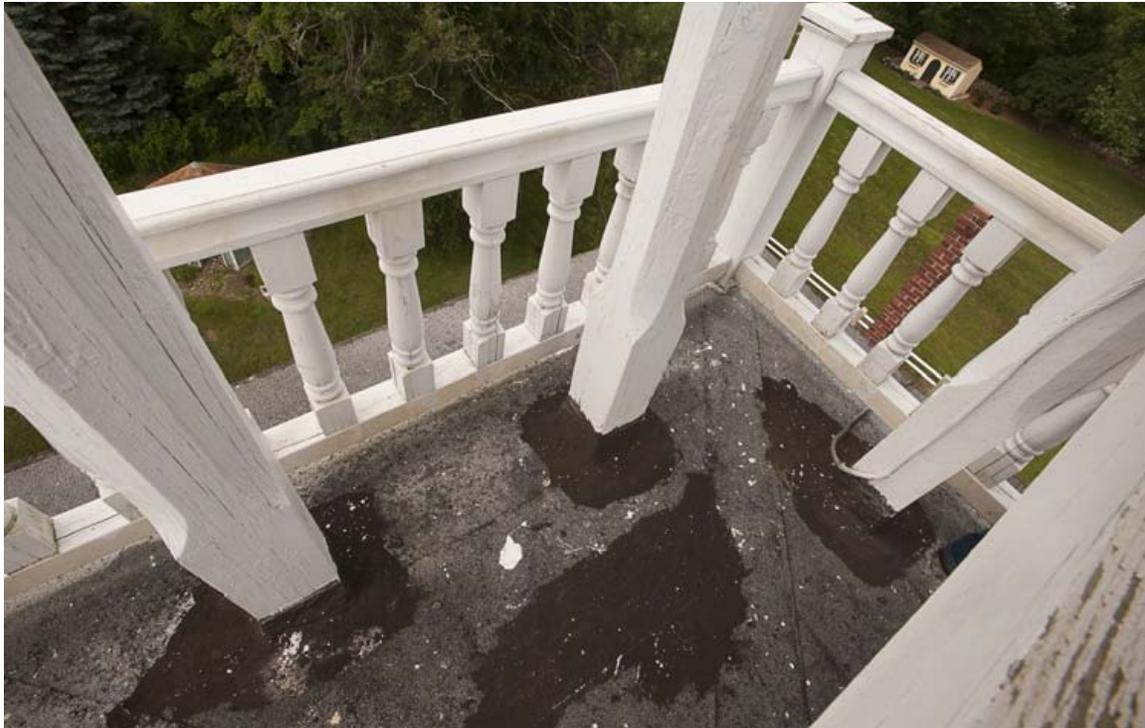
The bell deck roof is extremely worn and many years past its useful service life. Past leaking is evidenced by water stains on the ceiling of the second floor and extensive patching of its surface with roofing tar. According to staff, the most recent repairs (presumably with tar) have stopped the leaking (at least to the extent that water has not penetrated to the second floor plaster ceiling. The cupola posts have in the past been the source of chronic leaks that ran down the posts in the attic and generated rot and insect damage in the transfer beams supporting the posts. Much of this probably occurred many years ago, but some lesser leaking may still be occurring that reaches the transfer beams. The tar “flashing” is not an adequate way to prevent water penetration at the posts. The wood sheathing under the roll roofing was installed in 1982, and appears to remain serviceable.

16: Section of bell deck roof showing roll composition roofing installed in 1982 that is severely deteriorated with numerous roofing tar patches. This material normally has only a 15 year service life. Replacement with flat seam soldered copper is recommended.

*The bell deck roofing should be replaced within the next 1-2 years. ****

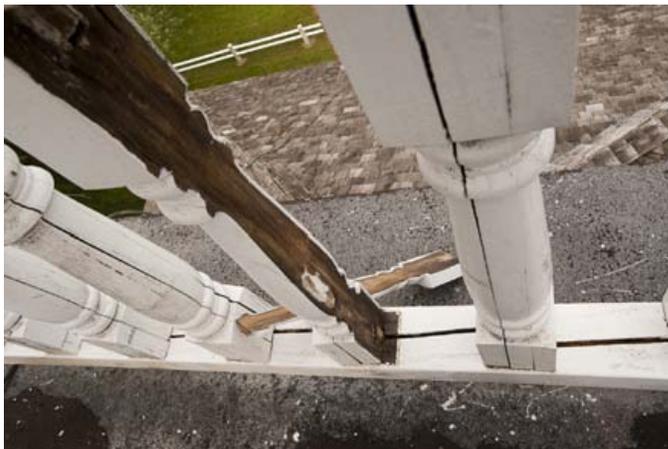
17: Detail of delaminating balusters. Pieces splitting off are a potential hazard in that they may fall off the edge of the main roof.

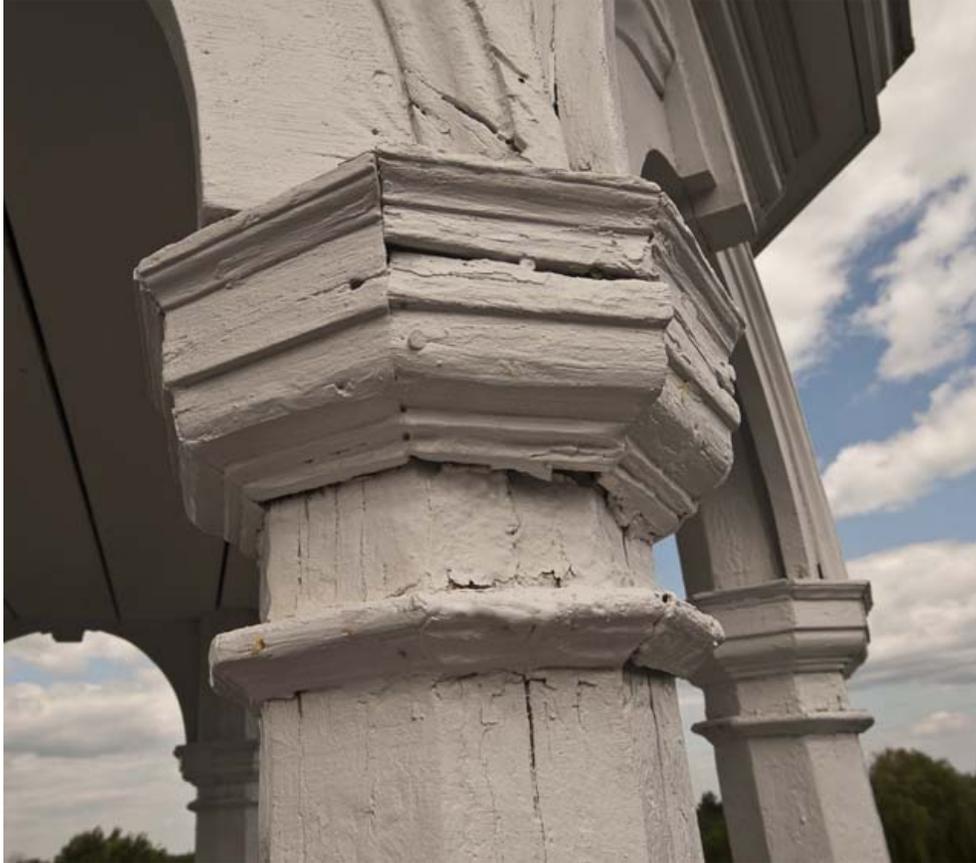
19: The worst case example of deteriorated trim on the cupola columns. Much of this trim is original and was stripped of paint in the 1982 restoration of the cupola.

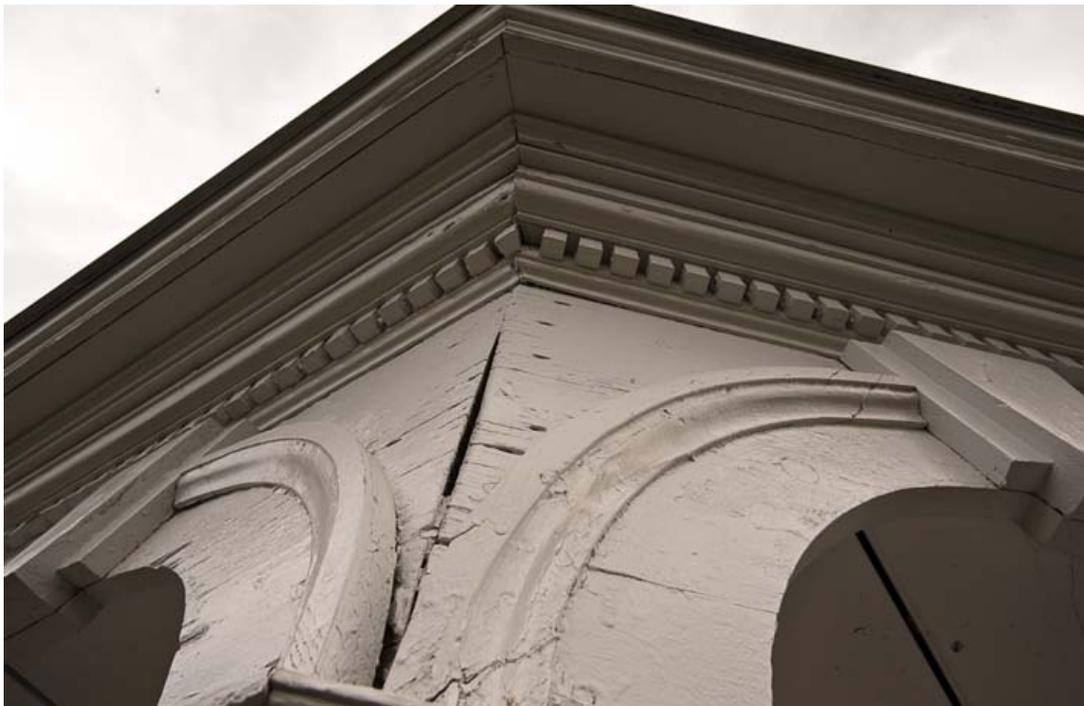
20: Original arched boards and moldings show separations and splits. These conditions warrant conservation treatments.

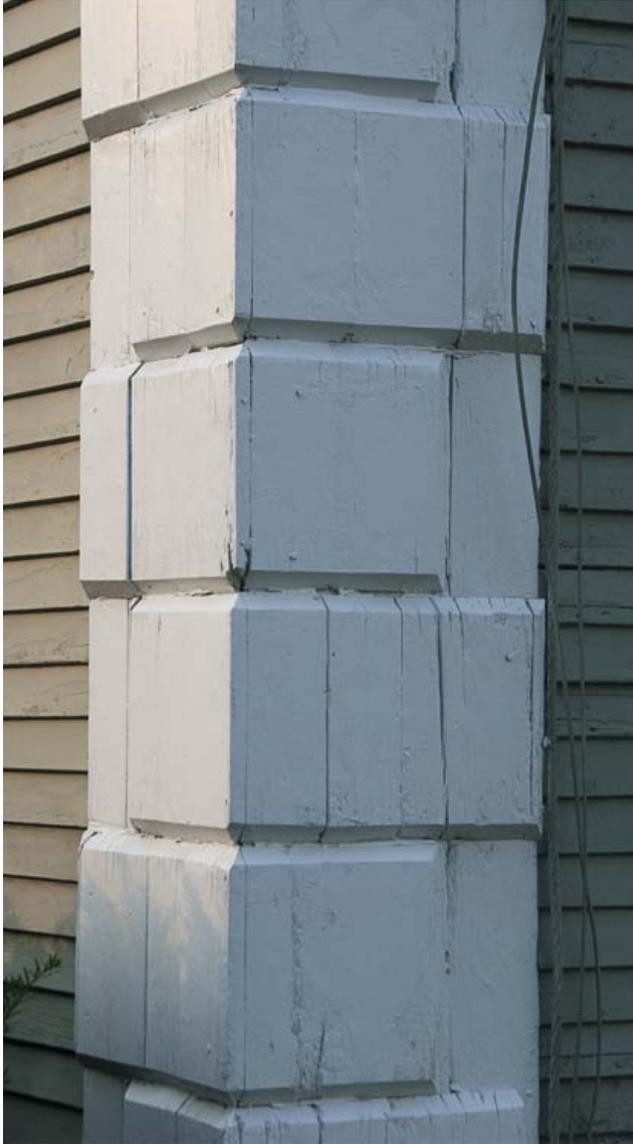
21: The quoins installed in the first floor front corners after the fire house doors were removed have splits and separations due to their construction detailing. These sections of the corner boards should be redone more accurately detailing the construction detailing of the originals.

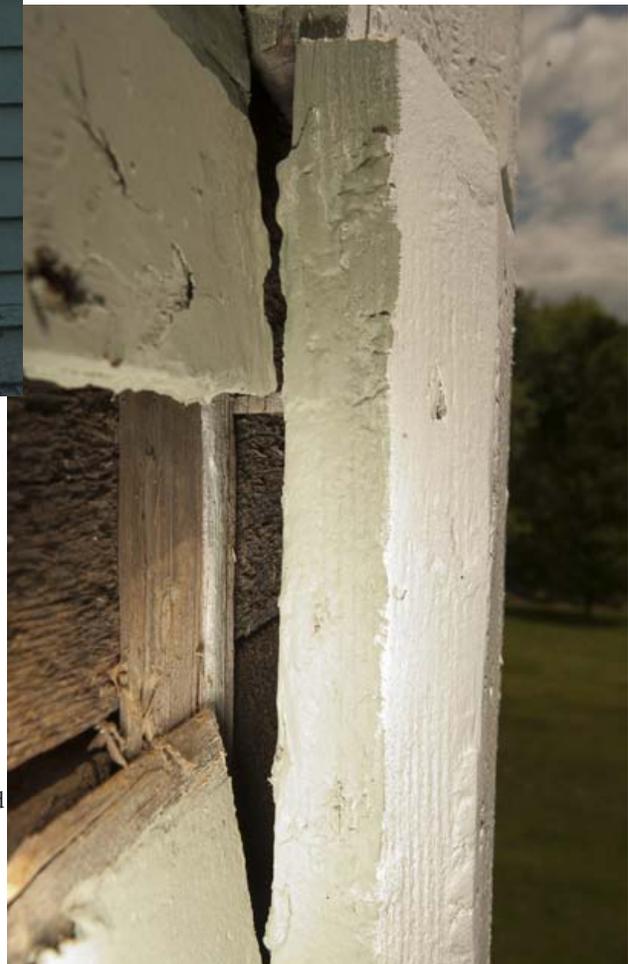
23: Detail of the top of the loose board with a clapboard removed showing the strip of original wood flashing under the junction between the corner board and the clapboards. The original flashing should be preserved, but may be covered over with a strip of aluminum or copper flashings to better protect the joint.

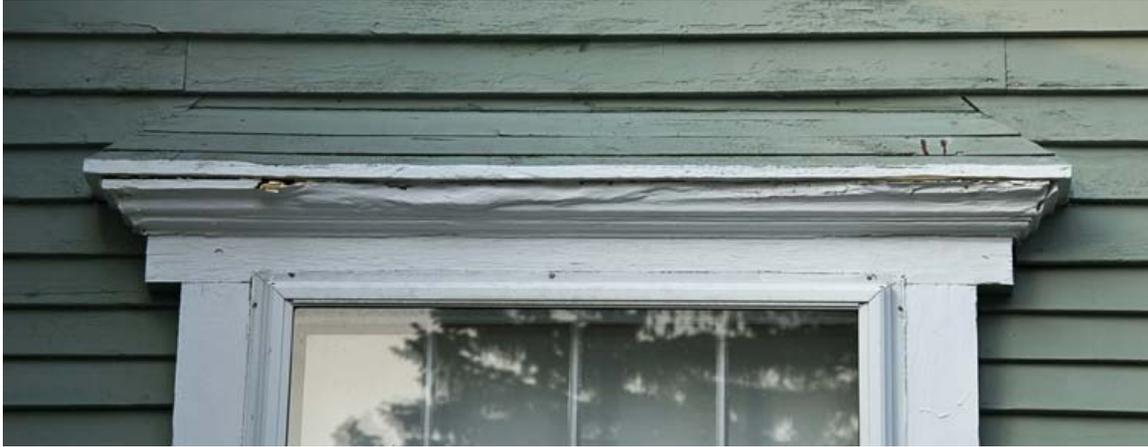
24: One of the two window frames installed c. 1980 after the fire house doors were removed. The cap is made of laminated stock and is coming apart. The crown molding under it is rotting. An ogee band molding matching the moldings on the original frames was never installed. The window needs a new cap made of a single piece of rot resistant wood matching the detailing of the original caps.

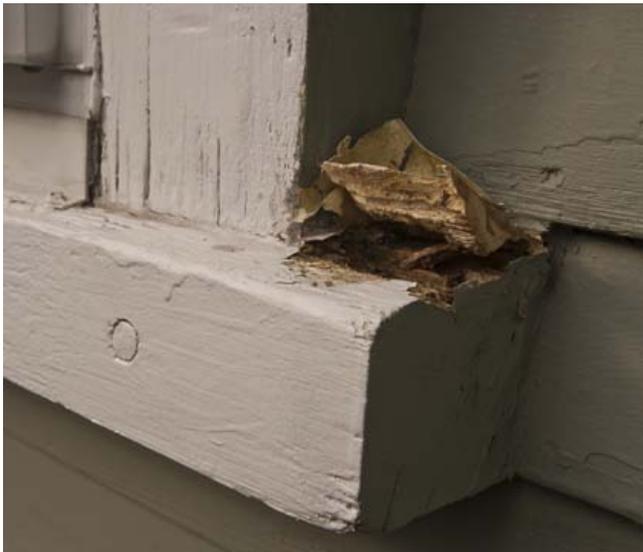
25: Lower corner of one of the two window frames installed c. 1980 after the fire house doors were removed showing rot that has been repaired with some type of wood filler that is now failing. The repair needs to be redone using epoxy conservation and/or a wood Dutchman.

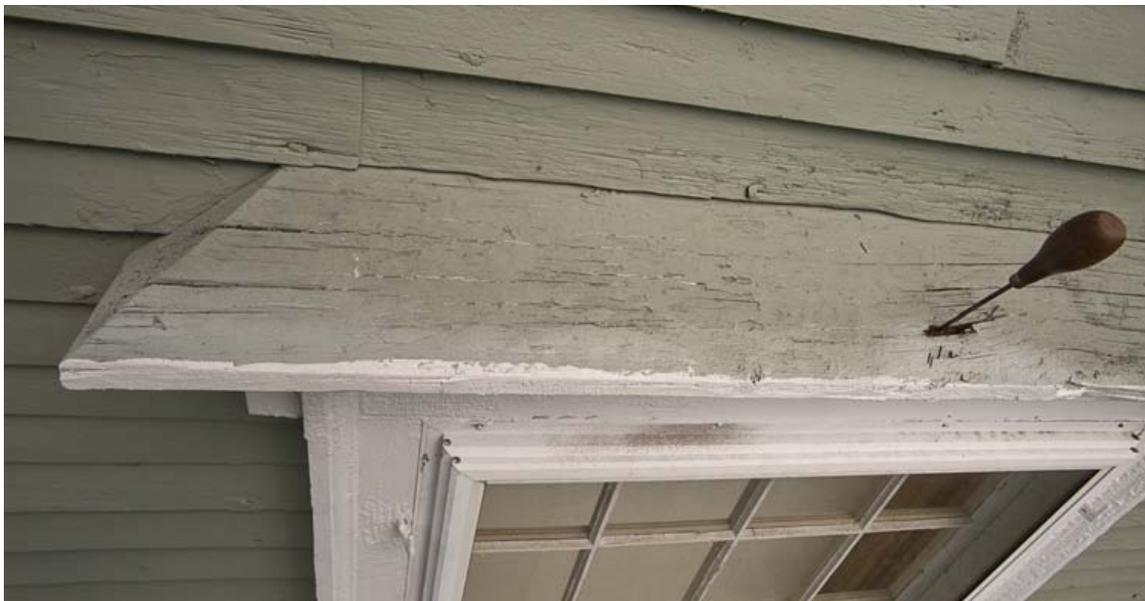
26: Original window cap on the south facade showing typical moderate weather checks. The awl is in a small area of rot that should be repaired with epoxy and/or a wood Dutchman. The wood in the other checks seemed to be solid.

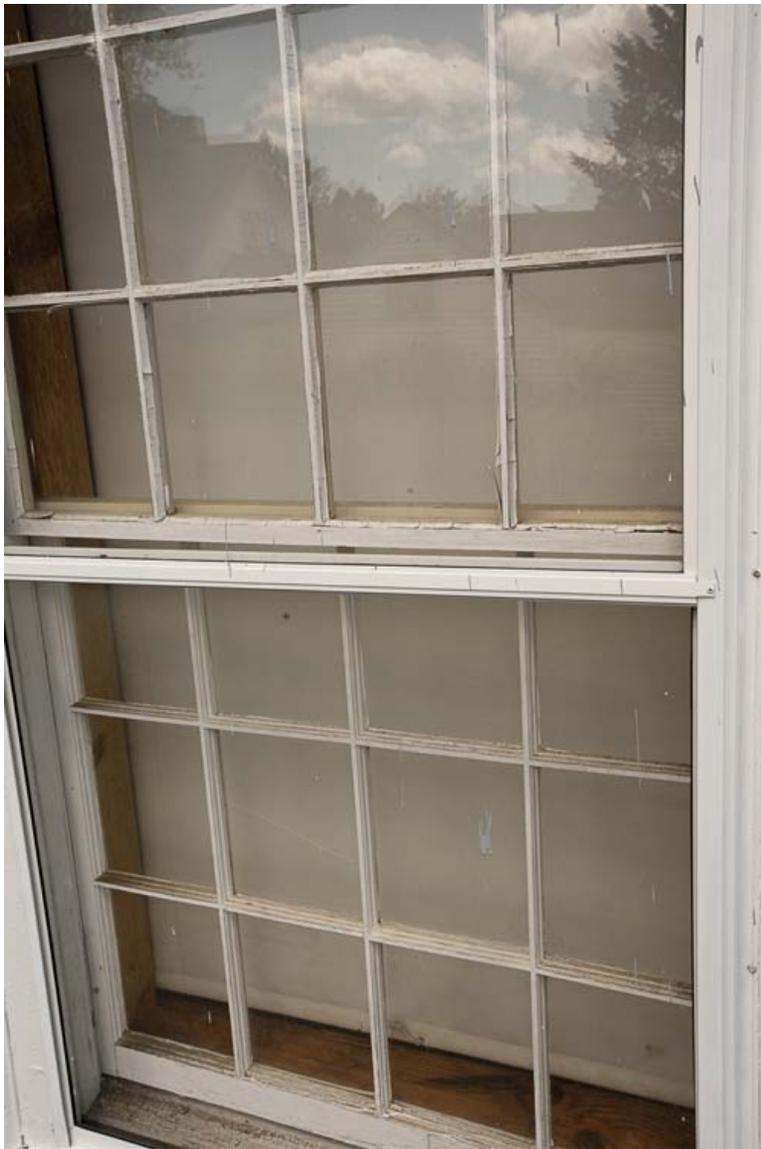
27: Typical window sash installed in the c. 1980 restoration. The lower sash has been turned around and installed with its interior side facing outwards. The upper sash is facing the right way, but its glazing putty is failing.

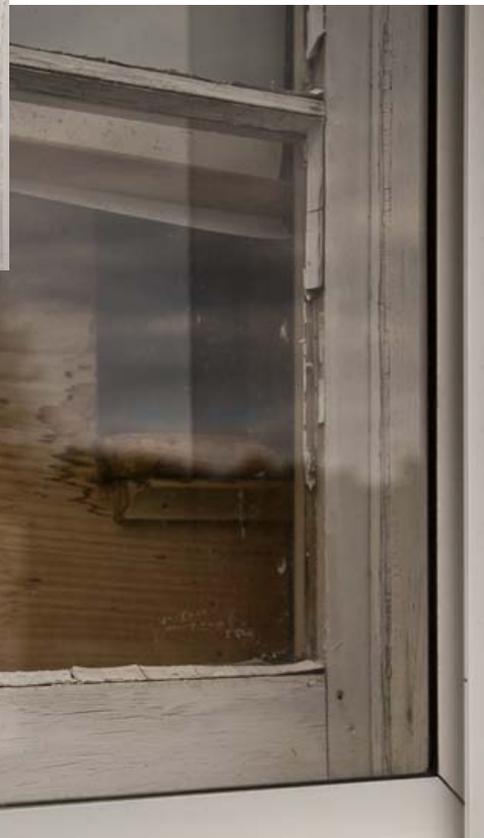
28: Detail of a typical window sash showing extensive area of missing or loose glazing putty. All the windows need to be reglazed.

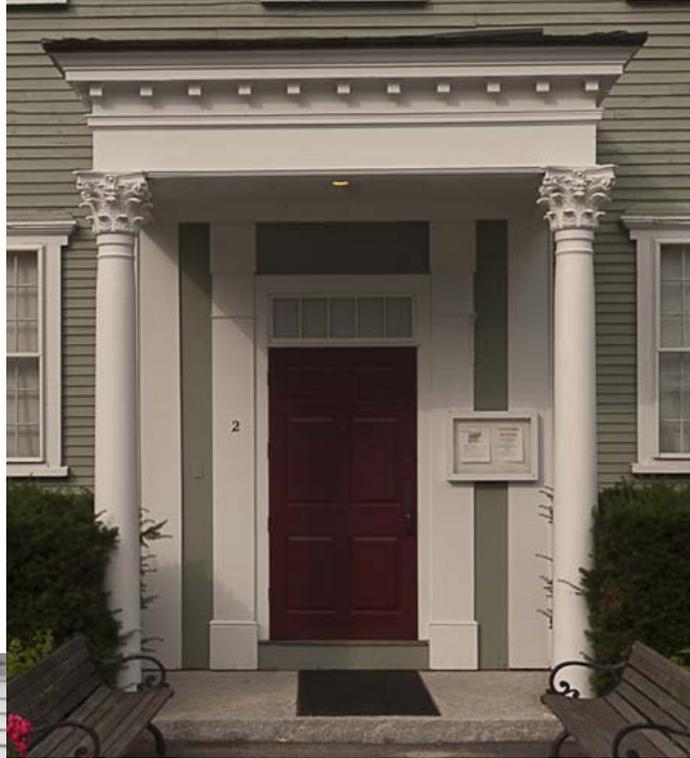
29: Front entry and porch as reconstructed in the c. 1980 restoration. Due to budget constraints round rather than fluted columns were used.

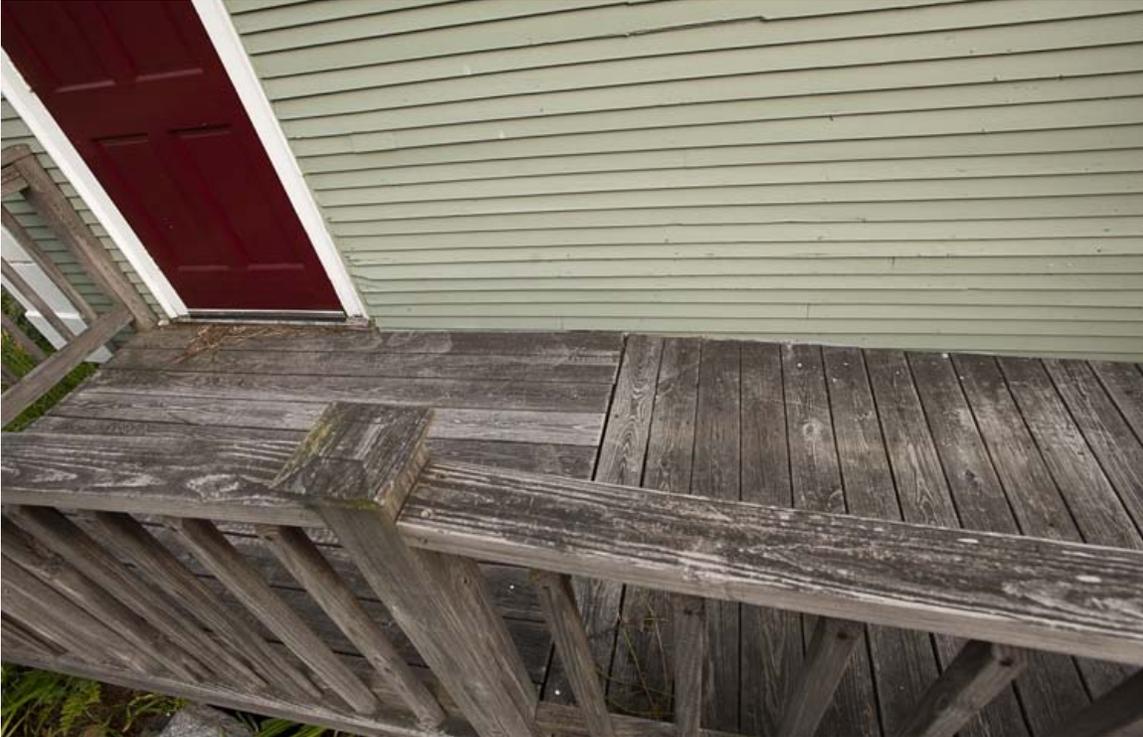
31: Handicapped access ramp and door on the north side facade. The door casing on the right side (arrow) is starting to rot at its base. Having the full length of the ramp tight against the clapboards will eventually rot the clapboards and framing beneath them due to snow piling up against the wall and rain splashing back.

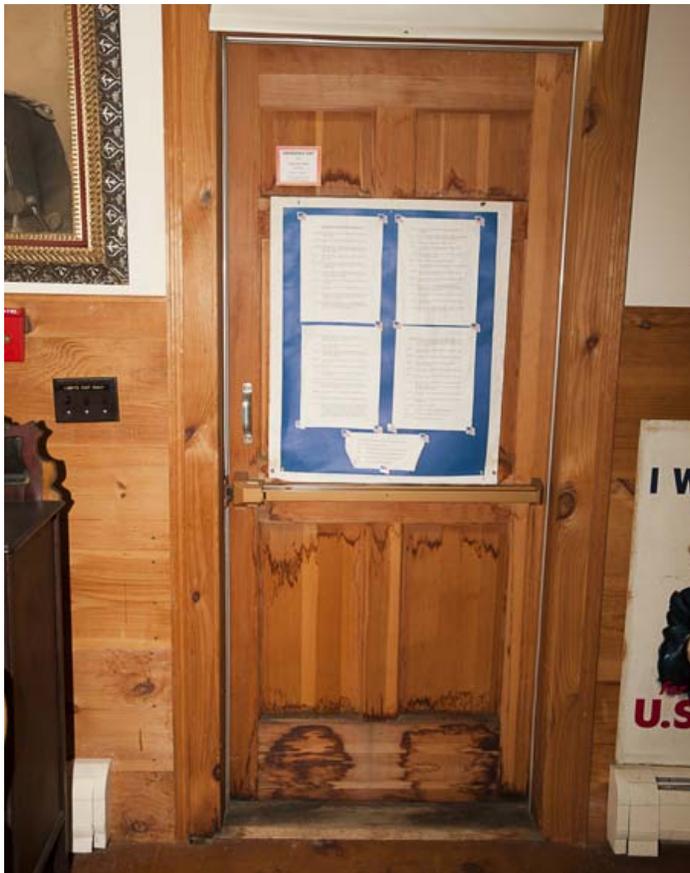
32: Interior side of the handicapped entrance door is damp-stained from water leaking under the door and at the joints of the panels to the rails.

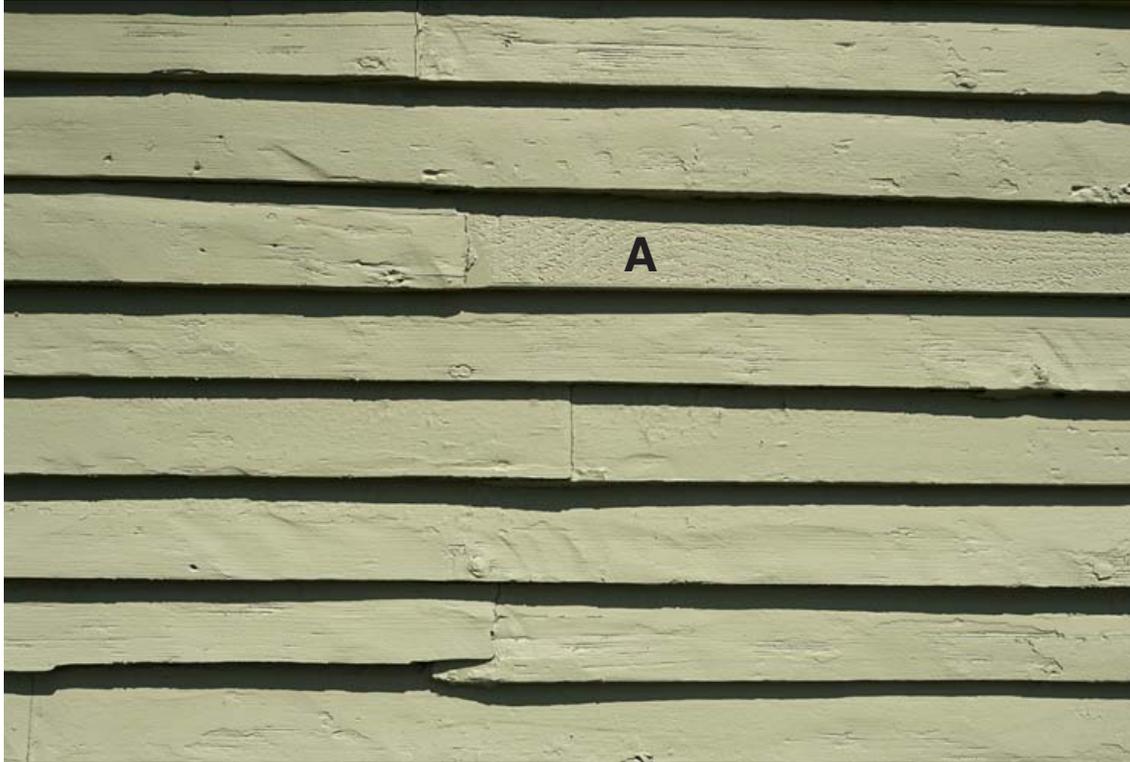
33: Area of original clapboards that have been gouged and disfigured by inept preparation with a circular grinder to remove paint. "A" marks a poor quality replacement clapboard that is flat-sawn. It and others like it should be replaced with vertically grained clapboards.

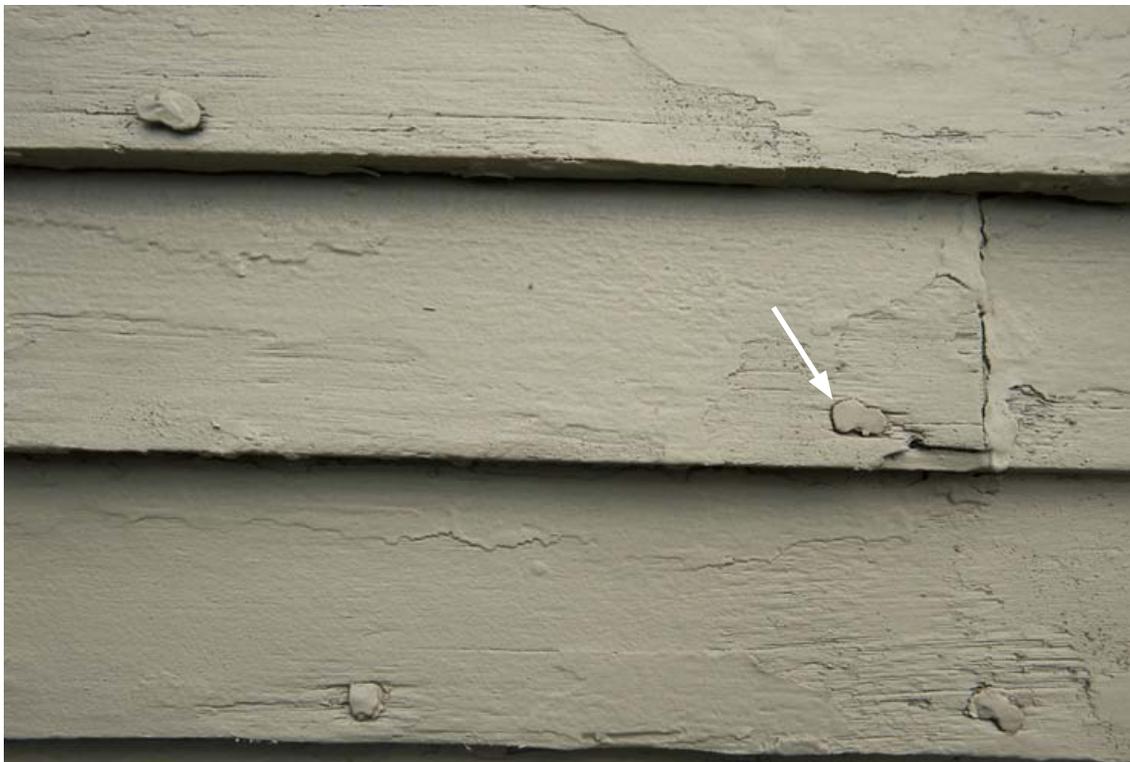
34: Detail of original clapboards showing their original butterfly headed hand wrought nails. One of the nail heads (arrow) has been flattened by the use of a paint grinder. Care should be taken during paint preparation to not damage the original nail heads.

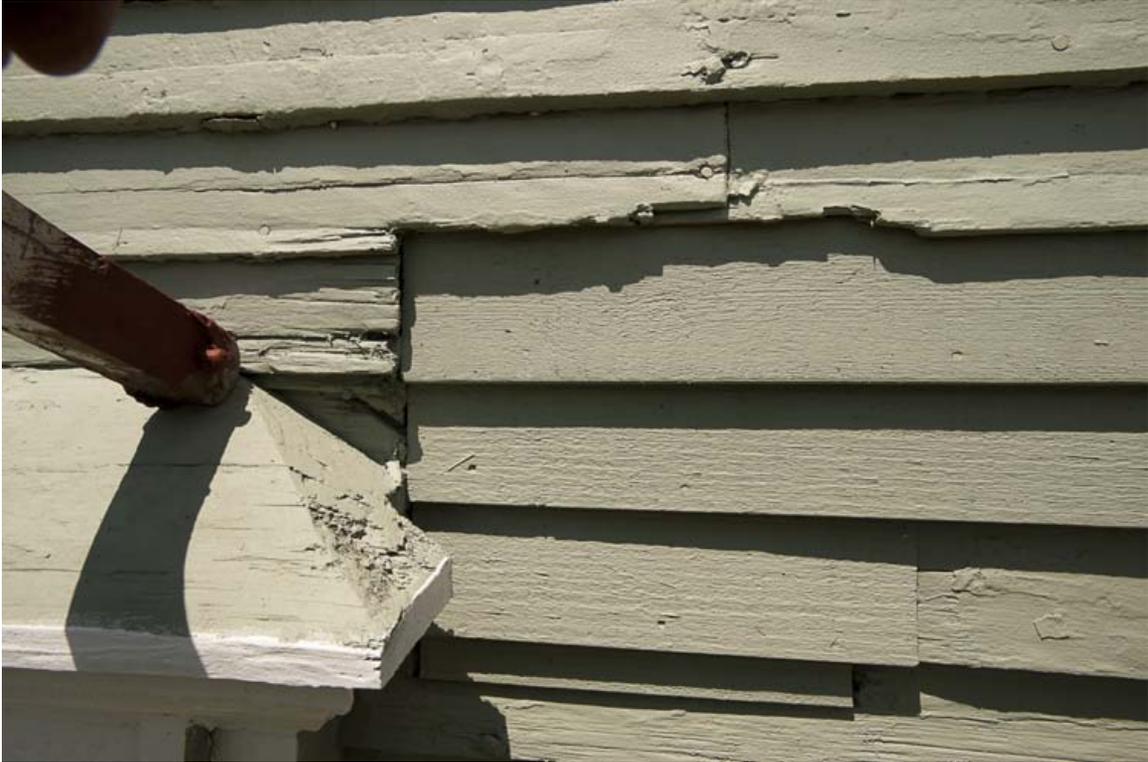
38: The back corner of this window head was cut away in the early 20th century to install a steel tie rod at the ceiling of the first floor, probably so that a columns could be removed to make space for the fire trucks. The rough textured clapboards to right are poor quality modern replacements.

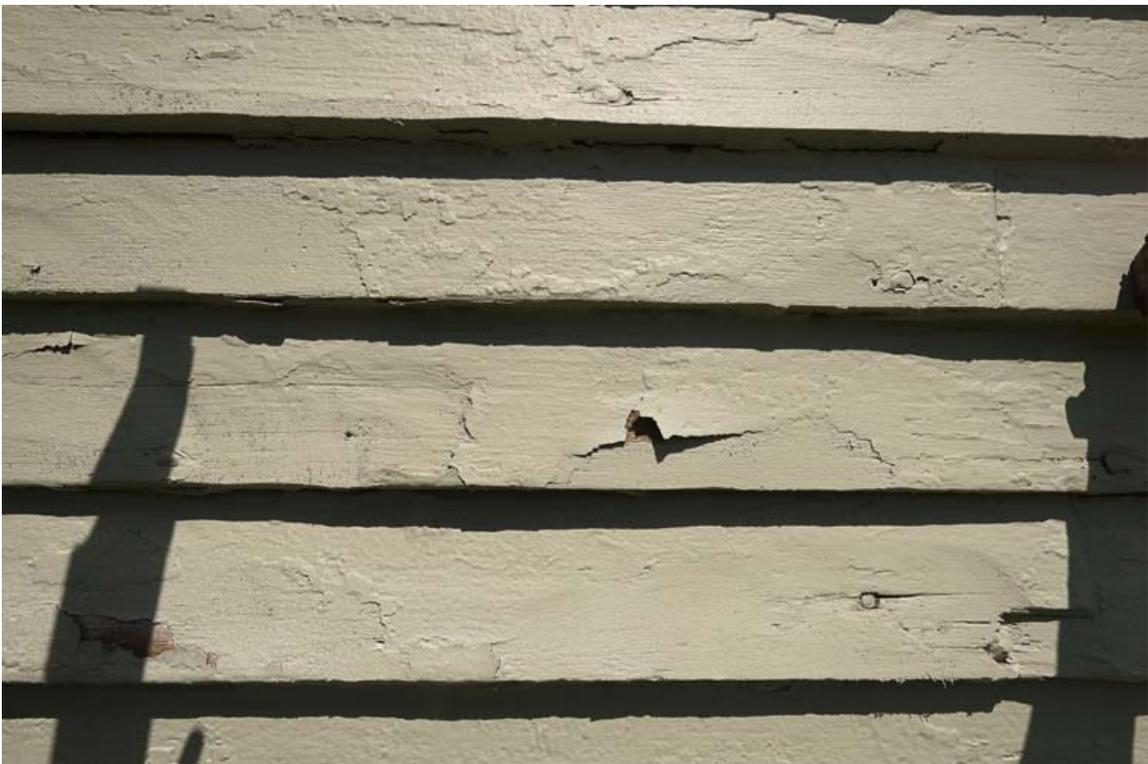
39: Typical small area of paint failure. To maximize the life of the current paint job, such areas should scrapped to remove the loose paint and touched up to match the adjacent sound paint.

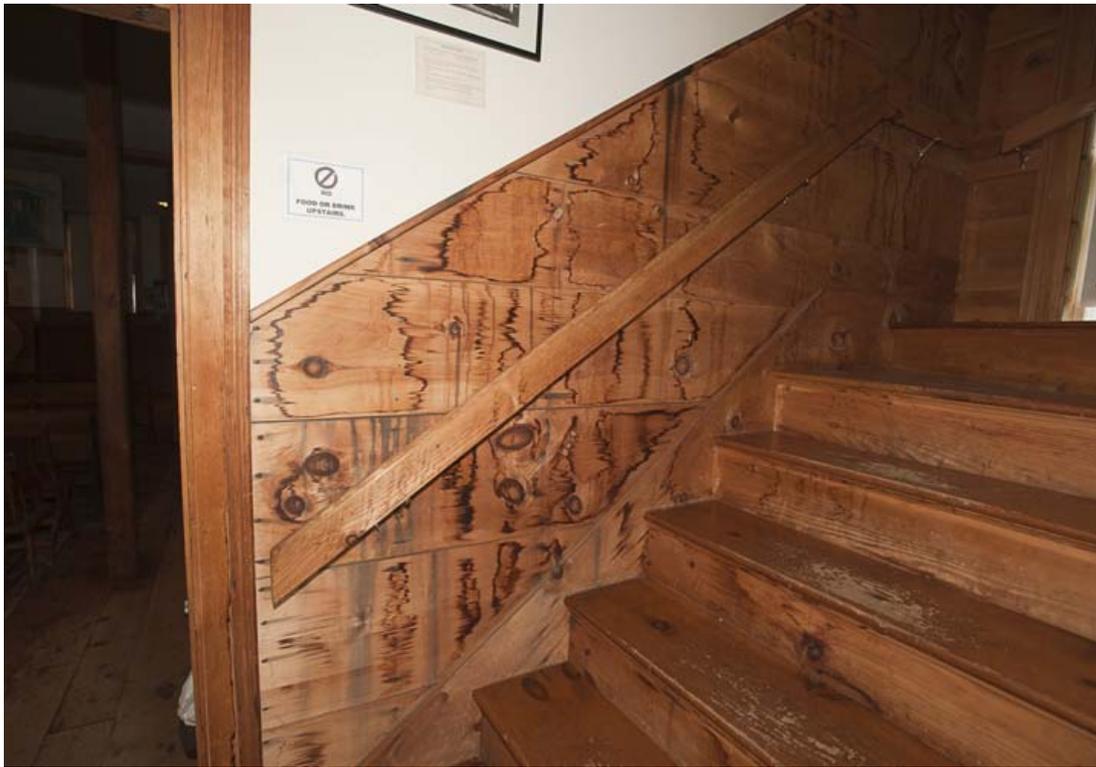
42: Unpainted woodwork in the entry vestibule is severely stained from past water leaks of unknown source. Painting would improve its appearance.

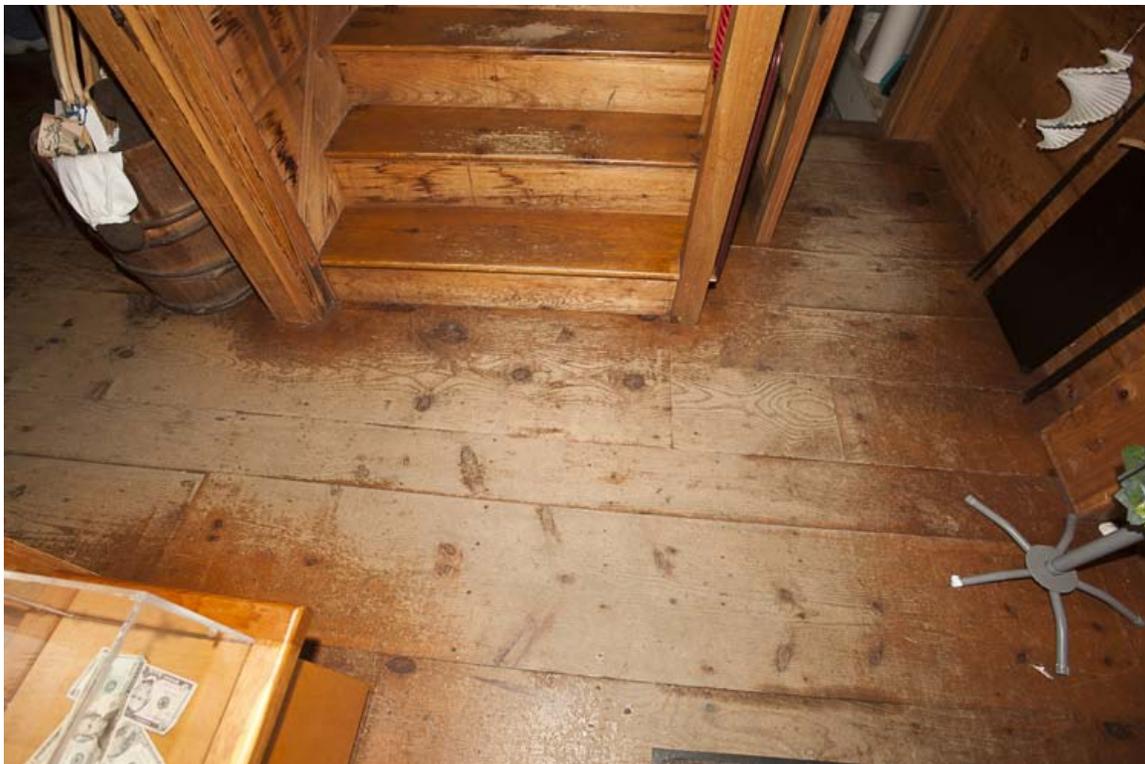
43: The floors received a finish in the 1980 restoration that is now wearing away to bare wood in areas of heavy traffic. A period typical treatment would be either all bare wood without a finish, or paint.
