ARCHITECTURAL CONSERVATION ASSESSMENT

August 1, 2011

1790 WESTFORD ACADEMY

TOWN OF WESTFORD & WESTFORD HISTORIC SOCIETY

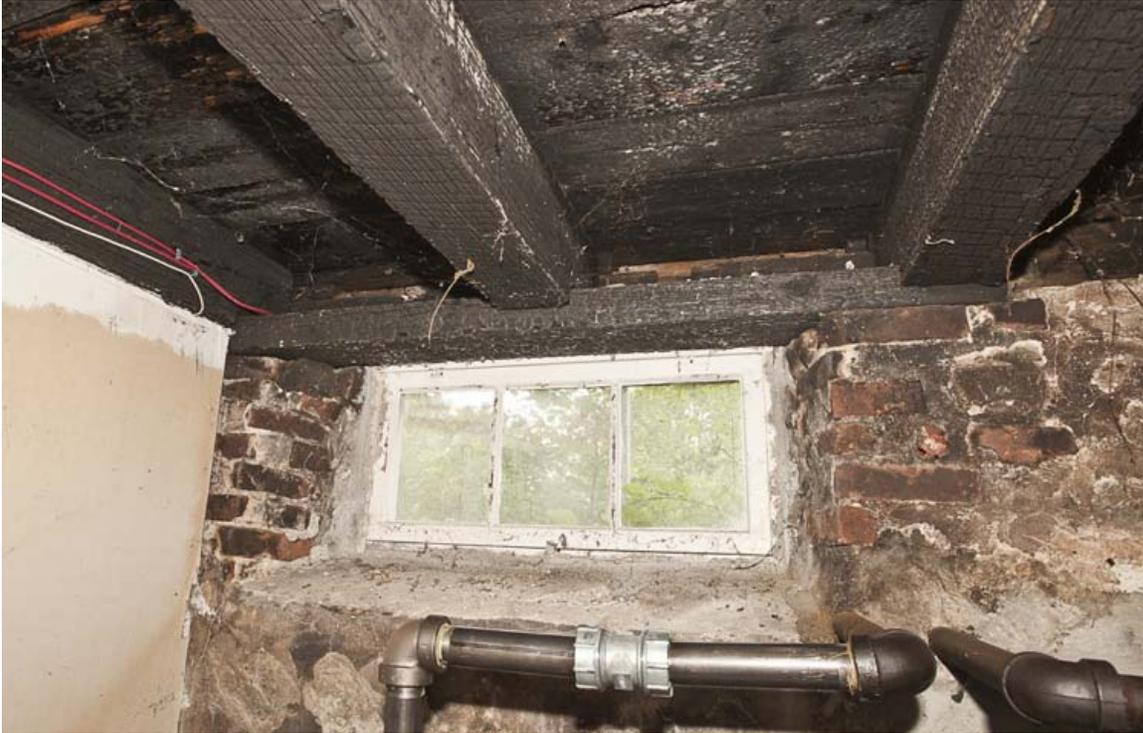
46: Char on the framing near the northeast corner is from a fire in 1982 that was started by a lightning strike on the cupola. The floor joist bears on charred lintel over the window opening. The lintel does not show any visible deflection or other visible signs of being over-stressed. To confirm the remaining sound thickness of the lintel, the char can be scrapped off a section of so it can be measured

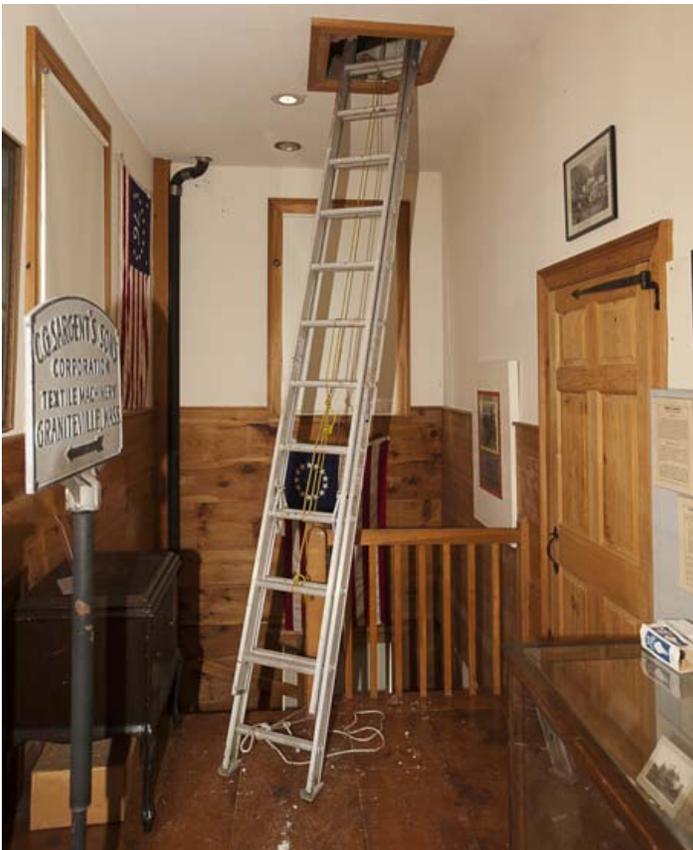
47: Existing access hatch to the attic with a ladder set up to enter the attic. The access is somewhat awkward and discourages regular checking of the attic. Re-positioning it and making it a little larger is recommended. We understand it is too high for a stock folding attic stair ladder, but perhaps a custom installation could be fabricated to eliminate the need to haul a ladder up the stairs.

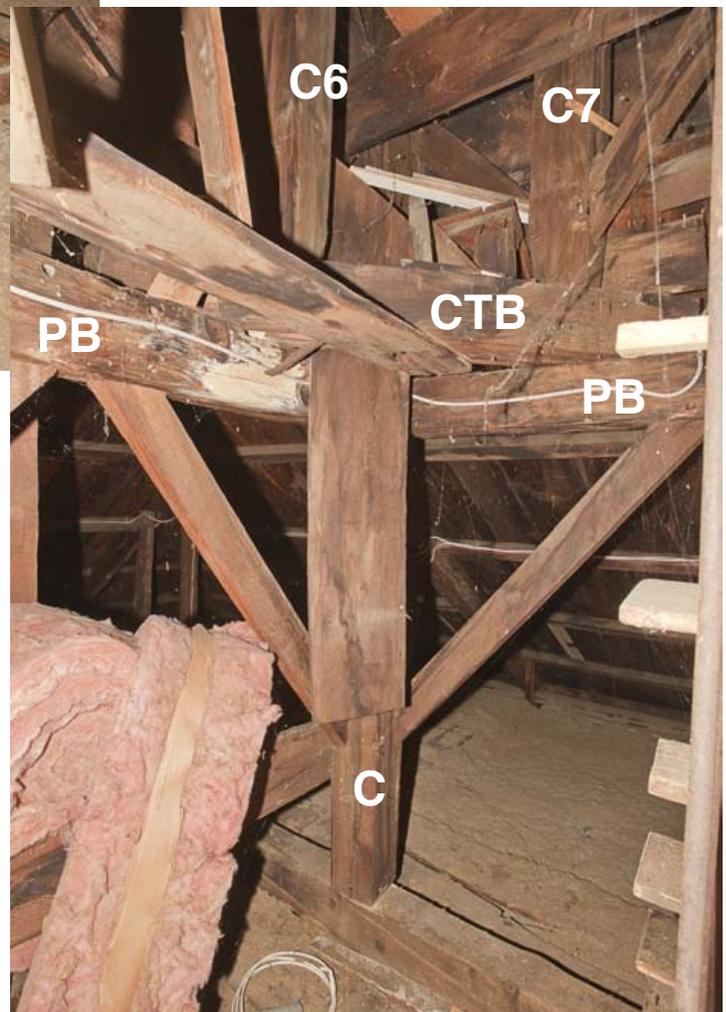
58: Looking up at the southeast bell deck post “C” sitting on the main transfer beam at the attic floor level. The lower perimeter beams between the bell deck posts are marked “PB”. The cupola post transfer beam (CTB) spans over the two perimeter beams and in theory transfers the loads from posts C6 and C7 to the perimeter beams, which in turn transfer the loads to bell deck post “C”. The whitish patch (arrow) on the perimeter beam is fungus with rot and insect damage behind it and on the portion of the cupola transfer beam above it. This is shown in more detail in photos 63 and 64. We suspect that much of the loading from C6 has been transferred above this area to the ridge beam as shown in photo 56. The end of the cupola transfer beam under C7 appears to remain sound.

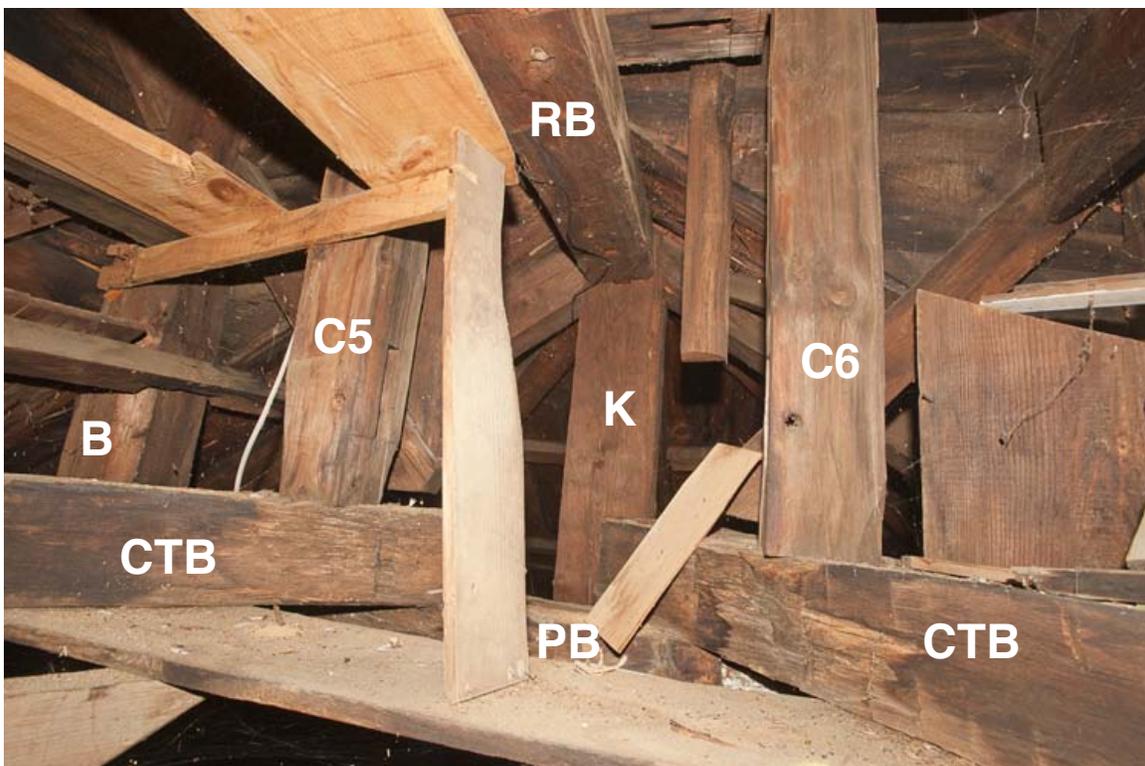
59: East side of the bell deck frame & cupola frame where the cupola transfer beams and perimeter beams appear to be sound. Arrow points to the fungus on the perimeter beam that is under the cupola transfer beam. The ridge beam (RB) may be carrying most of the loads on C5 and C6.

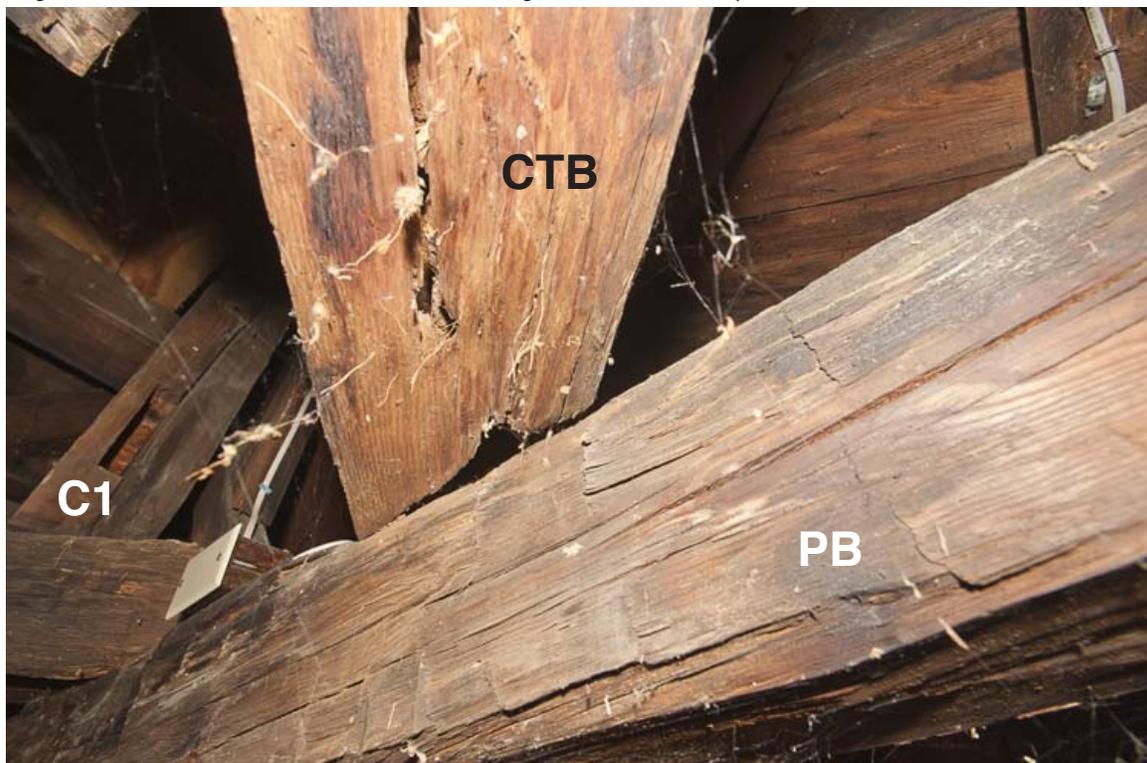
61: West side of cupola frame showing the underside of the cupola transfer beam under cupola post C2. This end of the beam is completely rotted out except for a thin shell where it bears on the perimeter beam below it.
