# *Planning Study*

## *Roudenbush Community Center*

*65 Main Street, Westford, Massachusetts*

*September 5, 2014*

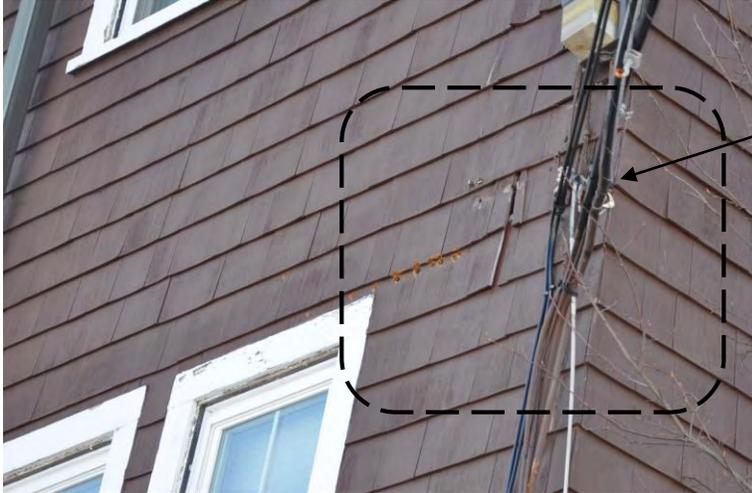
The wood shingle siding is in good condition with the exception of a few areas which were damaged by the removal of some utility wires at the front left corner of the building. There are other limited areas where the shingles should be replaced.

- 8.3 Selected limited areas each of the granite foundation and the brick chimney need to be repointed.
  - 8.4 Further evaluate the condition of, and selectively replace limited areas of the wood shingle siding. It is intended to preserve as much existing siding as is practical.

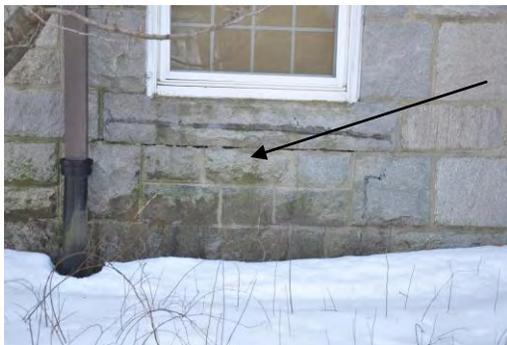
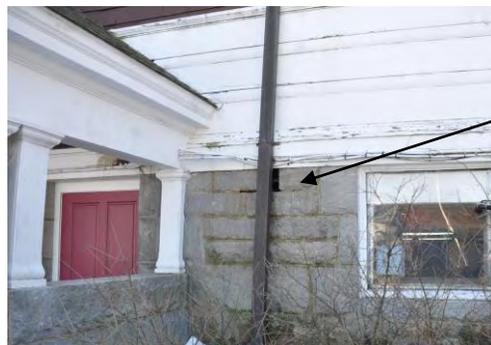
The foundation is cut granite. There are several locations where the mortar is missing or loose. There are stone sections missing from this foundation that should be restored. The downspouts on the main building are copper and are all in good condition.

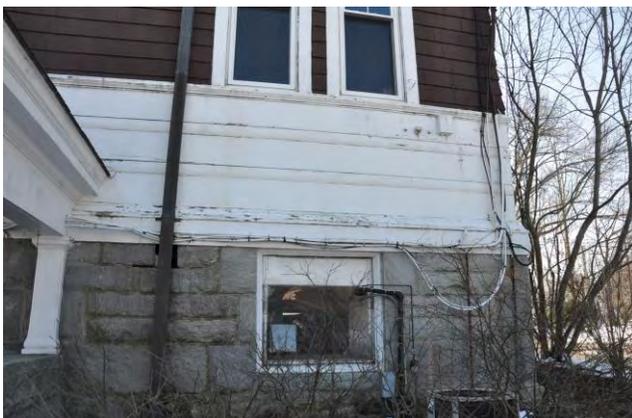
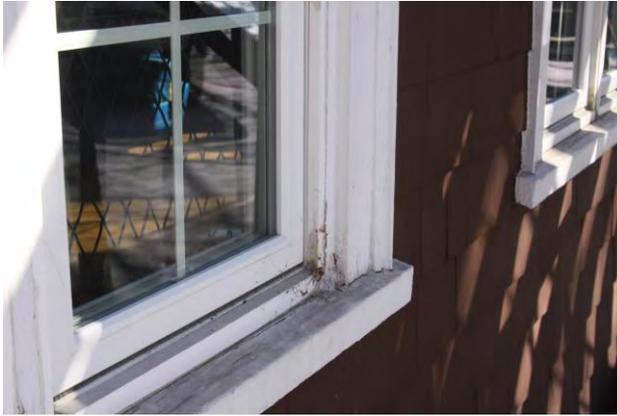
The exterior trim is painted wood. There are many areas where the paint is peeling. There are areas where the wood has started to decay due to long periods of weathering exposure.

8. Exterior repairs and improvements
  - 8.1 Exterior trim shall be cleaned and prepared for painting. Selective replacement of 10-20% is required.
  - 8.2 Repair the cupola. It is anticipated that all of the shingle siding will be replaced and most of the trim on the cupola will be replaced. A lift or other access will be required to further evaluate the scope of replacement of the cupola trim. Due to the difficulty of accessing the cupola for future maintenance, it may be preferred to replace the trim with a very low maintenance product such as PVC or Mahogany. The exact material will need to be determined based on maintenance and historic preservation concerns. Upgrade the roof hatch providing access to the cupola floor; replace the waterproof floor/roof covering. Patch and preserve the copper cupola roofing.

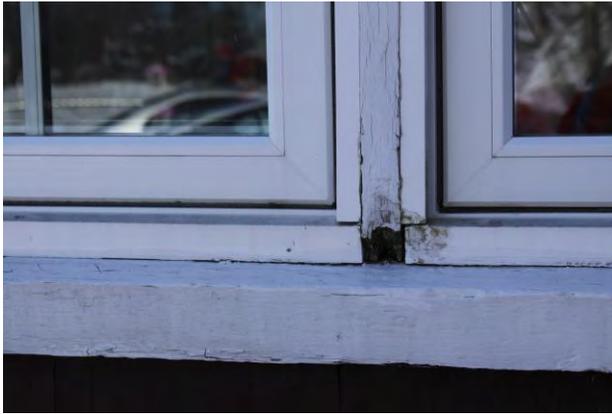
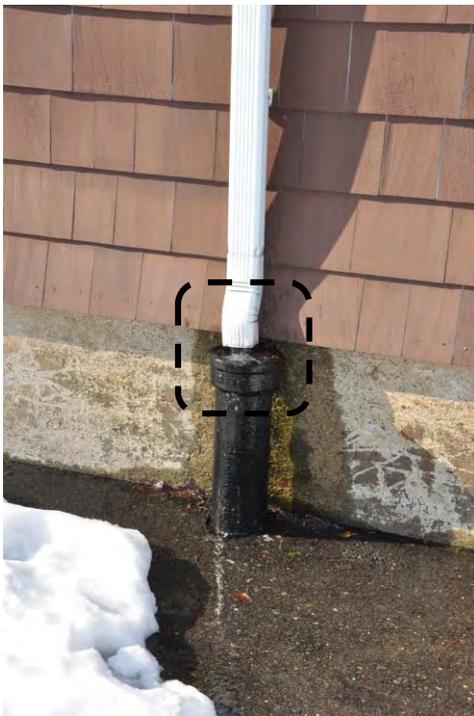
The windows are vinyl with insulated glazing. The windows at the gymnasium were installed in 2006, and in 2007 vinyl windows were installed in the rest of the building. There are a few remaining single glazed units in the arched windows at the stair towers on the North and South sides.

- 8.7 The brick chimney is generally in good/fair condition with limited areas requiring repointing.
9. Most of the windows in the building have been replaced with vinyl windows. It is intended for these to remain. The irregular shaped and smaller decorative units have not been replaced and these windows are candidates for repair and interior storm windows.

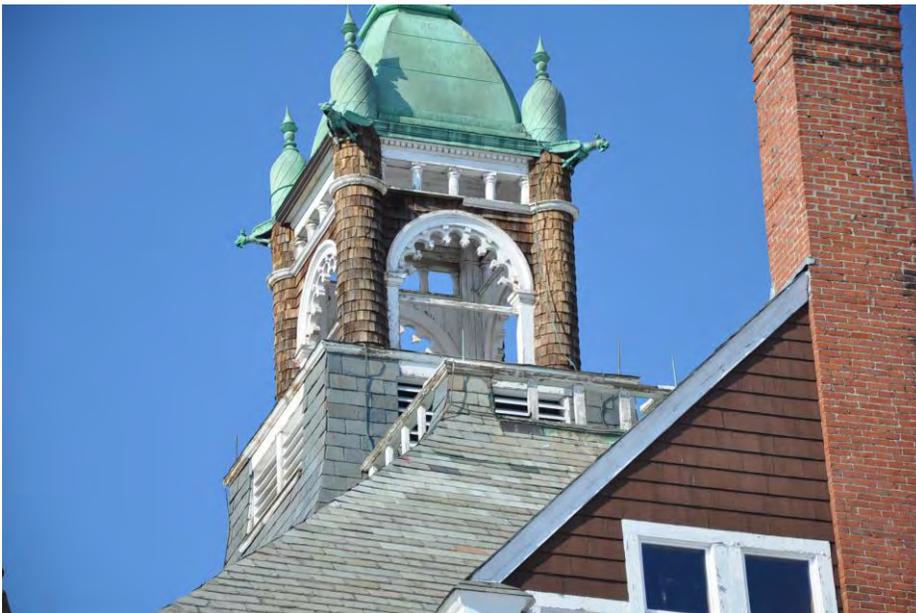
Many areas of the main roof slate shingles are loose and cracked. There is an absence of flashing in some areas and improper fasteners have been used. There are ongoing failures of the roof, including falling slate.

The cupola siding and wood trim has deteriorated. The painted wood trim is peeling in many locations. Sections of the wood trim are missing. From a distance, the copper roof and ornamental finial appear to be in acceptable condition. Better access is required to further evaluate.

repairs have been required and based on these repairs it appears the general installation was of poor quality and ongoing failures are likely. The primary failure is falling slate. It is possible that some of the existing copper flashings may be acceptable to remain. This should be further evaluated.

- 8.5 Paint the entire exterior.
  - 8.6 Replace the slate roofing with new slate roofing. Copper accessories such as existing ridge caps and finials should either be carefully removed and reinstalled, or new ones should be made to match the existing. New snow guards to be installed. Integral gutter systems should be relined. Entire substrate to have new roofing felt, and ice and water shield at the eaves, rakes and valleys. Any damaged sheathing should be replaced. The existing slate roofing was installed in the last several years (15+/-). However, numerous

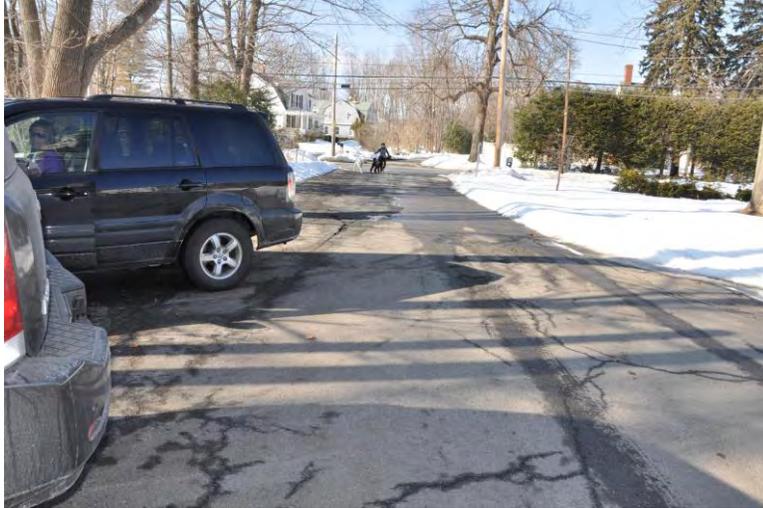
Observations of the parking reveal cracking and crumbling due to freeze/thaw cycles and settling due to traffic use. Parking striping is very faded but has been restored since this photo was taken.

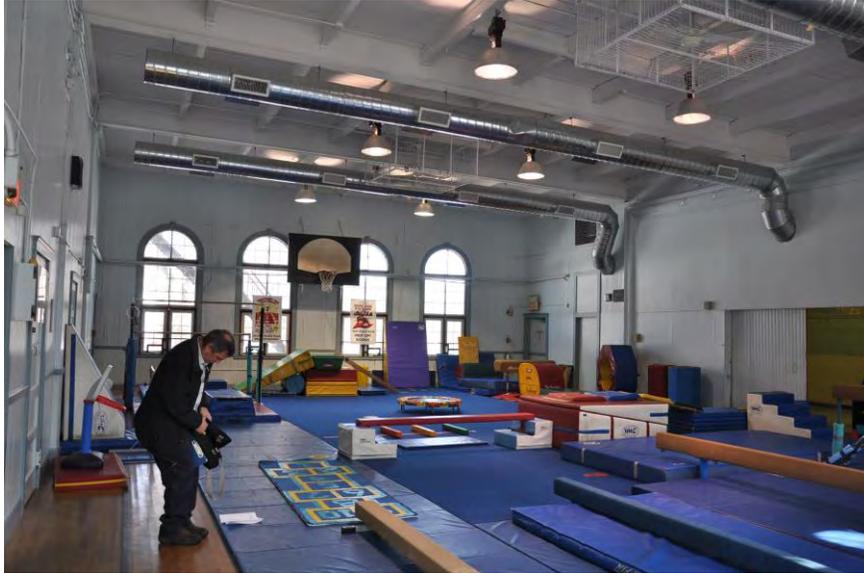
The gymnasium has hardwood flooring, painted gypsum walls and a painted exposed structural ceiling. The roof structure is composed of the main support framing in steel with the purlins and decking in wood. There is exposed, unpainted spiral ductwork. The North and South elevations have floor to ceiling windows. There are two ceiling fans in the room.

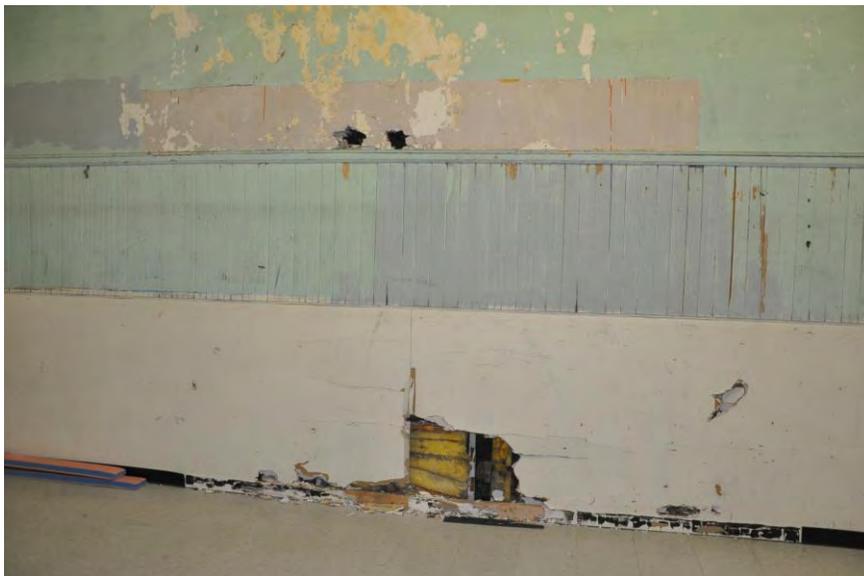
Wall damage in a storage closet.

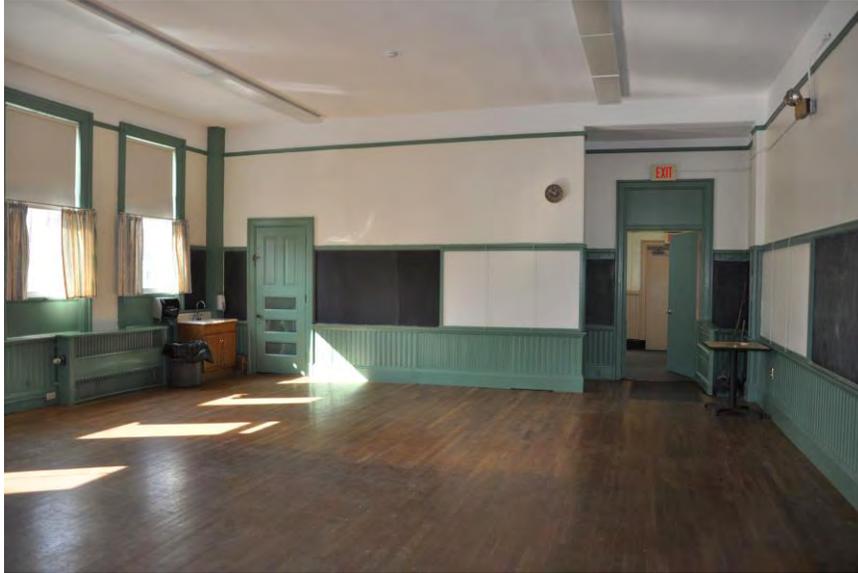
Classroom at First floor level with wood floors, painted wood wainscoting and trim, plaster walls and ceilings. Light fixtures are linear fluorescent fixtures mounted to the ceiling. There is a steam radiator. There is a sink in the corner of the room. The wood floor shows considerable wear.

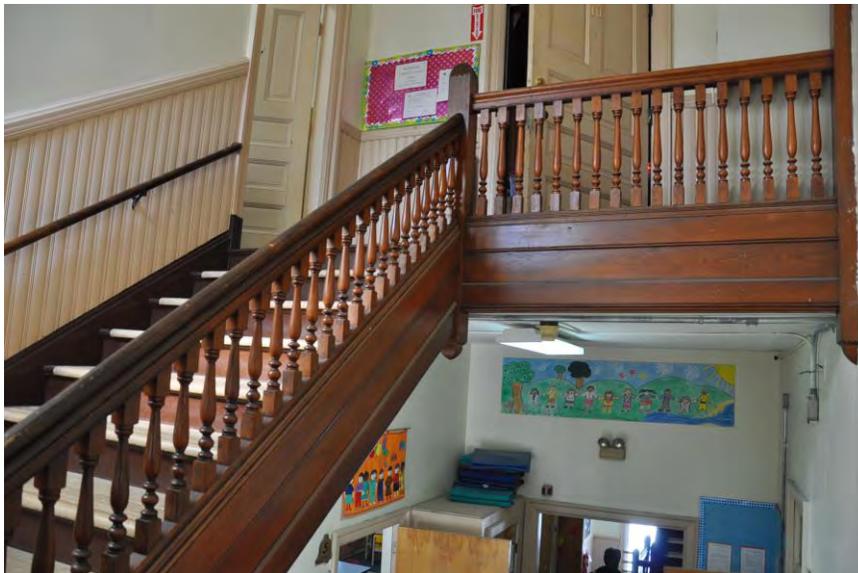
Existing stair railings do not meet current code requirements. Stairs are not enclosed for egress requirements. Rooms open off landings (not permitted by current codes).

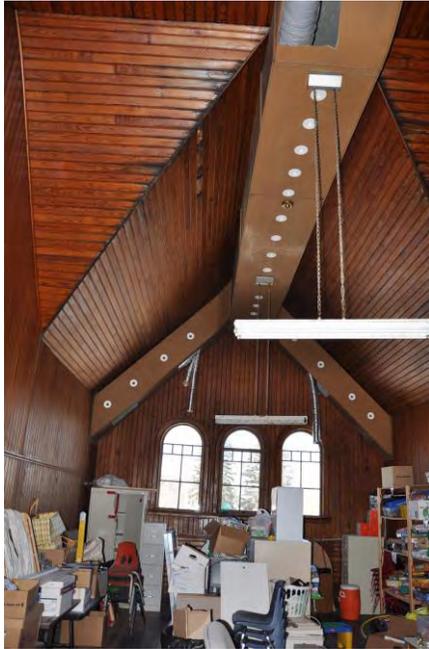
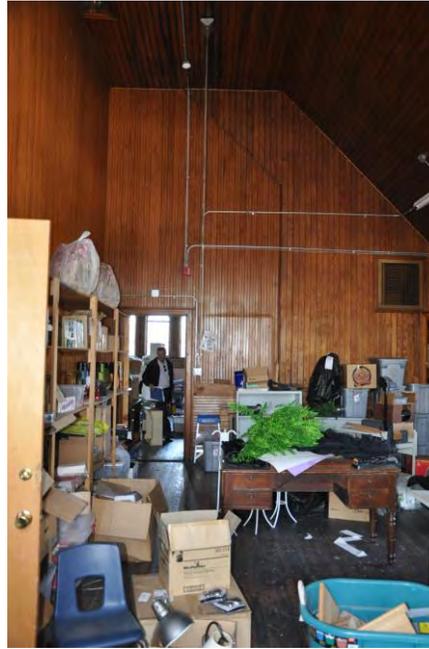
View of an abandoned, high velocity HVAC system to third floor. High velocity piping and outlets were installed in ductwork originally part of a gravity ventilation system.

Rooms at Third floor level are currently used as storage. This is primarily due to having no handicapped accessibility, limited HVAC and dependency on a fire escape.

- Remove existing high velocity duct air handling unit located on the third floor and replace with ducted hot water fan coil units.
