Westford
 Museum
 Historic Rehabilitation
 2 Boston Road
 Westford, MA 01886

Job Number: 1301
 Scale:
 Drawing Name:
 Site and First Floor
 Plan & Site Details

A-101

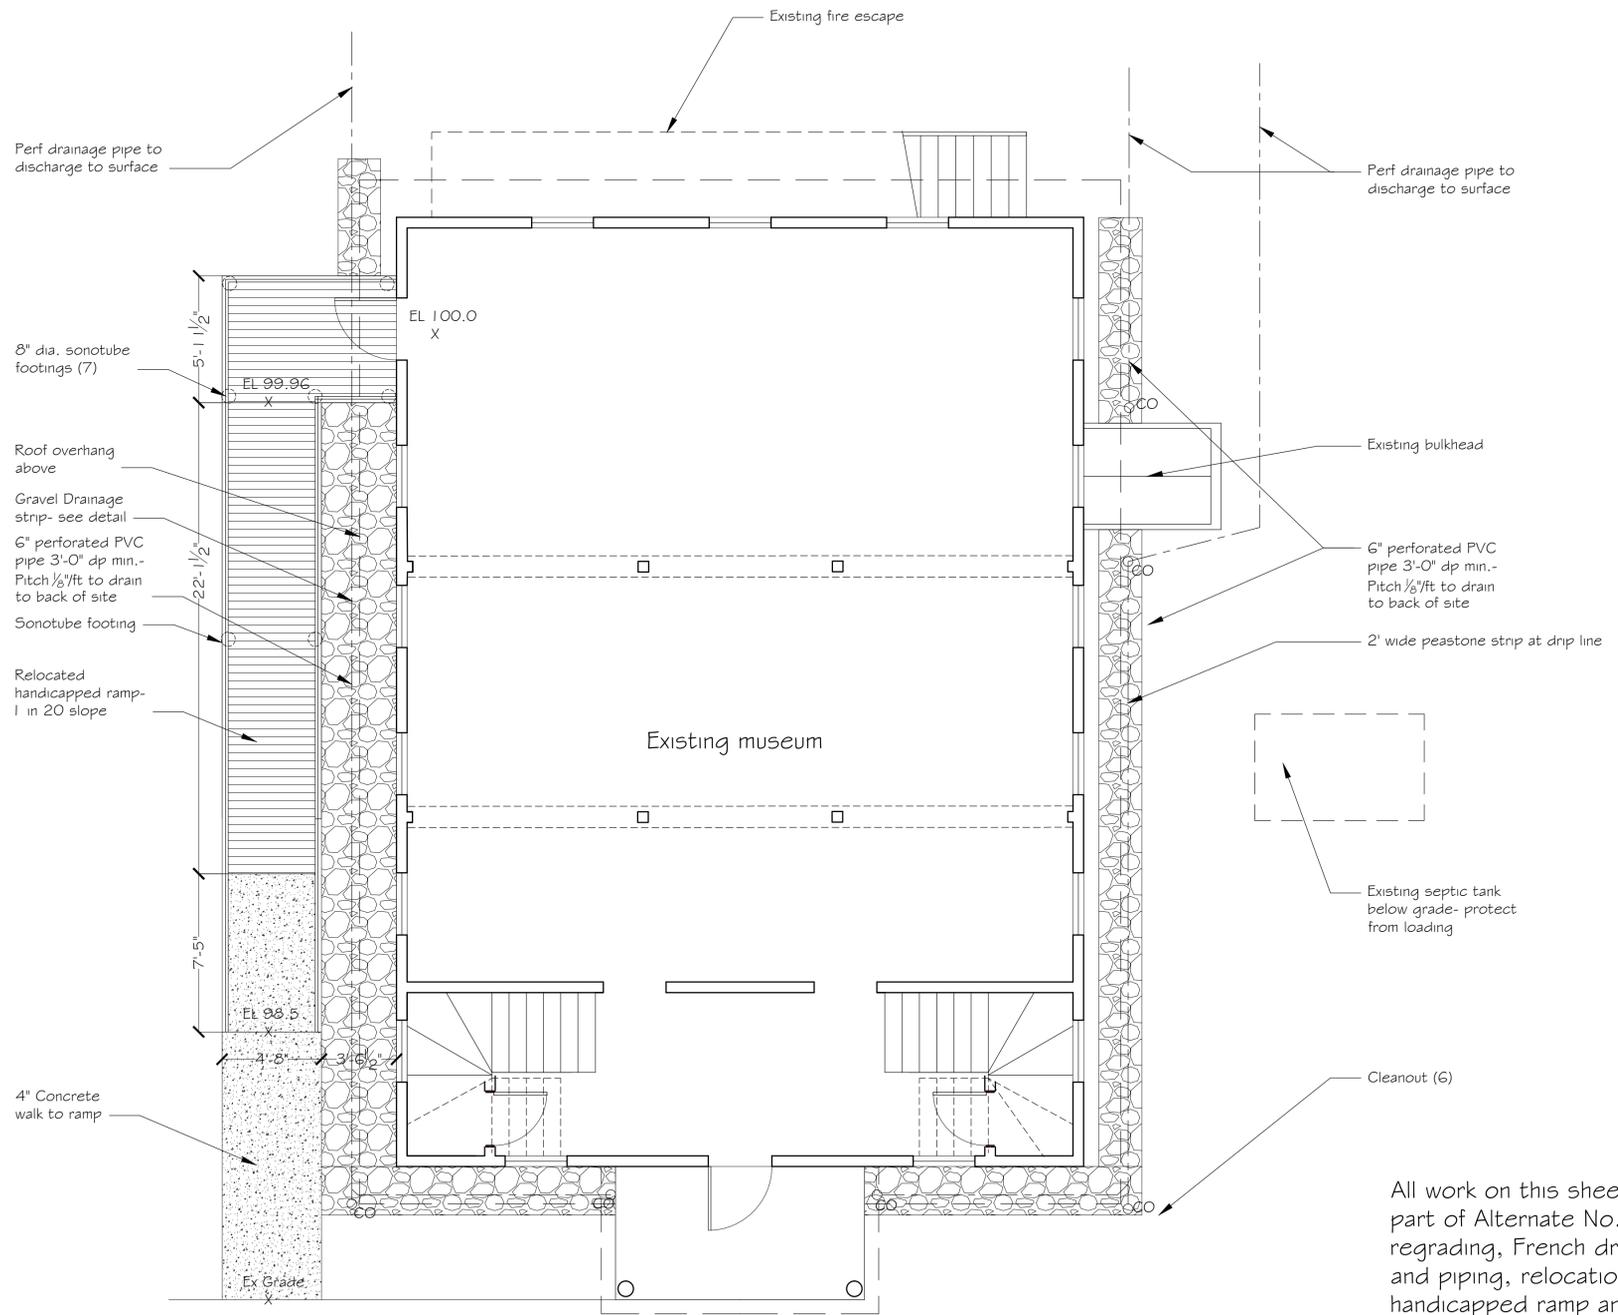
1 First Floor/Site Plan (Alternate 2)
 A-103 1/4" = 1'-0"

All work on this sheet is part of Alternate No. 2; regrading, French drains and piping, relocation of handicapped ramp and walk, foundation repointing

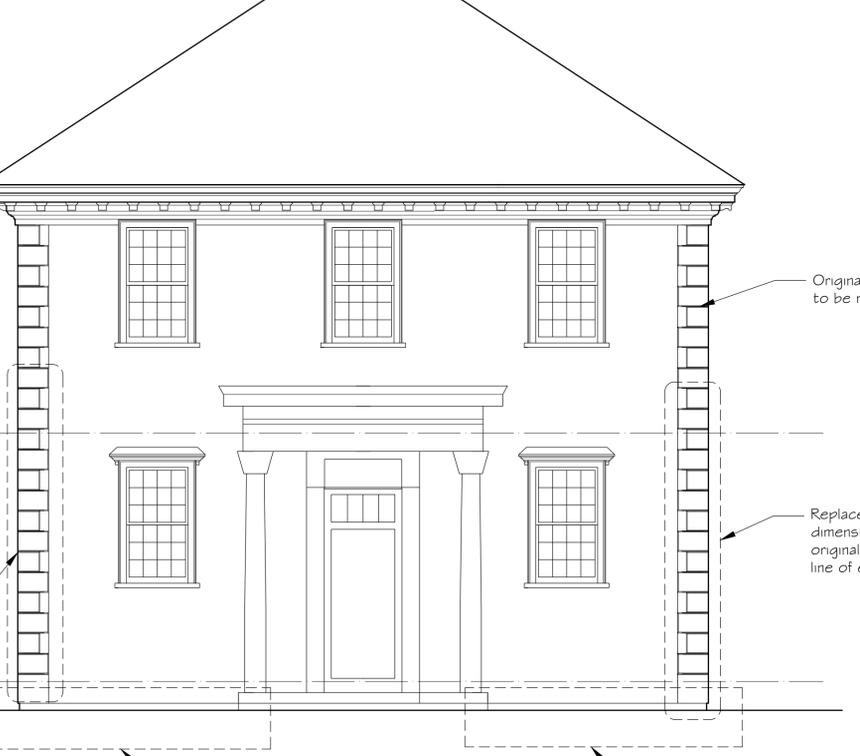
21
 A-104 1/4"=1'-0" West Elevation

(Alternate 2) Excavate to bottom of granite facing- repoint joints and fill voids with mortar

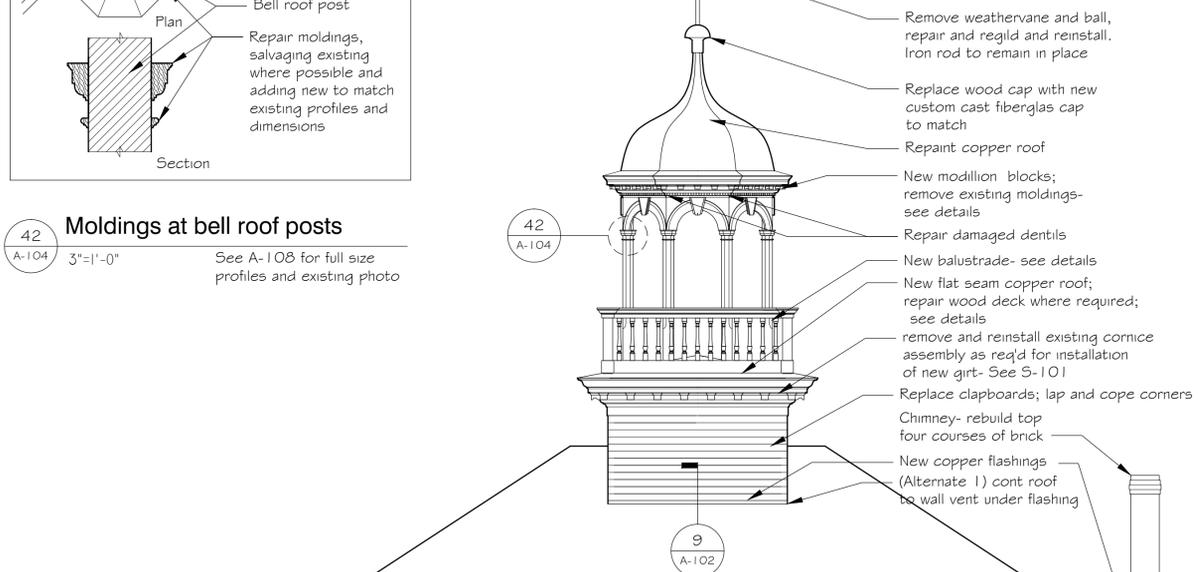
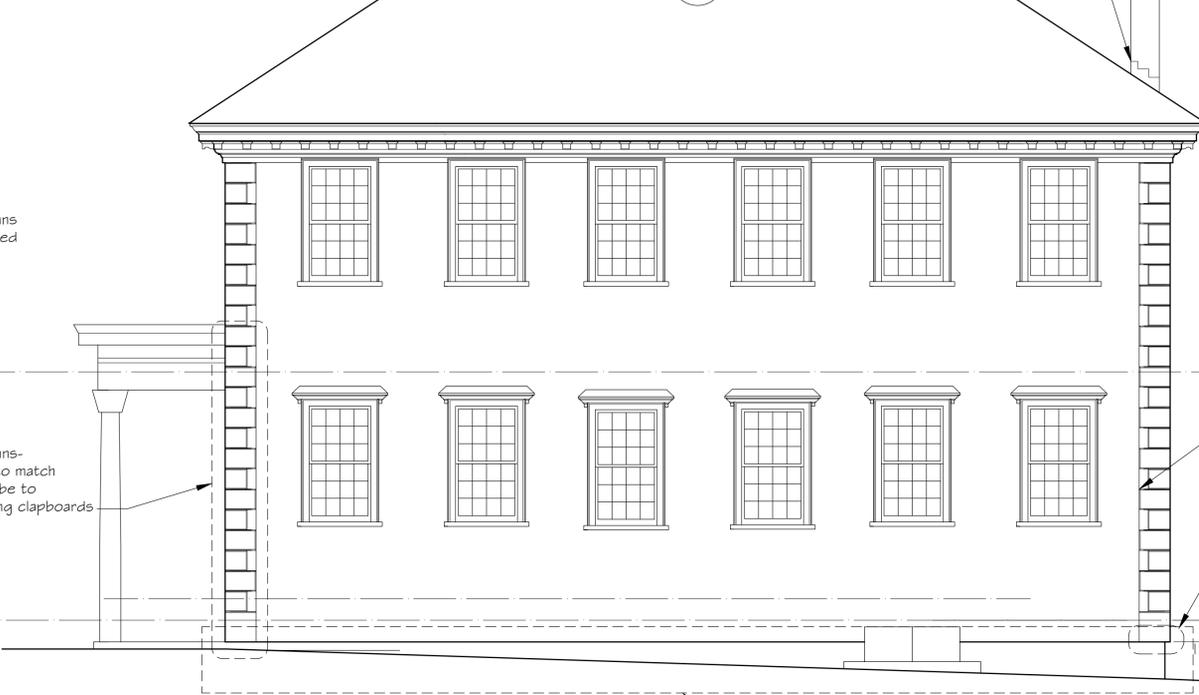
22
 A-104 1/4"=1'-0" South Elevation

(Alternate 2) Excavate to bottom of granite facing- repoint joints and fill voids with mortar

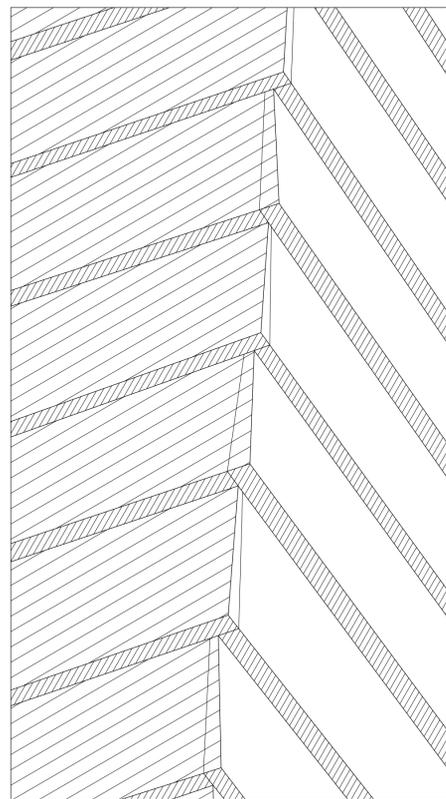
29 Cupola Base Clapboards
 A-106 3"=1'-0"

Lap ends of clapboards and cope to clapboard on other face, alternating direction each course. Run 3' wide ice and water shield underlayment vertically 18" both sides of corner

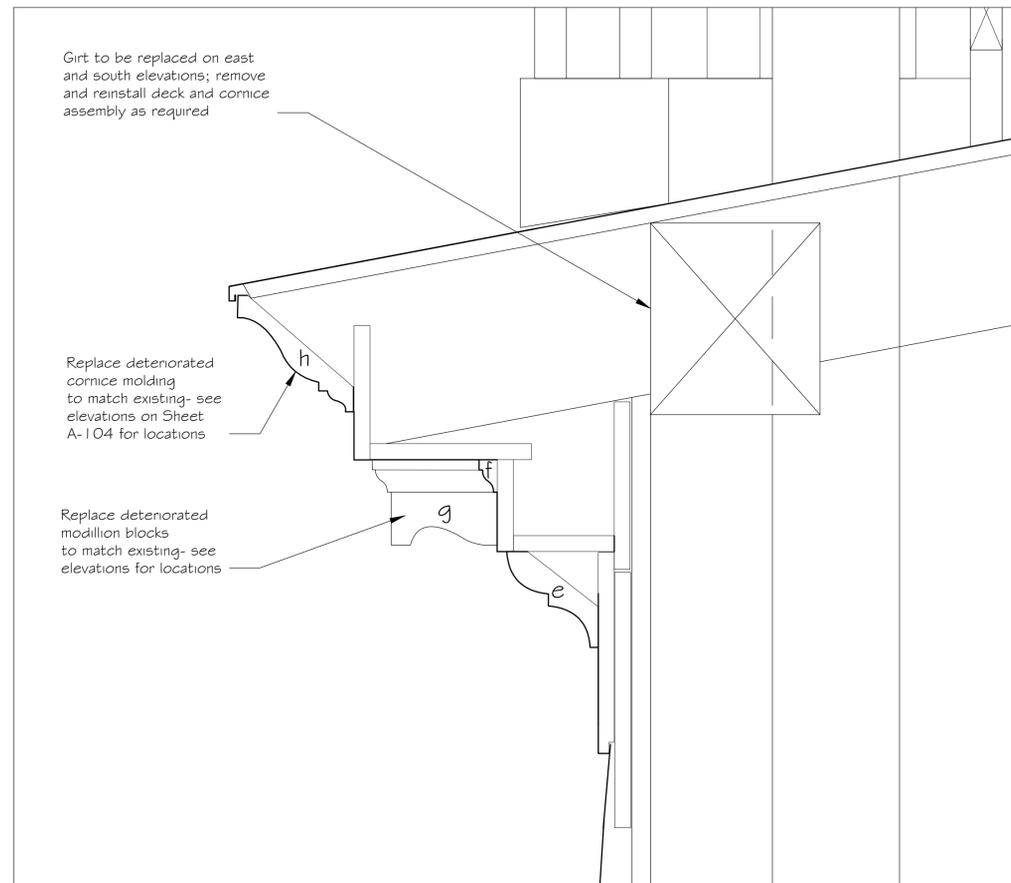
27 Bell Deck Cornice Section
 A-106 3"=1'-0"

See A-108 for full size molding profiles. All new exterior wood to be primed all 6 faces

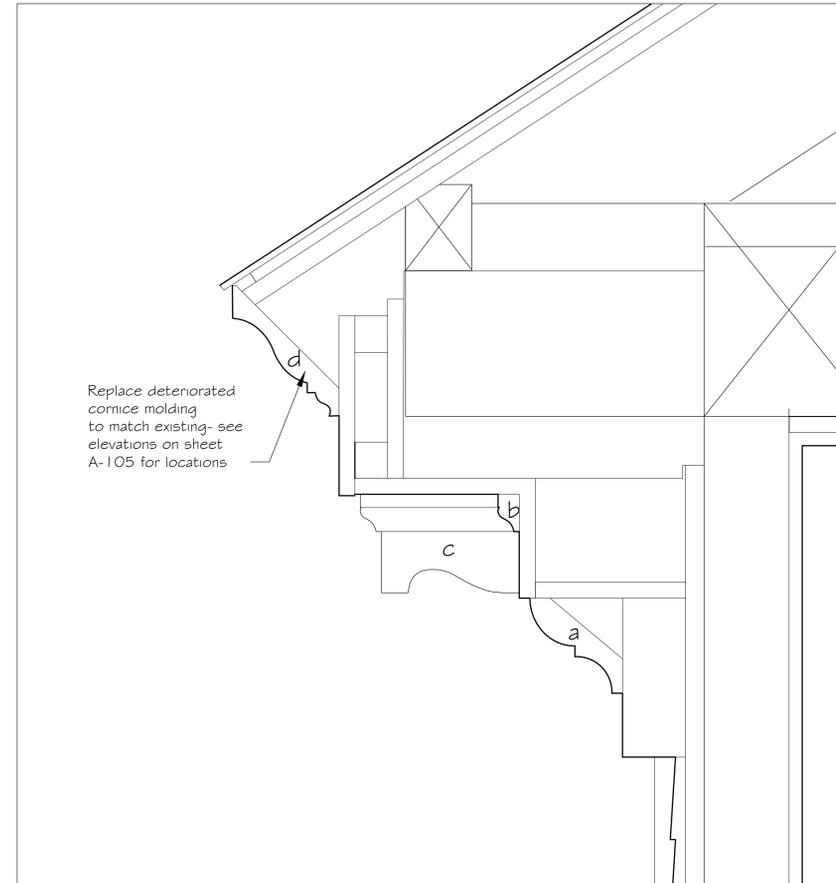
25 Main Roof Cornice Section
 A-106 3"=1'-0"

See A-108 for full size molding profiles. All new exterior wood to be primed all 6 faces

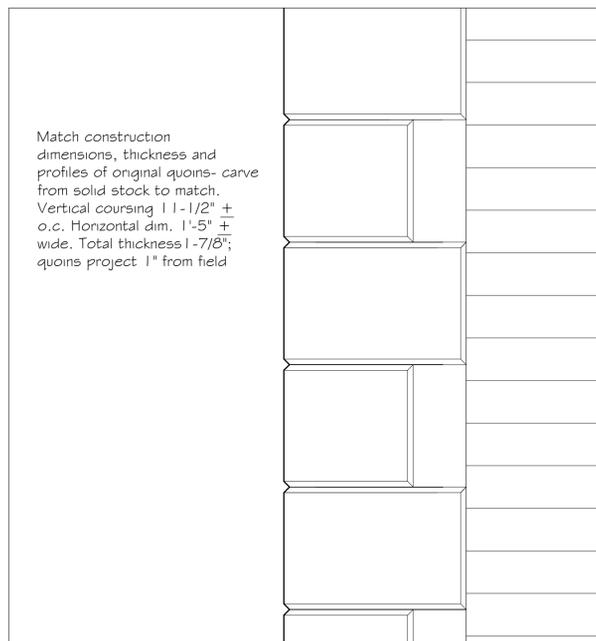
30 Corner Quoin Details
 A-106 1/4"=1'-0"

Match construction dimensions, thickness and profiles of original quoins- carve from solid stock to match. Vertical coursing 1 1/2" +/- o.c. Horizontal dim. 1'-5" +/- wide. Total thickness 1-7/8"; quoins project 1" from field

All new exterior wood to be primed all 6 faces

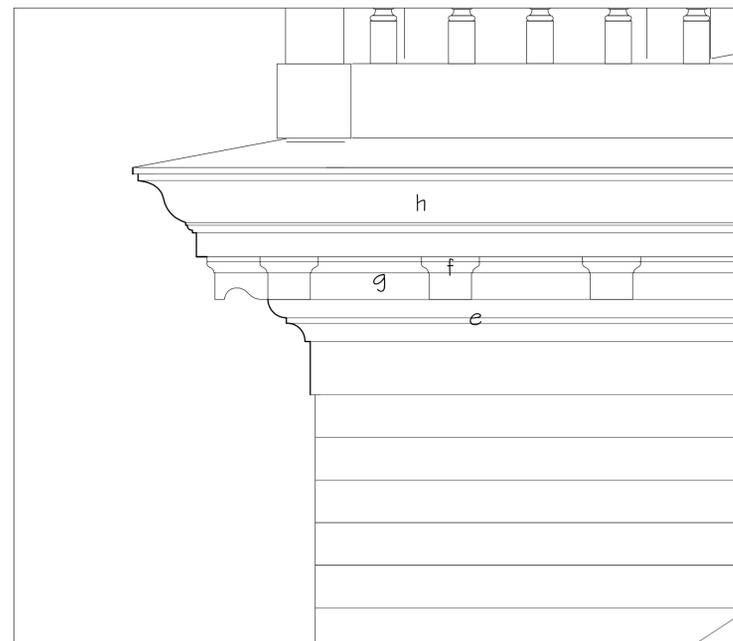
28 Bell Deck Cornice Elevation
 A-106 3/4"=1'-0"

See A-108 for full size molding profiles. All new exterior wood to be primed all 6 faces

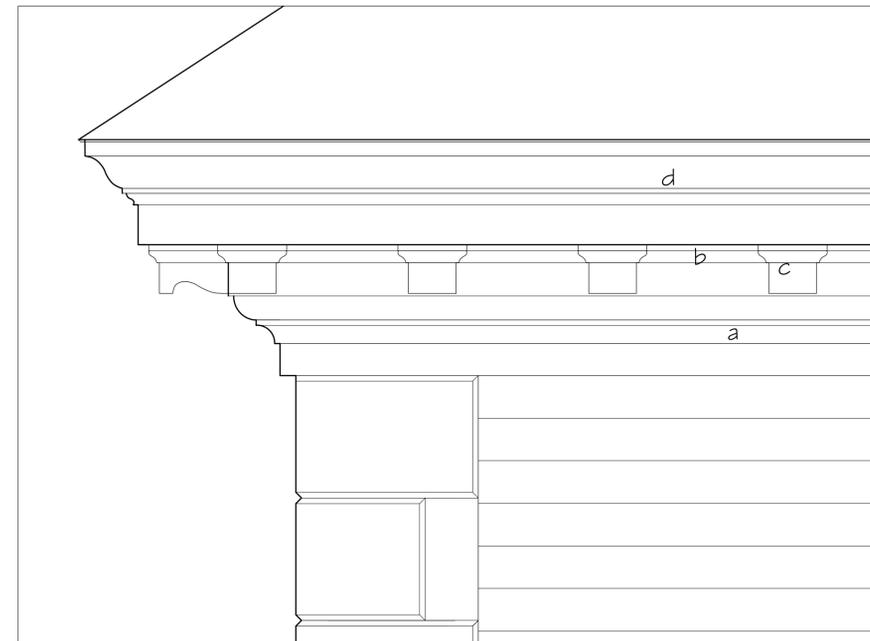
26 Main Roof Cornice Elevation
 A-106 3/4"=1'-0"

See A-108 for full size molding profiles. All new exterior wood to be primed all 6 faces
