SCHEMATIC DESIGN FOR HISTORIC REHABILITATION

PROJECT FOCUS: Integrating Accessibility
Improving Life Safety
Protecting Historic Fabric

WESTFORD ROUDENBUSH COMMUNITY CENTER
Mills Whitaker Architects LLC
1 Oct 2015

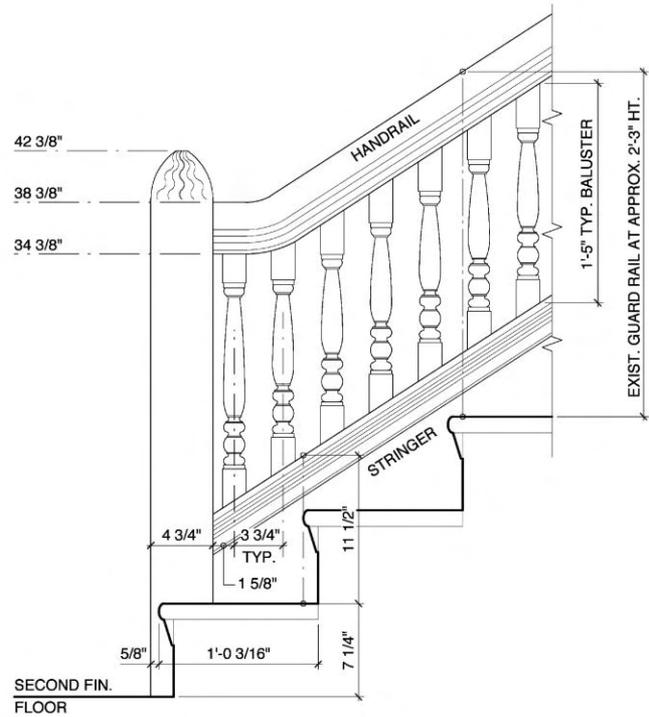
EXISTING
 GUARD AT SECOND FLOOR

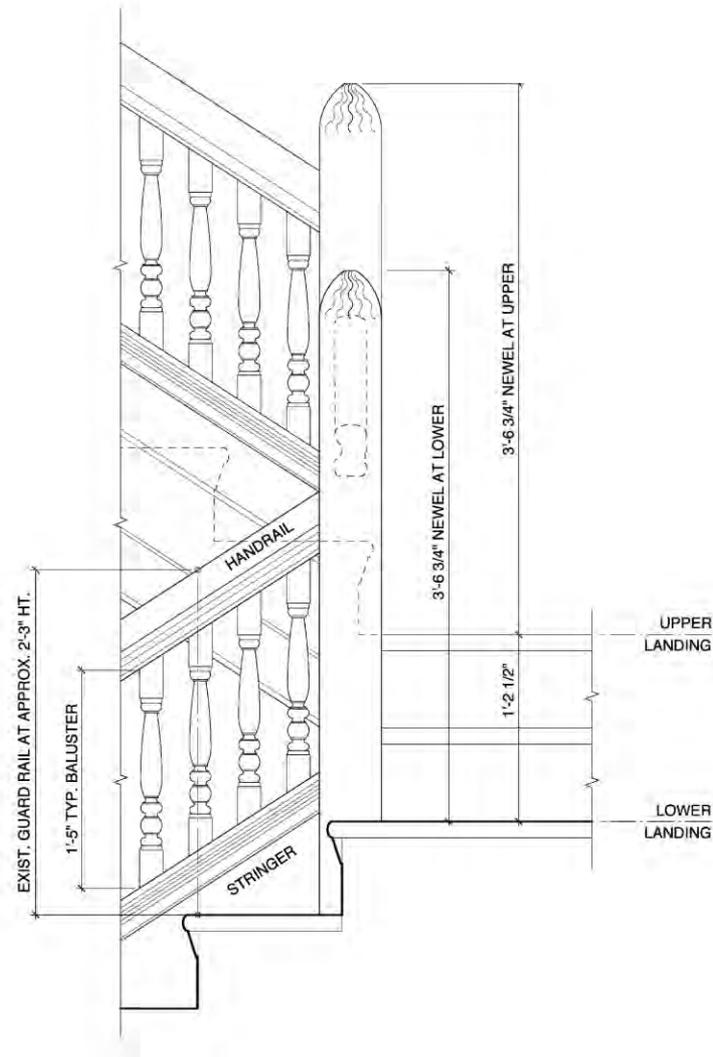
**EXISTING
 LANDING (1.5 + 2.5)**

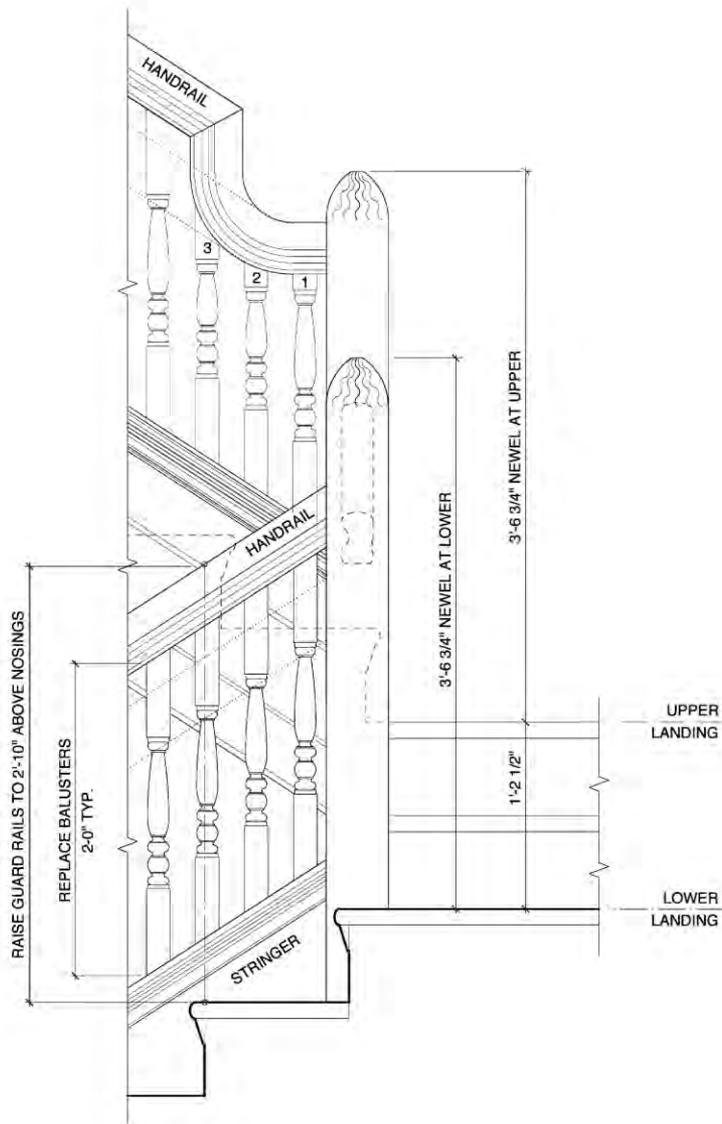
**INTERMEDIATE
 LANDING (1.5 + 2.5)**

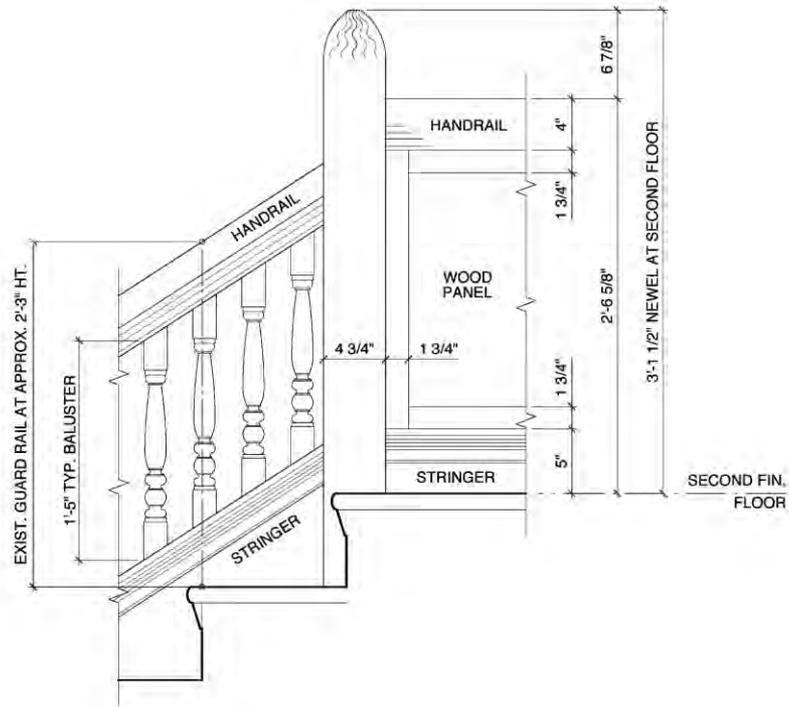
EXISTING
 SECOND FLOOR LANDING
