FEASIBILITY STUDY & INVESTIGATION

Feasibility Study for Exterior Physical
Needs of Roudenbush Community
Center

Roudenbush Community Center

May 15, 2002

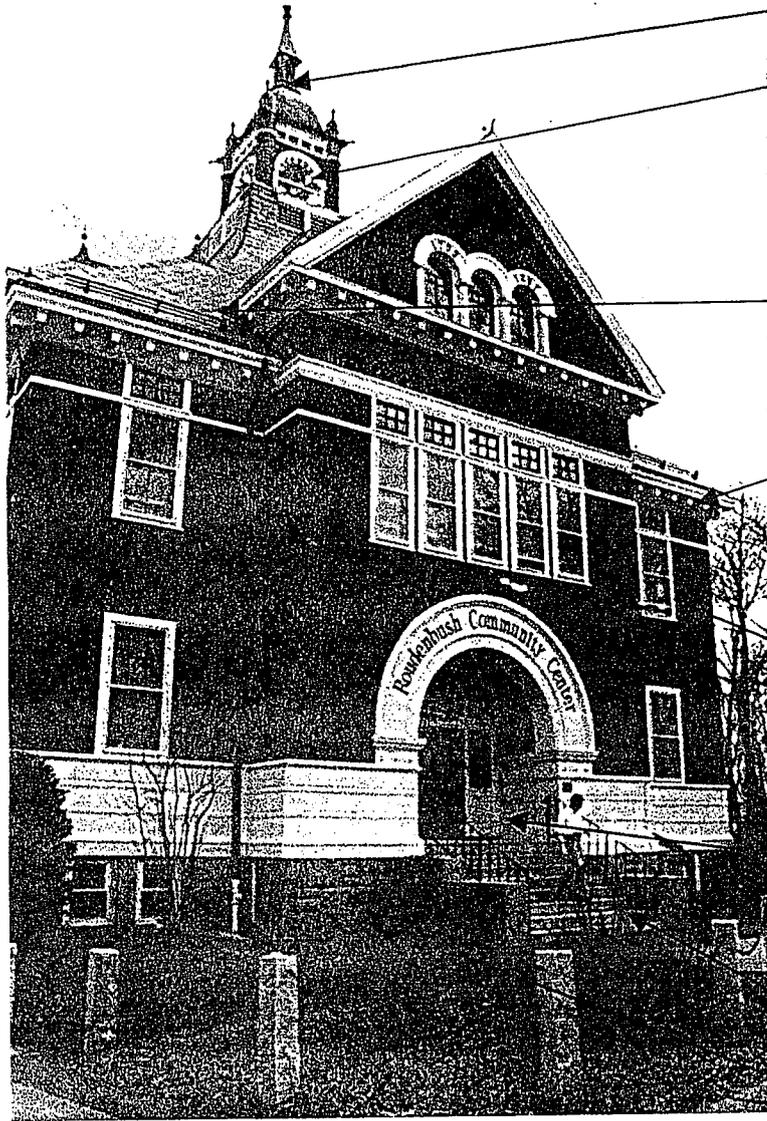
INVESTIGATION @ MAIN ENTRANCE

Copper cupola recently repaired.

New slate roof recently installed with
copper snow rails & metal ridge caps.
(Typical)

Repoint granite steps with flexible joint
sealant. Color to match stone. Railings
do not meet MAAB handicapped codes

Cut and remove exist deteriorated or
missing grout on entire foundation of
building.

Repair or replace to match existing
Deteriorated trim, replace shingles &
metal flashing on cupola with original
details. Prime and paint all surfaces to
match original historic stain colors.

Scrape wood trim paint @ dentils, repair
wood as necessary, prime & paint with
with oil based paint. Apply sealants as
necessary at wood trim and windows,
dentils, etc.

All exterior windows to be replaced with
true divided insulated window glass,
replicating the original pattern & style
Remove all storm windows.

Repair or replace interior foyer wood trim
with new wood to match original. Add
automatic door control for handicapped
accessibility at main & side entrances.

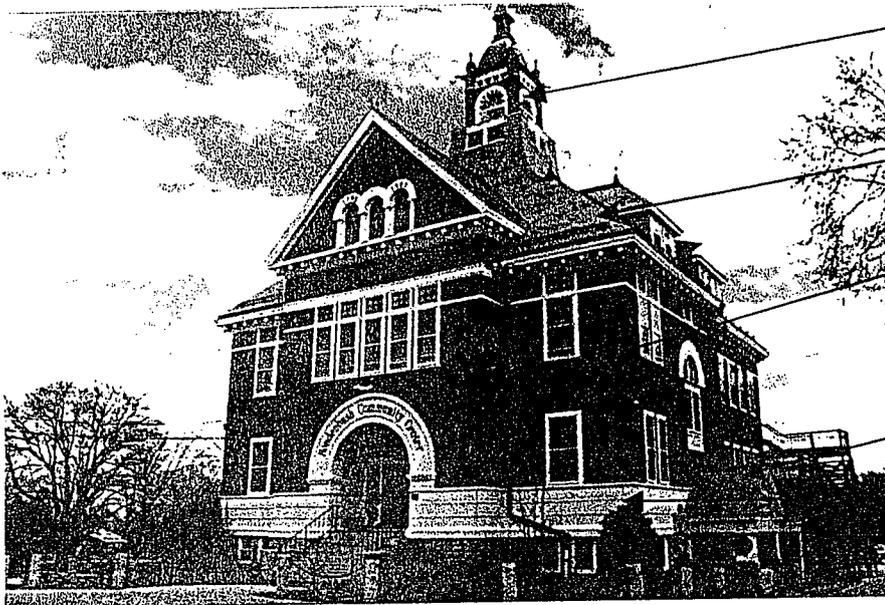
INVESTIGATION @ EAST ELEVATION

Misc. metal & interior wood trim repairs recently completed on cupola.

New slate roof & copper metal vents completed in 2001.

New slate roof.

Existing wood shingles, replace as necessary when found deteriorated.

Existing wood banding & trim. Scrape and repaint with oil prime And two coats of latex finish.

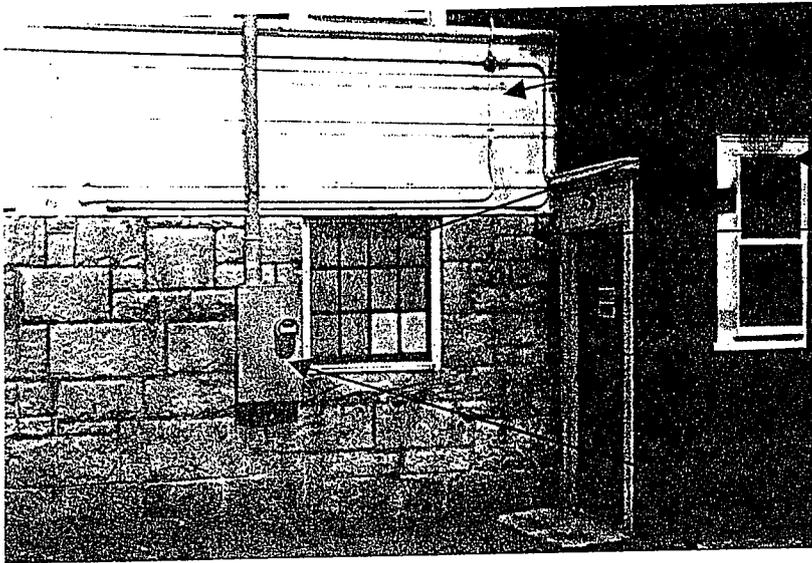
INVESTIGATION @ MASONRY WALL

Wood trim banding.

Old deteriorated window.

Old door, not HP accessible, replace with new to match original raised panel wood door with appropriate Hp hardware.

Exterior electrical panel, consider burying overhead electrical lines to maintain original appearance of the building.

Storm window to be removed.

Cut and repoint granite to match existing colors & texture.

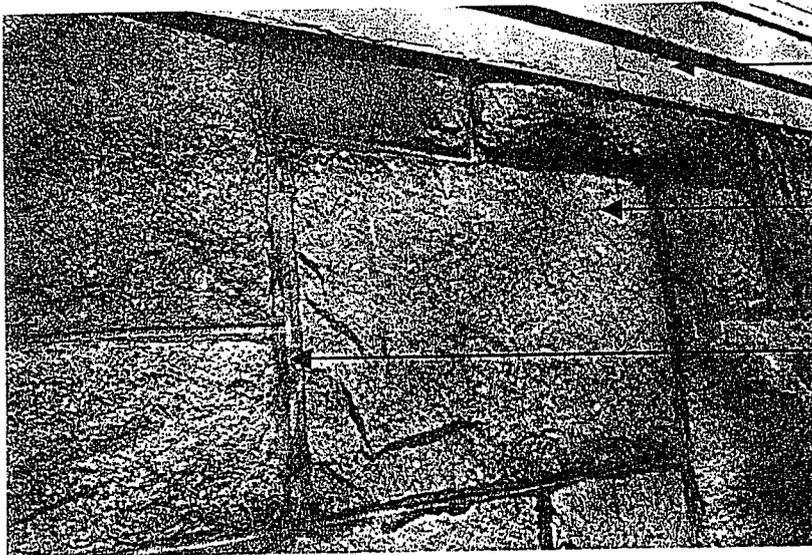
INVESTIGATION @ MASONRY WALL

Deteriorated wood trim.

Random pattern granite stone size found on the perimeter of the building.

Detail of mortar with recessed mortar using tooled joints.

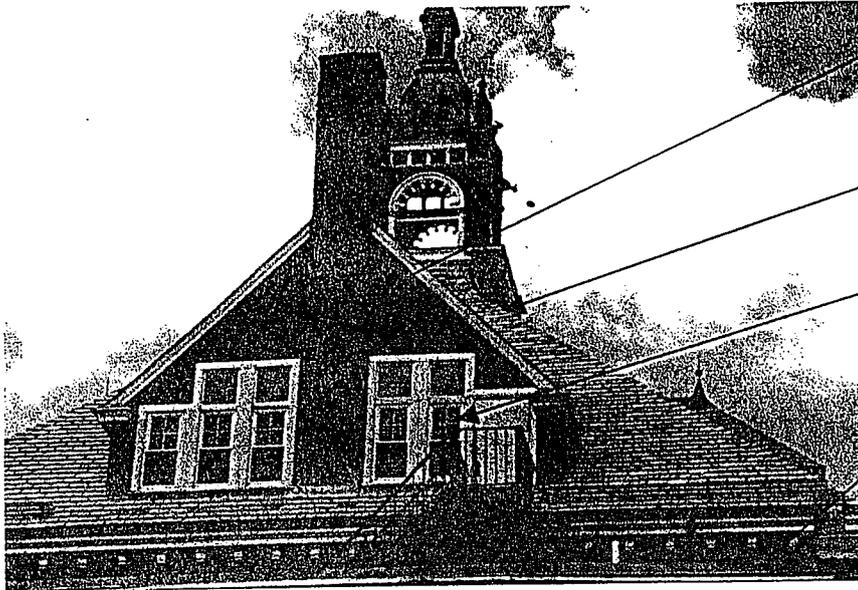
INVESTIGATION @ WEST ELEVATION

Recently installed existing slate roof.

Replace old shingles with new #1 cedar and stain to match original color.

New insulated windows and trim to replace old leaky single pane wood windows.

Repair of dentils and cornice moldings as necessary to prevent Wood rot and water damage.

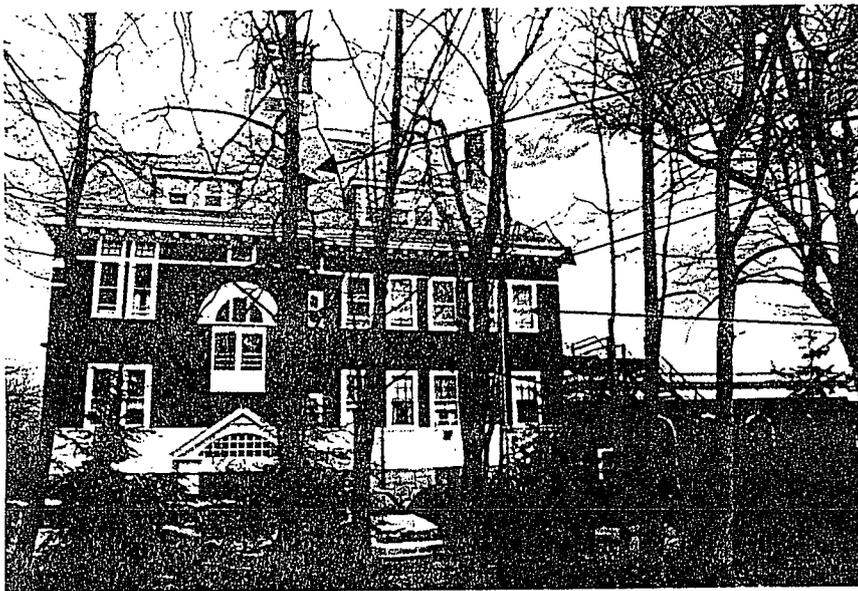
INVESTIGATION @ SOUTH ELEVATION

Recently installed existing slate roof.

Replace rotted wood gutter face with new half cornice molding. Re-attach new metal gutter and rain leaders

New insulated windows and trim to replace old leaky single pane wood windows.

Replace old shingles with new #1 cedar and stain to match original color.

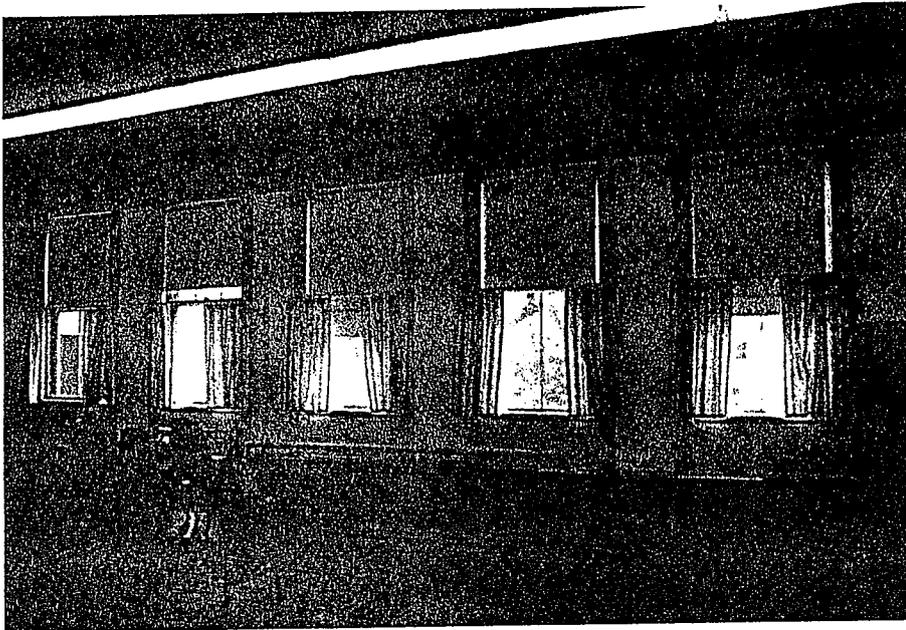
INVESTIGATION @ INTERIOR WINDOWS

Existing double hung windows wood sash and casings. Glass is single pane. Wood stops should be tested for hazardous materials and new metal double hung windows are recommended.

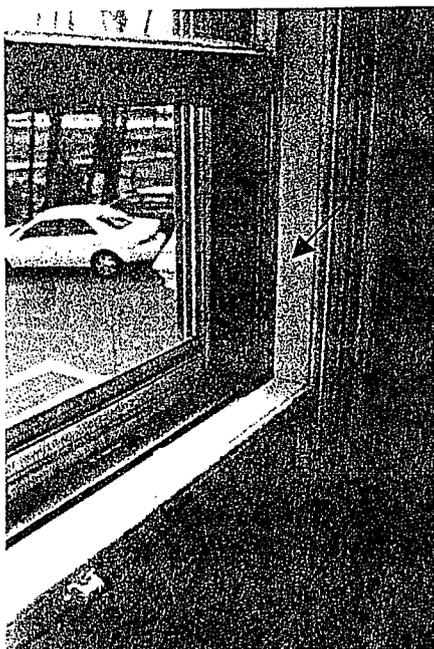
INVESTIGATION @ INTERIOR WINDOW SILL

Existing wood casing and trim.

Replace old leaky single pane wood Windows with New insulated windows and trim to match exist.

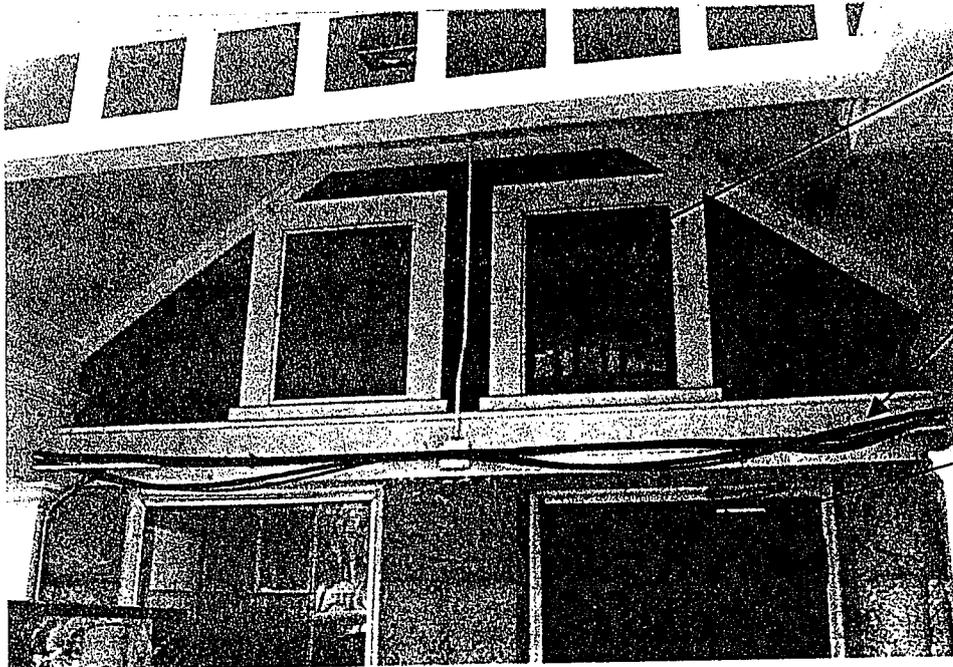
INVESTIGATION @ SOUTH SIDE ENTRANCE

Door closer mounted on incorrect side of door. Subject to weather.

Replace single pane wood window with new trim, use divided light windows.

Remove all exterior mounted wires from building & redirect to the exterior.

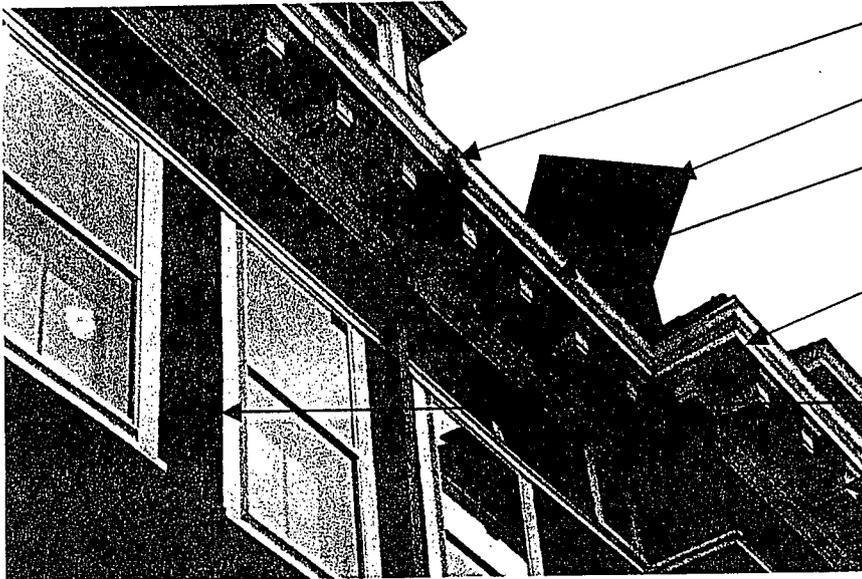
INVESTIGATION @ ROOF DENTILS

New copper rain leaders installed.

New metal ventilators installed.

Repair wood cornice & wood structural systems as necessary.

Replace deteriorated wood gutters cornice with new moldings to match original.

Wood trim window repairs.

Scrape and paint all wood trim.

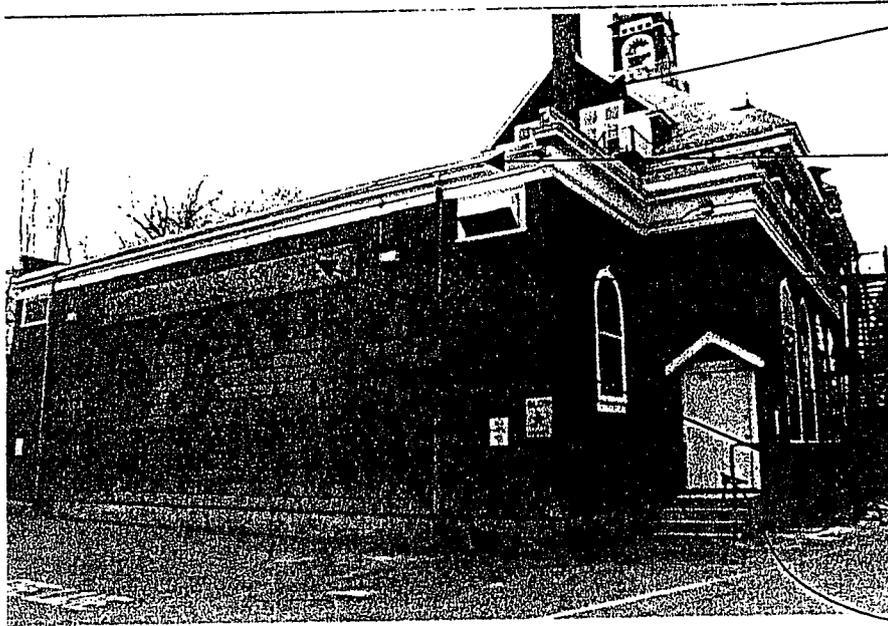
INVESTIGATION @ GYMNASIUM SIDING

Original school sign in need of painting.

Replace old deck with new deck, fence guard, metal cap & roof (Hidden in Photo).

New gutter and wood trim recommended.

Replace old deteriorated shingles With replacement #1 wood cedar shingles.

Wire brush & repaint existing fire escapes.

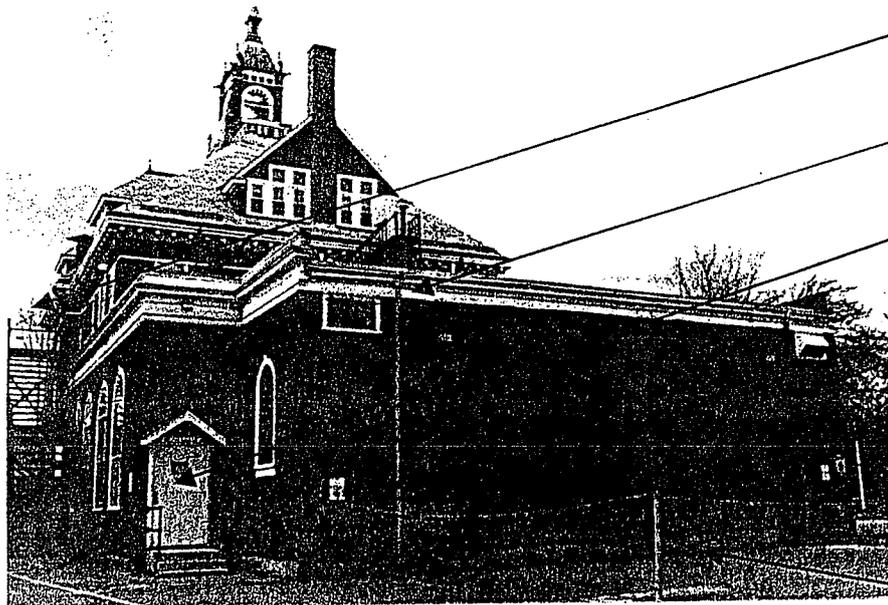
INVESTIGATION @ GYMNASIUM SIDING

Egress door does not meet HP door code.

sun is fully exposed
LANDING

Wire brush & repaint existing fire escapes.

New gutter and wood trim recommended.

Replace old deteriorated shingles with replacement #1 wood cedar shingles.

Repair of concrete gym foundation wall.

Suggest capping lands to soften hard paving edge to building.
