ARCHITECTURAL CONSERVATION ASSESSMENT

August 1, 2011

1790 WESTFORD ACADEMY

TOWN OF WESTFORD & WESTFORD HISTORIC SOCIETY

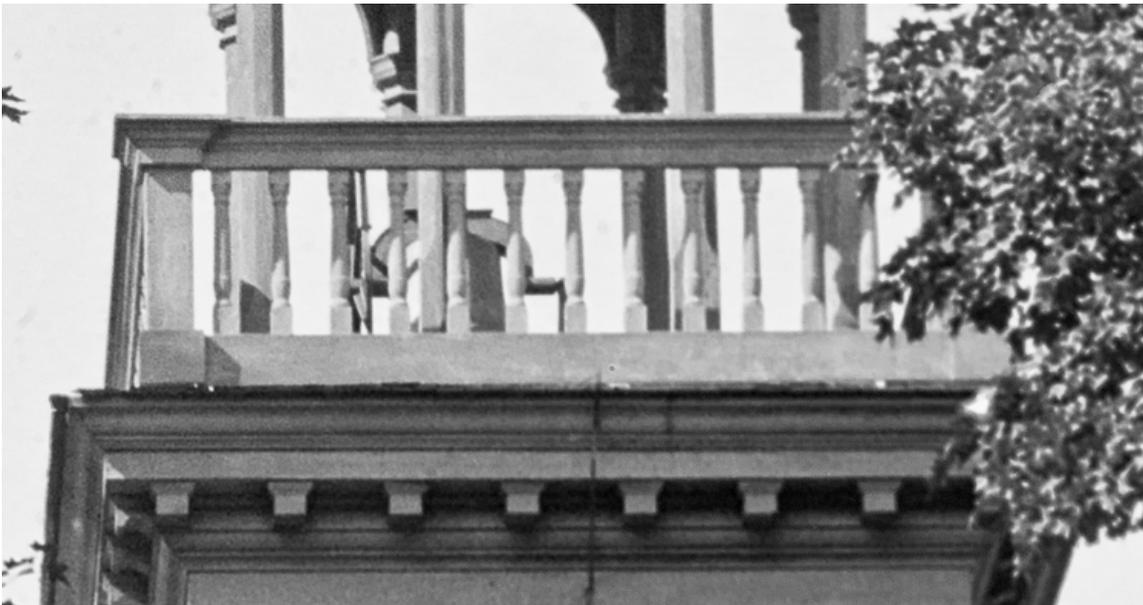
15: Detail from the late 19th century photograph showing what are likely the original balusters, railing, and posts. There are 13 balusters on a side whereas the current balustrade has only 11. The current balusters are also heavier than the ones in this photo.

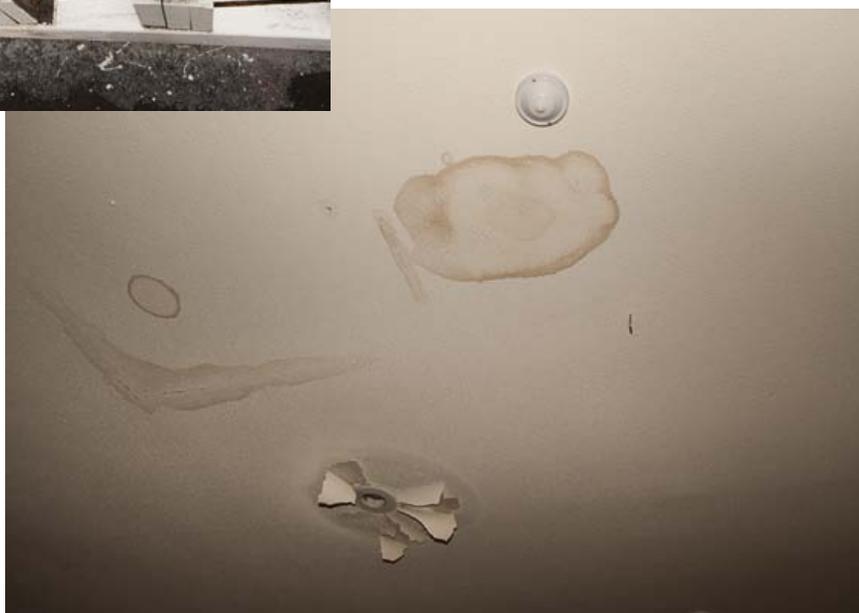
18: Stains on second floor ceiling from past leaks at the cupola. Less heavy leaks could still be occurring without showing up on the ceiling, and could continue to provide moisture for fungus and insect activity in the cupola framing.

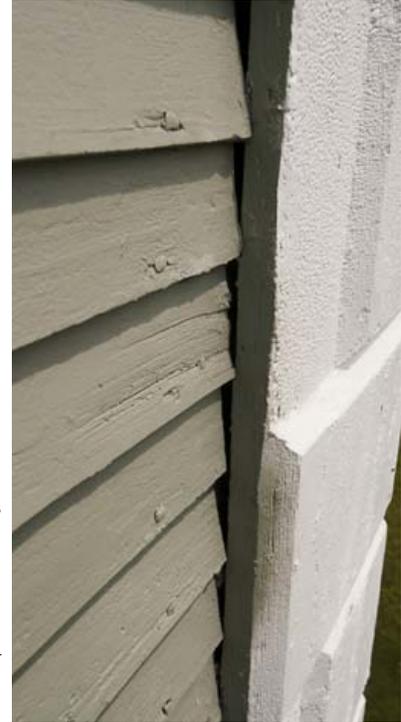
22: A portion of the original corner board at the southeast corner has pulled away from the building leaving a large gap for water penetration. The board should be taken off and rest tight to the sheathing.

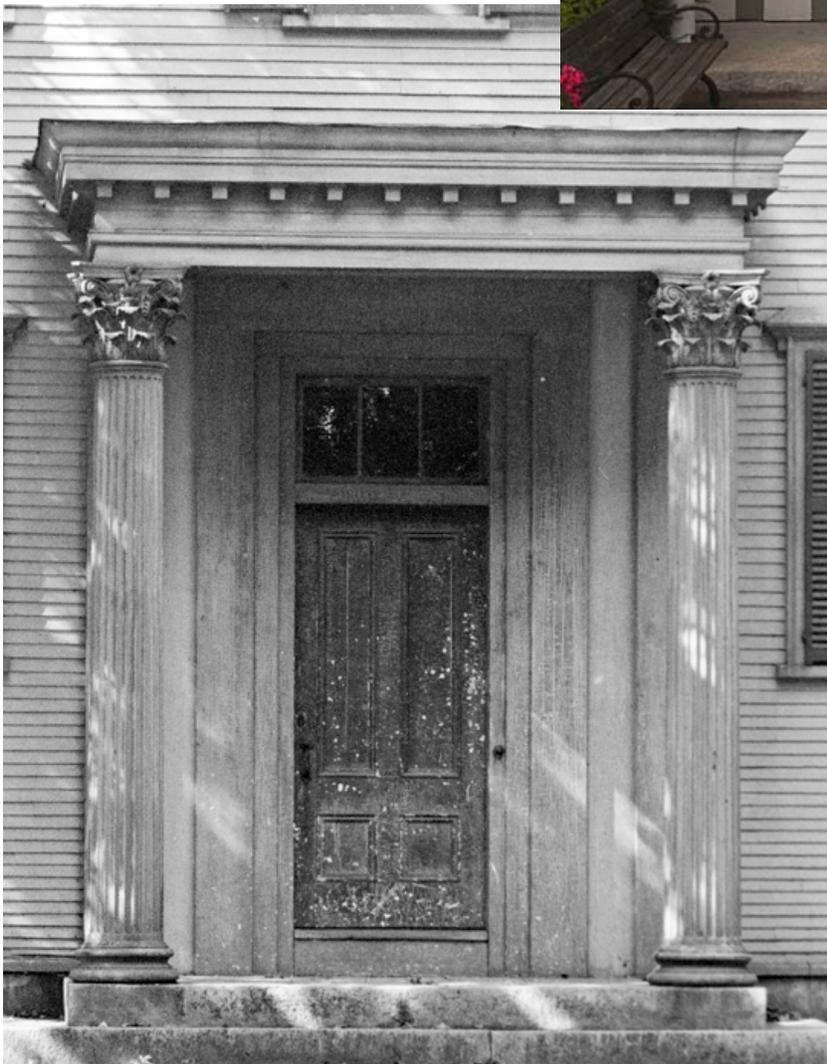
30: Detail of late 19th century photograph showing original fluted columns with fully developed classical bases, and mid-19th century door and transom light. There is also a difference in the height of the entablature and cornice of the porch from the current porch. It would be desirable to redo the columns to better match the originals.

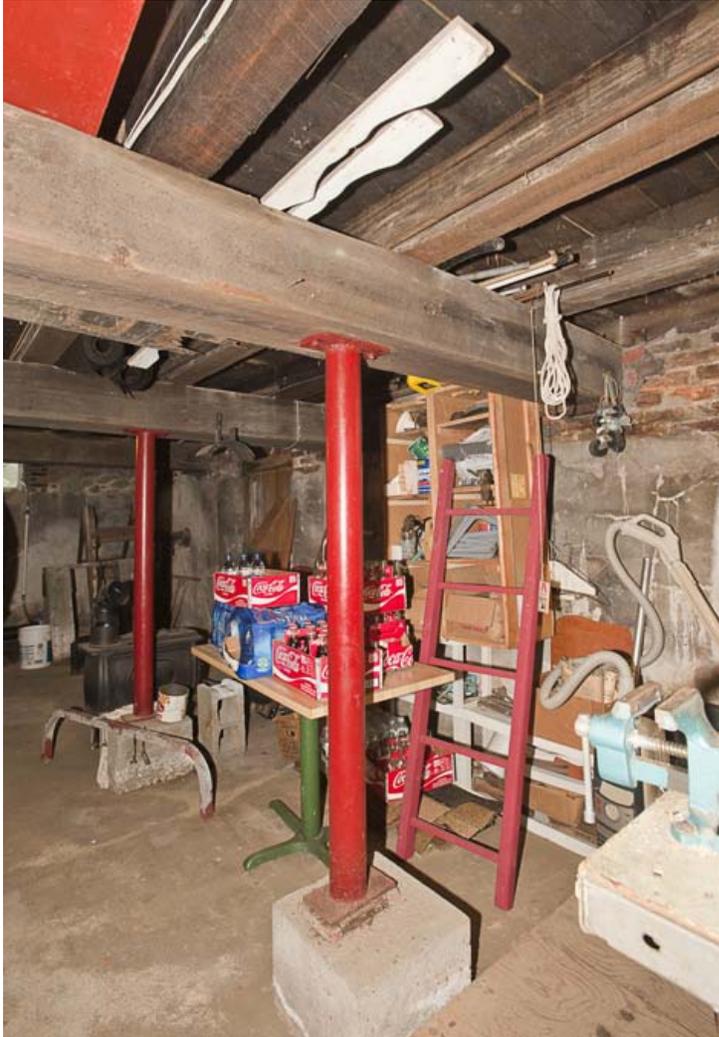
44: Cellar showing the posts and framing for the first floor installed in the mid-20th century to support the fire engines. This framing is in good condition and obviously extremely strong.

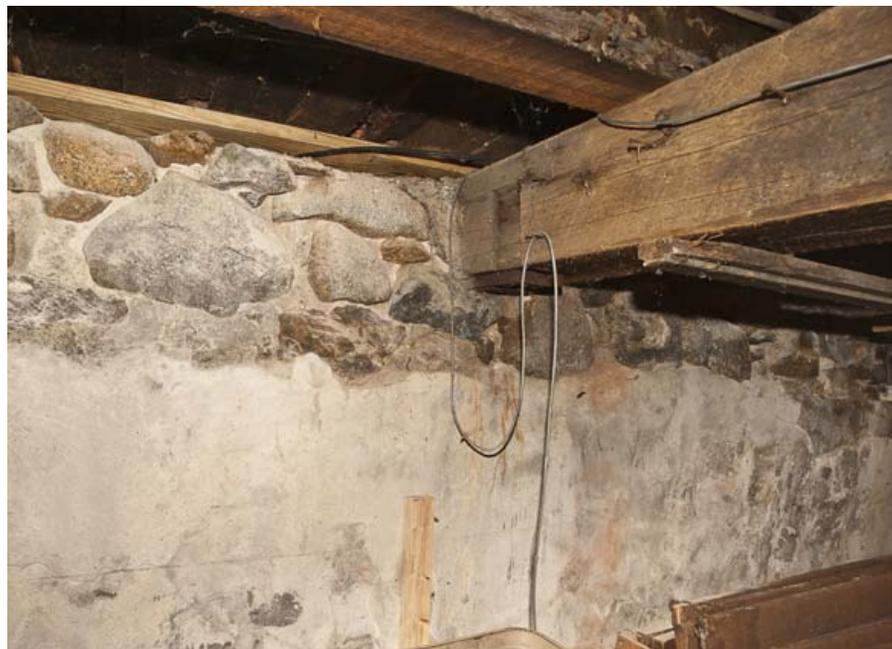
45: Cellar wall on the north side showing the cement plaster parging over the fieldstone foundation wall. As noted in the IRE report, the parging has lost its bond to the stone in places, and the upper section has apparently fallen off, all due to water seeping in through the foundation. Installation of a subsurface drain around the exterior perimeter of the foundation is recommended to reduce the seepage through the foundation. The ends of the beams appear to be incased with masonry without provisions for ventilation. This can lead to premature rot in the beam ends. The beam ends should be checked every two years for signs of any rot.

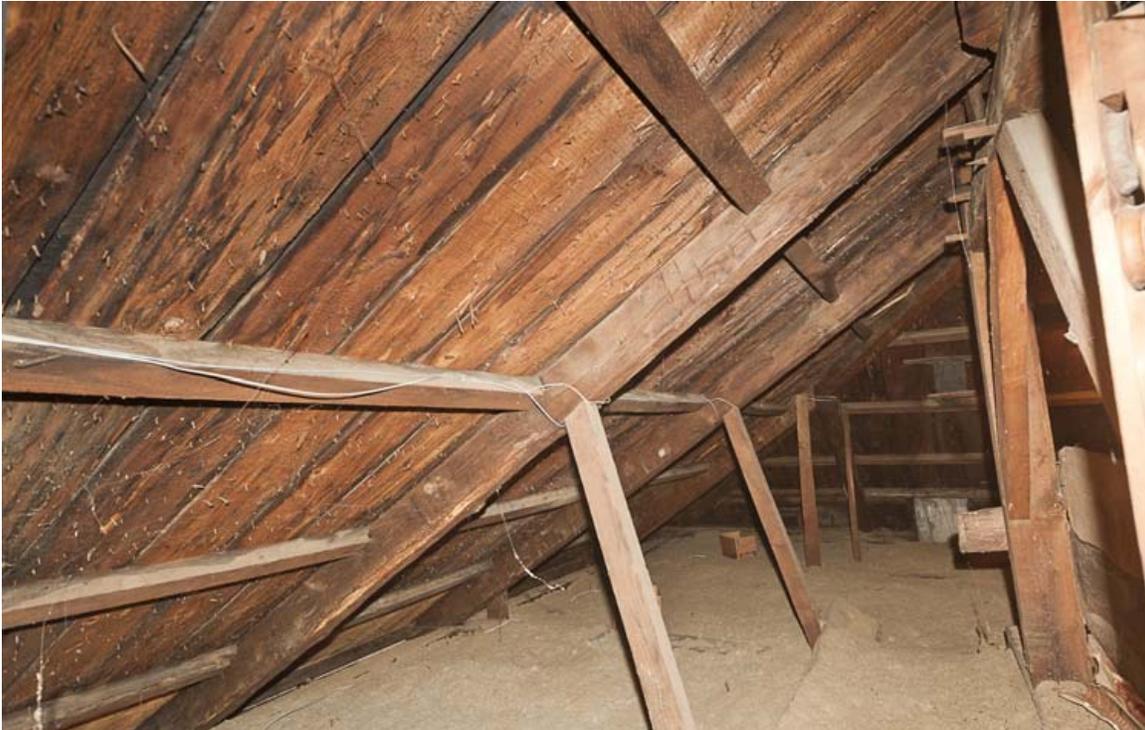
48: North pitch of roof in attic looking towards the rear. Purlins and rafters are straight without visible deflection or other signs of distress. The struts between the rafters and the tie beams in the attic floor are also straight. The original strut under the hip rafter in the rear of the photo has been replaced by two thick boards. This has been done at all four hip rafters.

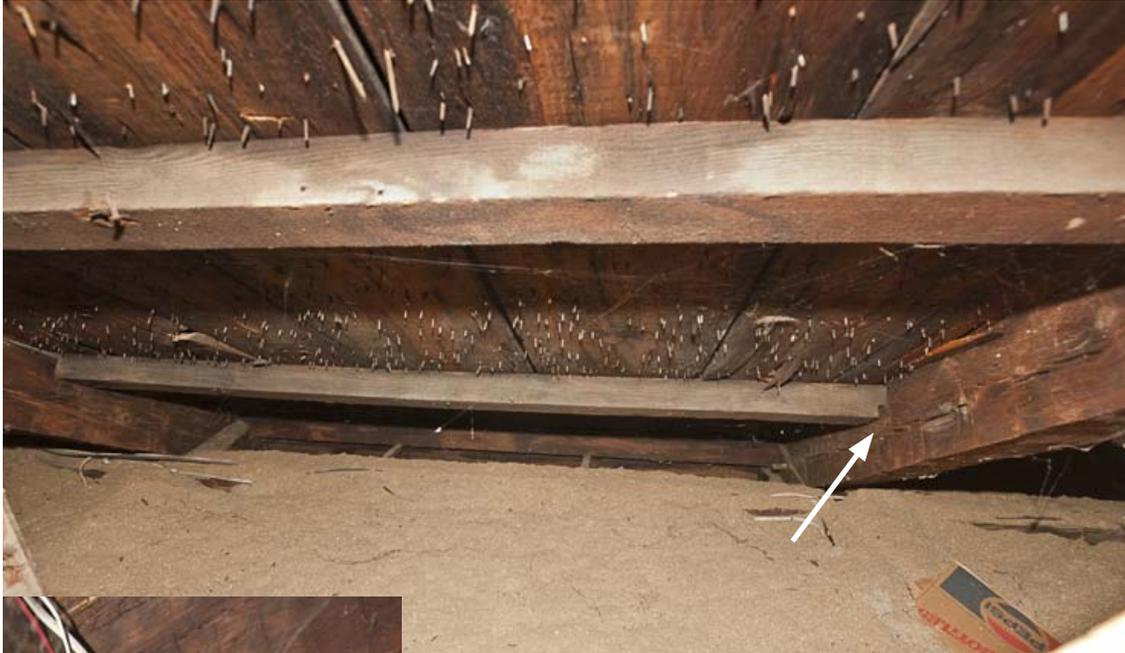
50: Typical roof purlin showing its joint with the rafter (arrow). The purlin is sawn oak with no sign of deflection or cracking where it has been cut to form the tenon that sits in the open mortise in the top of the rafter. This construction is typical of 18th and early 19th century roof framing. These purlins are more substantial and uniformly cut than one frequently finds in this type of framing.

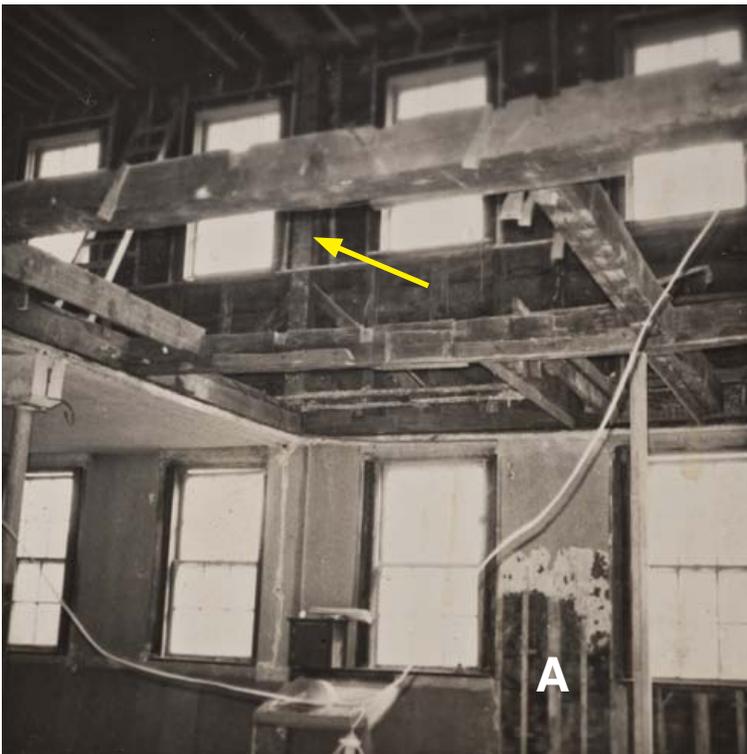
54: Photo of the attic floor and south wall framing taken during the restoration work c. 1980. The arrow points to the wall post under the easterly main roof truss. “A” marks the area of the south wall that currently shows a bulge on the exterior. It is not clear why or when the floor joists were removed in this area. *Photo by Robert Adam from the Westford Historical Society Archives.*

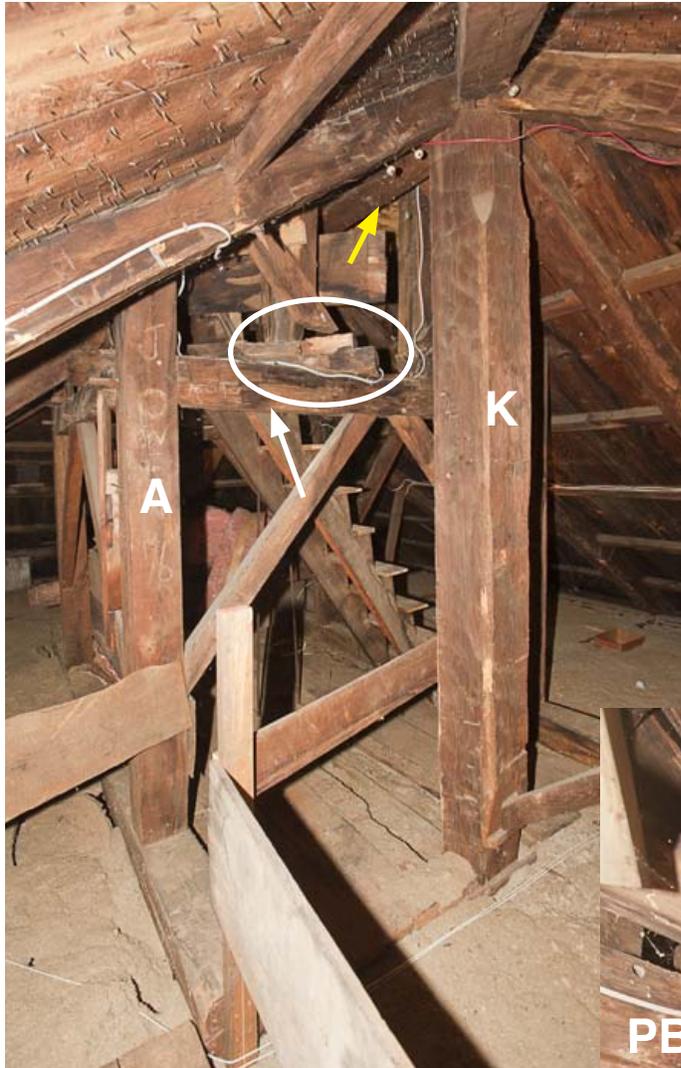
57: Looking at the southerly king post (marked “K”) with the lower portion of the bell deck frame beyond (its northwest post is marked “A”. The white arrow points to the lower perimeter beam between bell deck posts A and D (Post D is not visible). The white circle marks the severely deteriorated transfer beam end under cupola post C2 that is shown in more detail in photo 61. The yellow arrow points to the ridge beam that is framed into both the north and south king posts. It is shown in more detail in photos 59 and 60.

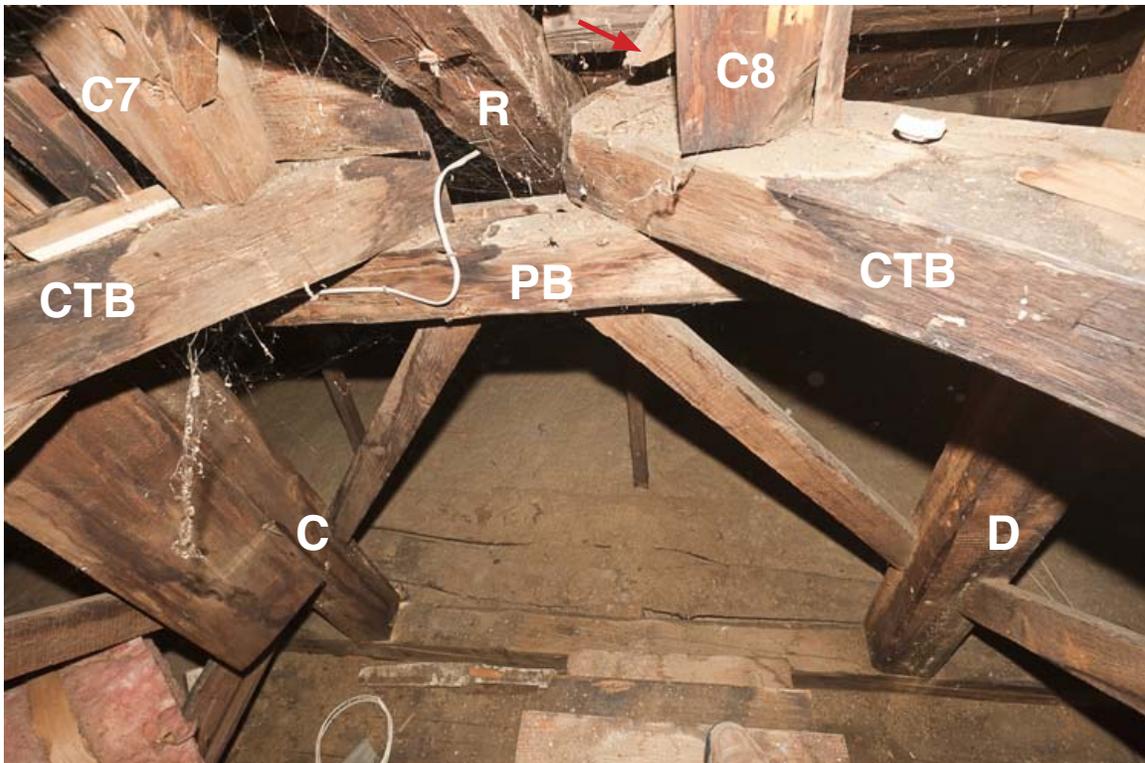
58: South side of the bell deck frame & cupola frame where the cupola transfer beams and perimeter beams appear to be sound. Arrow points to where the bottom of the bell deck post diagonal brace was been cut off to fit in the cupola transfer beam. The empty mortise that was cut to receive it is visible on the top of the perimeter beam.

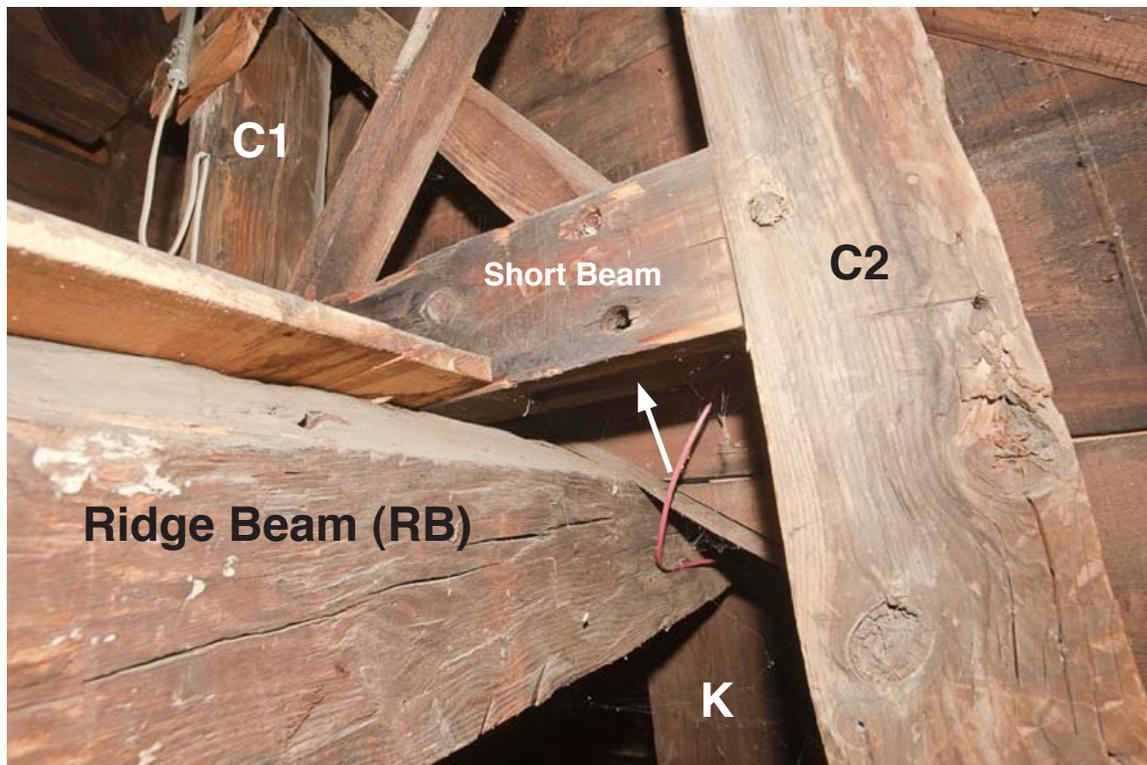
60: West side of cupola frame showing the short beam between C1 and C2 sitting on the top of the ridge beam. The arrow points to the empty mortise and empty pin hole in the short beam that was cut to receive the top of the lower diagonal brace that was never installed because the ridge beam was in the way.

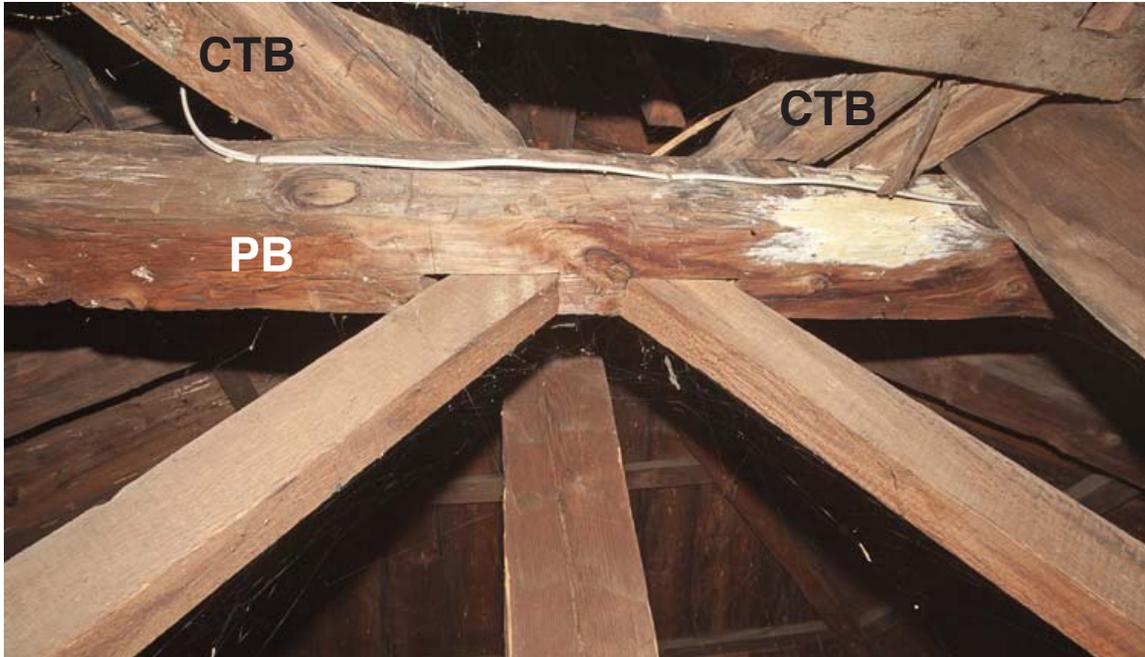
62: East side of frame showing the underside of the perimeter beam (PB) between bell deck posts B and C, and the undersides of the cupola transfer beams under cupola posts C5 (left) and C6 (right). This end of beam CBT has substantial center rot under post C6 and where it bears on the perimeter beam. The white area on the perimeter beam is a fungus with rot and insect damage beneath it. Exit holes for the Old House Borer are scattered along this perimeter beam. We suspect the loads intended for this perimeter beam are actually on the ridge beam above this area.

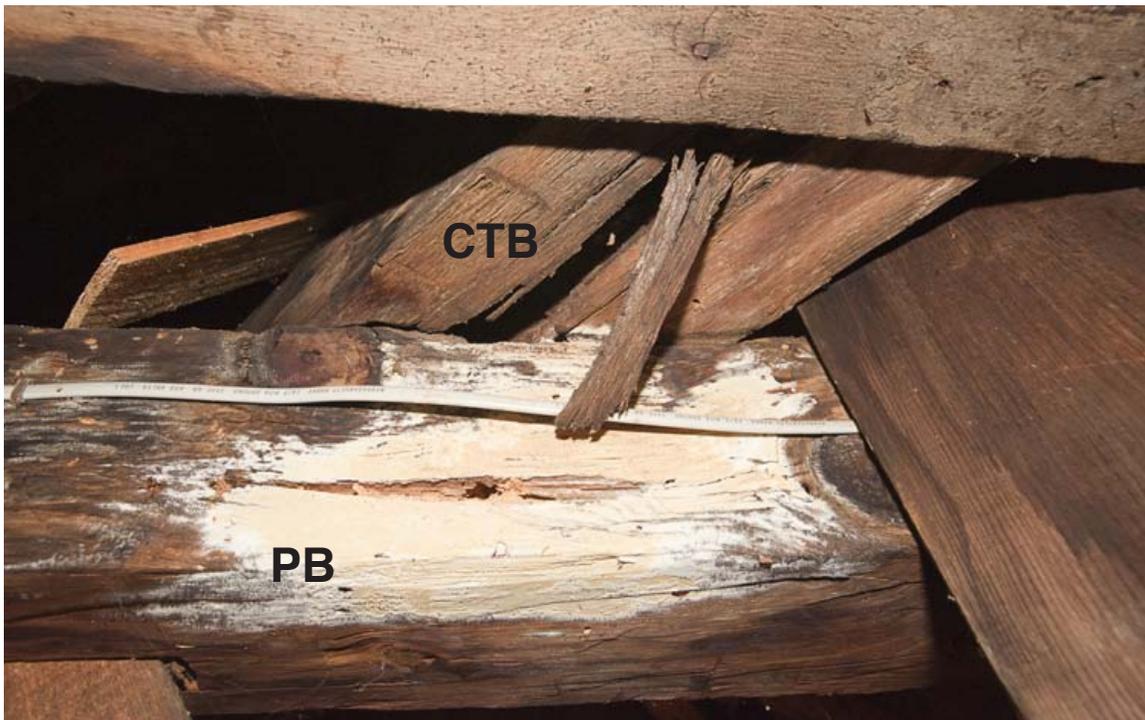
63: Detail of the area of fungus on the perimeter beam in photo 62. A sliver of the outer surface of the wood has been pried away to reveal insect damage behind it (arrow). Although we did not observe the specific cracks shown in Figures 7 & 8 of in the IRE report, we wonder if they are the peeling of the outer skin of the beams over insect damage rather than stress failure cracks. There are a number of insect exit holes visible in Figure 7.

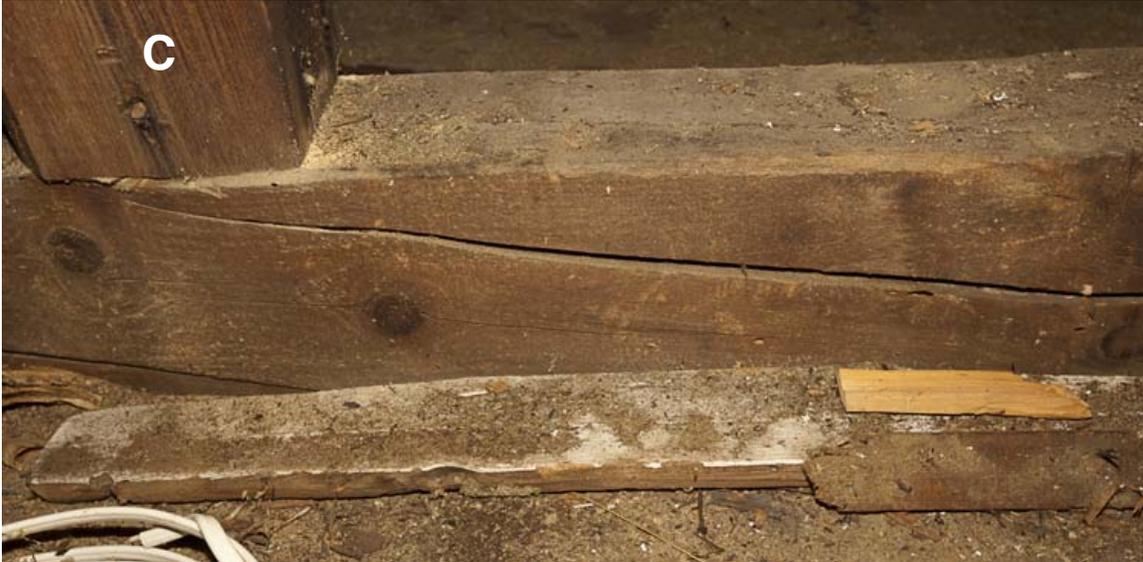
64: Detail of diagonal crack shown in Figures 5 & 6 of in the IRE report in the side of the southerly main transfer under bell deck post C. The surface of the wood in the cracks is dark with oxidation and dirt indicating they have been present a long time and are likely shrinkage cracks rather than stress failure cracks. They are diagonal because this particular beam appears to contain spiral growth wood.

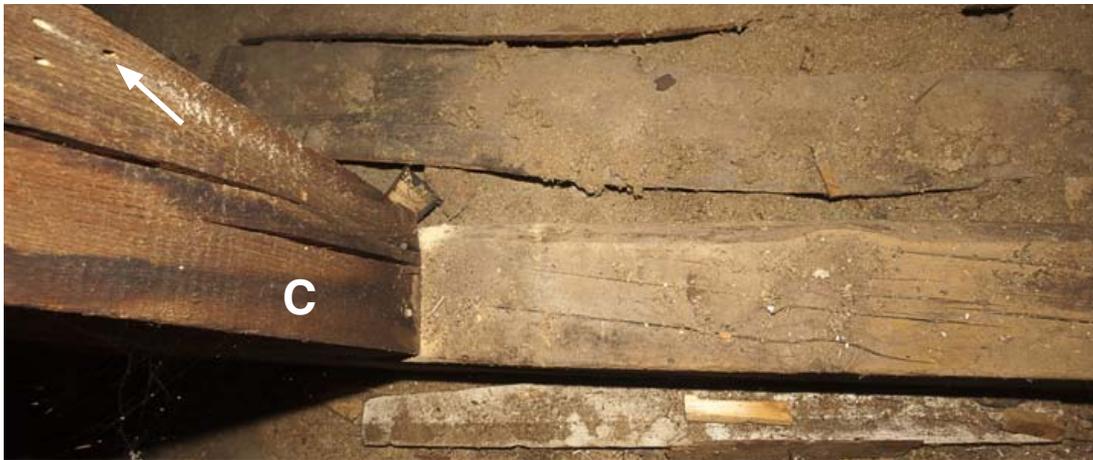
65: Top surface of the main transfer beam also shows diagonal cracks that are likely normal shrinkage cracks. The side of bell deck post C also shows similar shrinkage cracks. It also shows several insect exit holes (arrow) from old house borers. The wood was found to be solid when we test drilled near the exit holes.

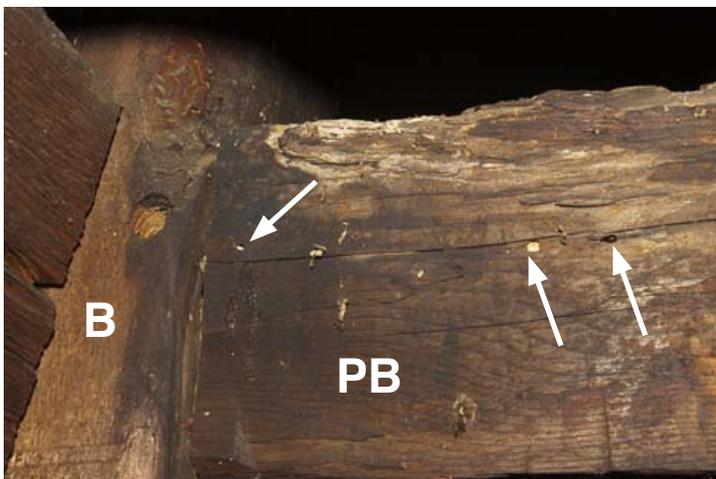
66: Detail of the north perimeter beam at bell deck post B showing several insect exit holes (arrows) from old house borers. These holes are much larger and more oval shaped than the exit holes of powder post beetles (*anobium*). Test drilling a few inches deep near these holes found some wood to be soft, although the actual extent of the damage is not known. More systematic drilling with a resistance drill is needed to determine if the damage is significant.

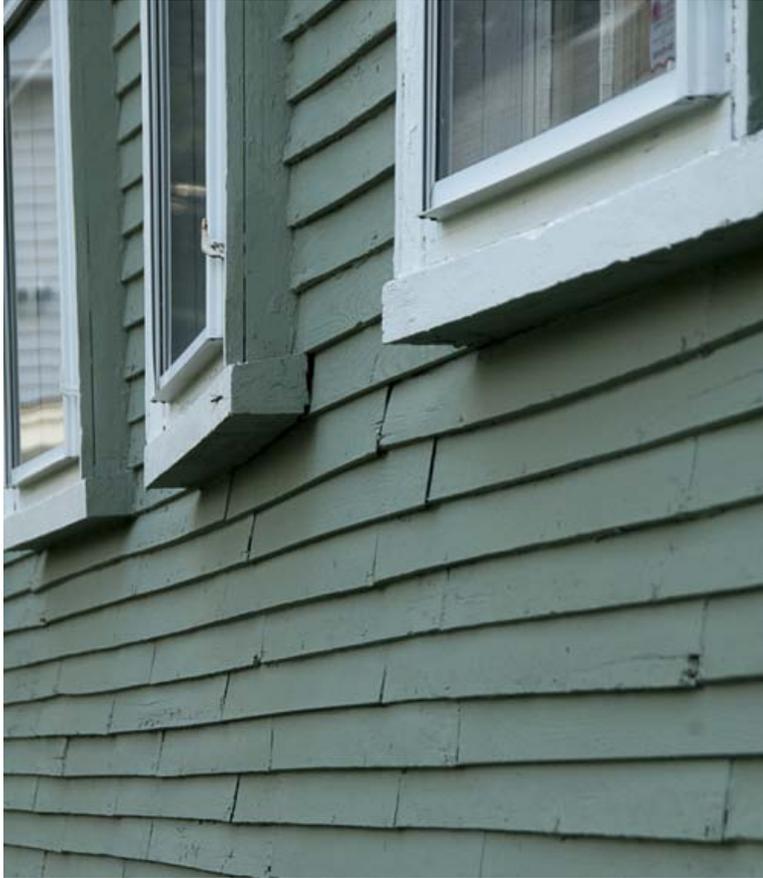
67: Area of bulge in center of south facade clapboards with that has also caused the ends of the two window sills to sit askew. The cause of this would best be investigated by removing the modern finishes on the interior side of this area.

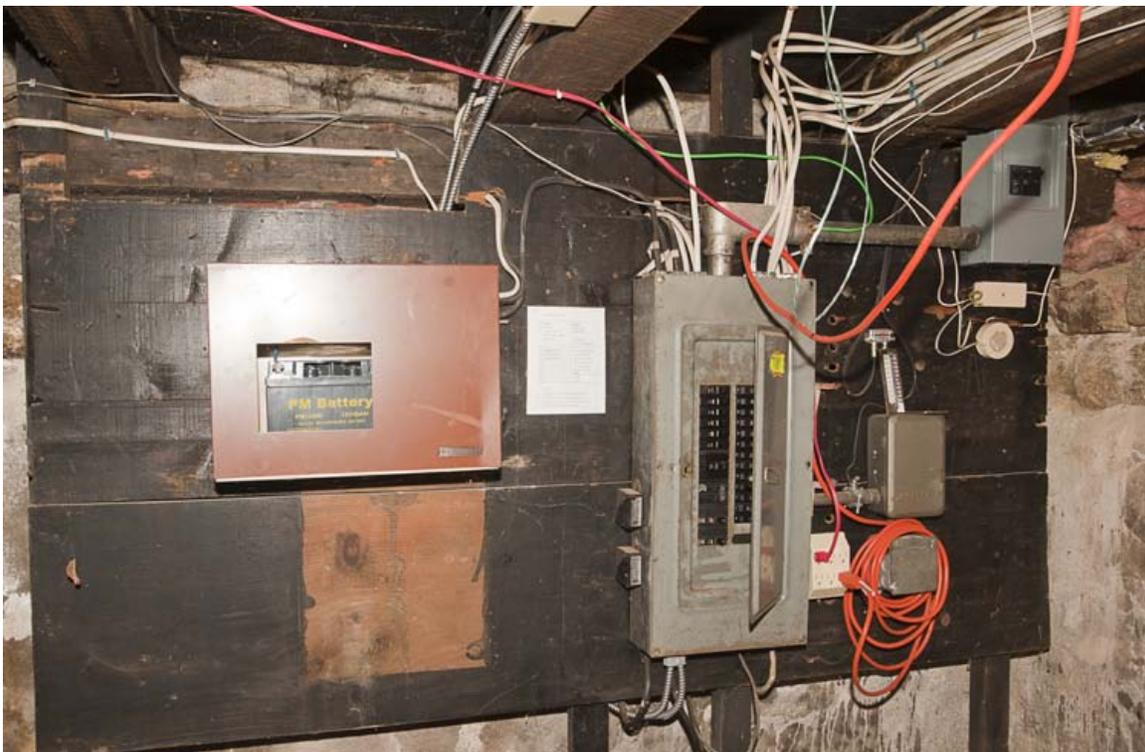
68: Electric panel in the cellar showing the building was updated with modern wiring and circuit breaker when the building was restored c. 1980.
