REQUEST FOR PROPOSALS

BEAVER BROOK ROAD CULVERT REPLACEMENT PROJECT (Bridge No. W-26-014, Structure No. W26014-26G-MUN-NBI)

EXISTING CONDITIONS PLAN
 BEAVER BROOK
 BEAVER BROOK ROAD
 WESTFORD, MA

Beaver Brook Road Culvert/Bridge
Replacement Feasibility Study

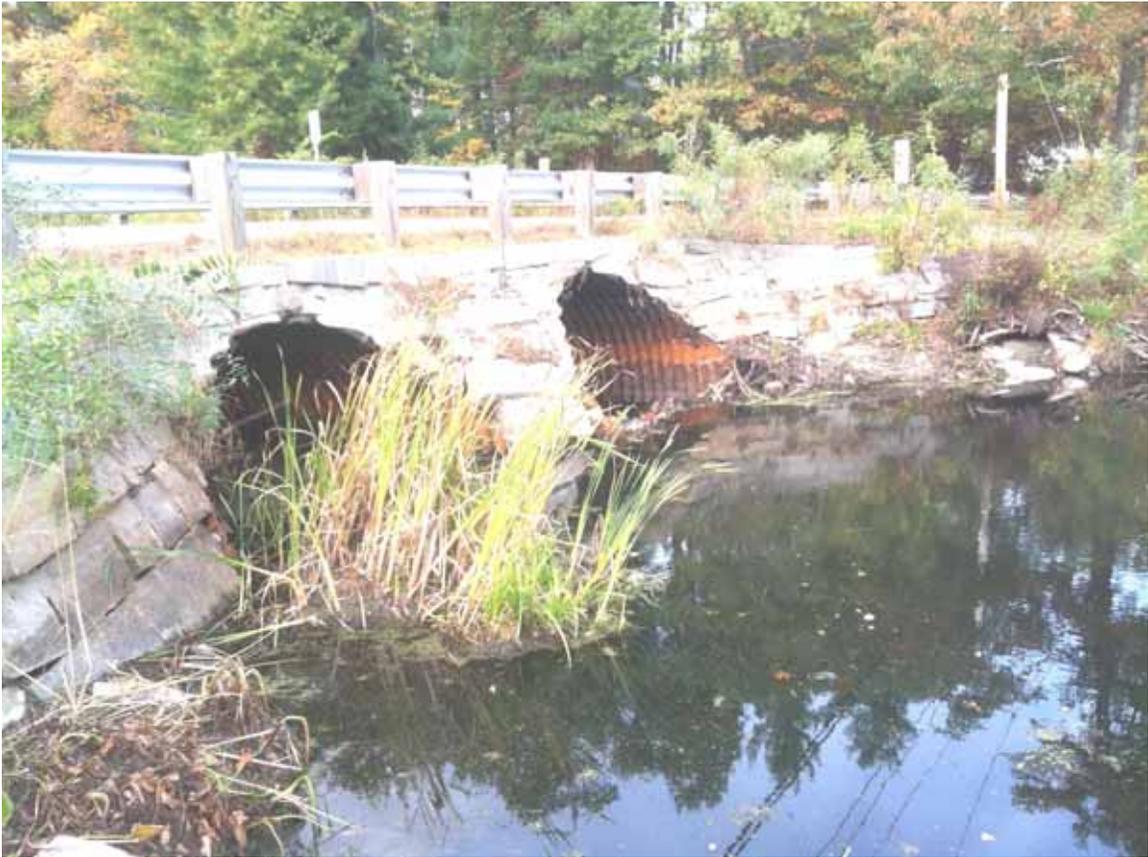
Culvert Upstream Inlet

The existing hydraulic opening provided by each culvert is 7'-5" rise by 10'-5" span ellipse. Scour has been observed on the upstream end of the northern most culvert. Some dumped riprap was placed in this location as a scour countermeasure.

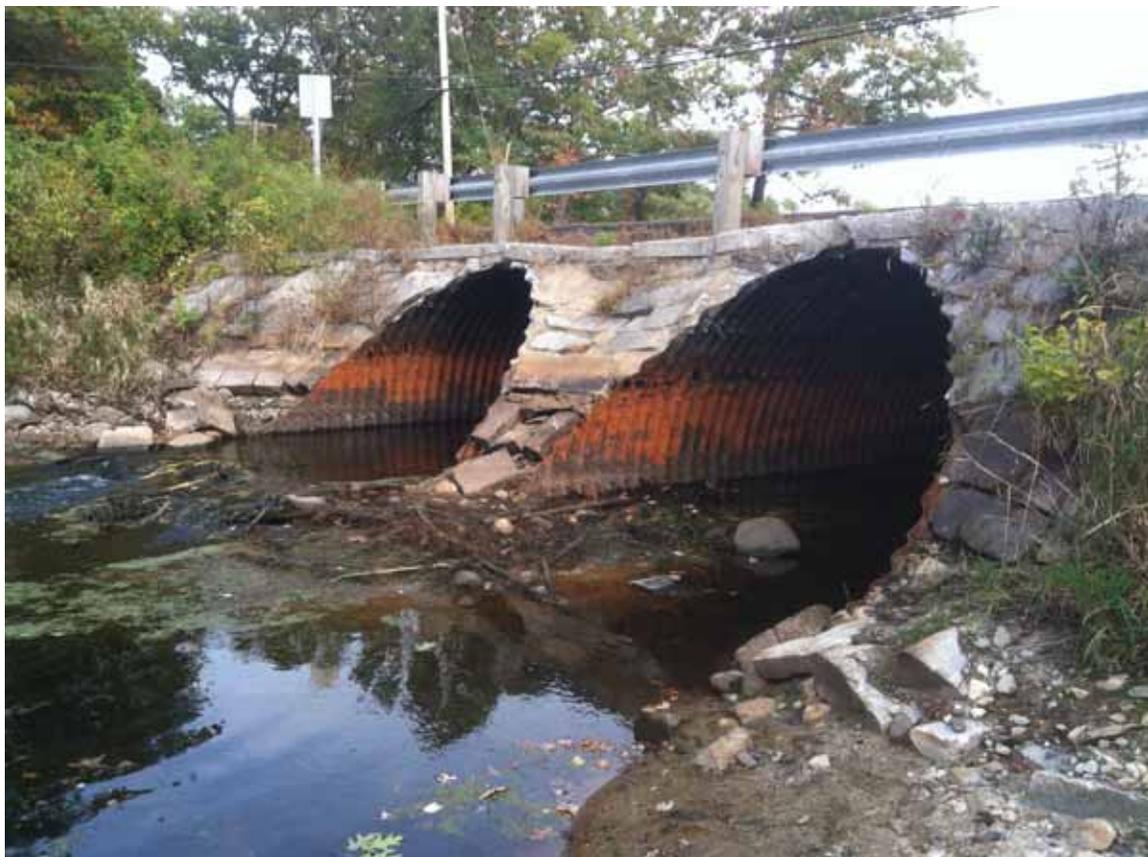
Culvert Downstream Outlet

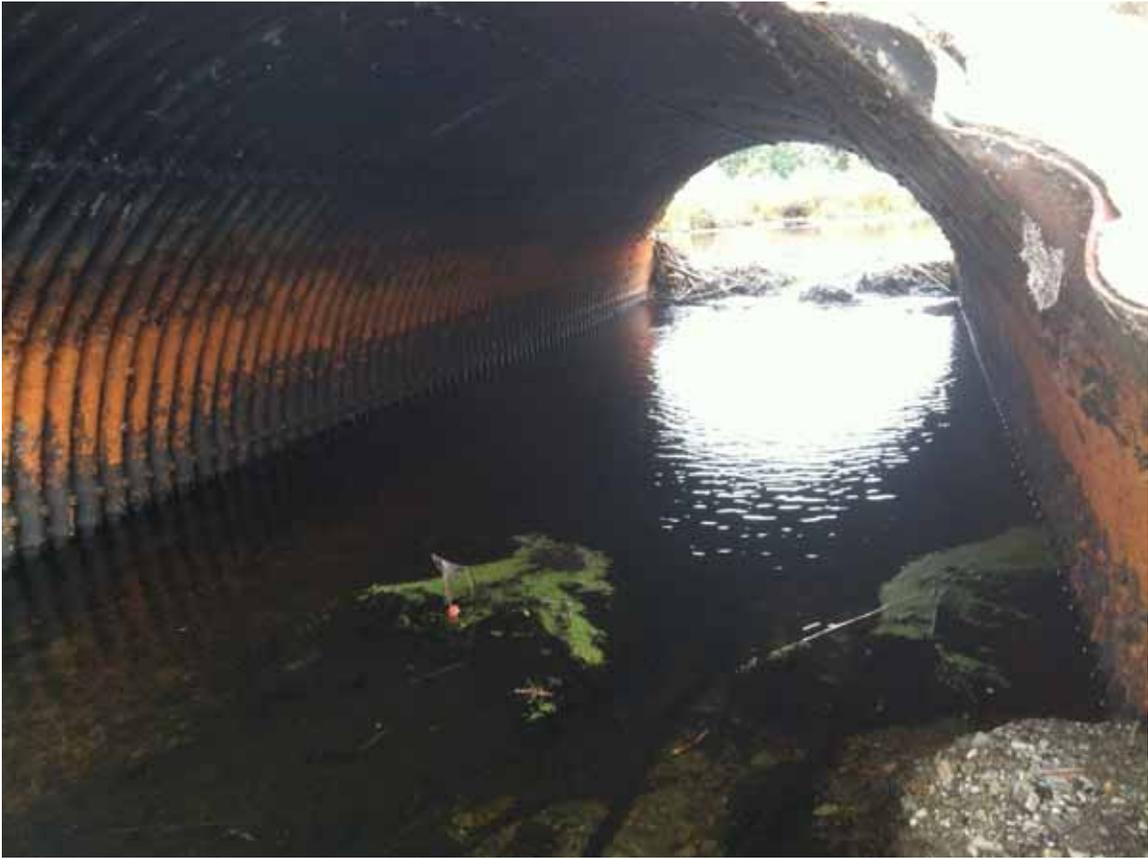
Culvert Interior

The culverts are in poor condition with many small areas of 100% section loss of the metal pipe culvert along the waterline. The culverts are also partially filled with debris.

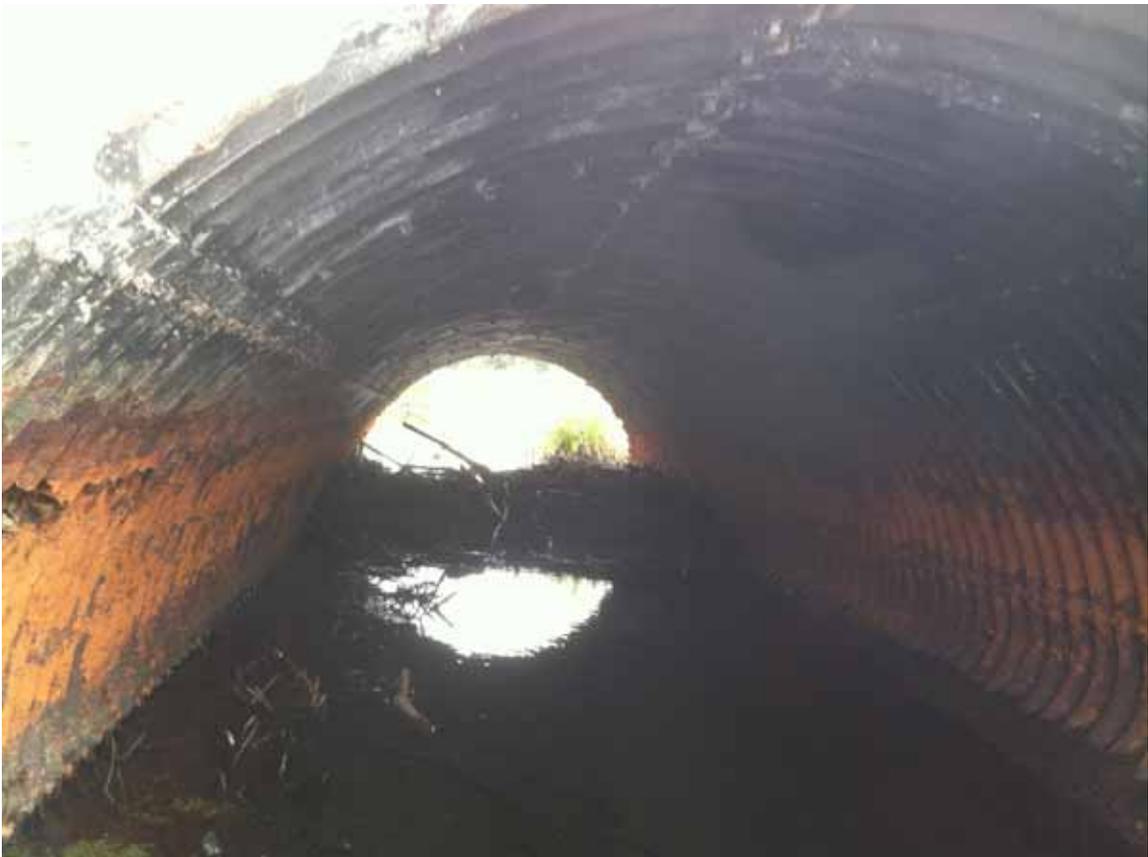
Culvert Interior with Beaver Activity

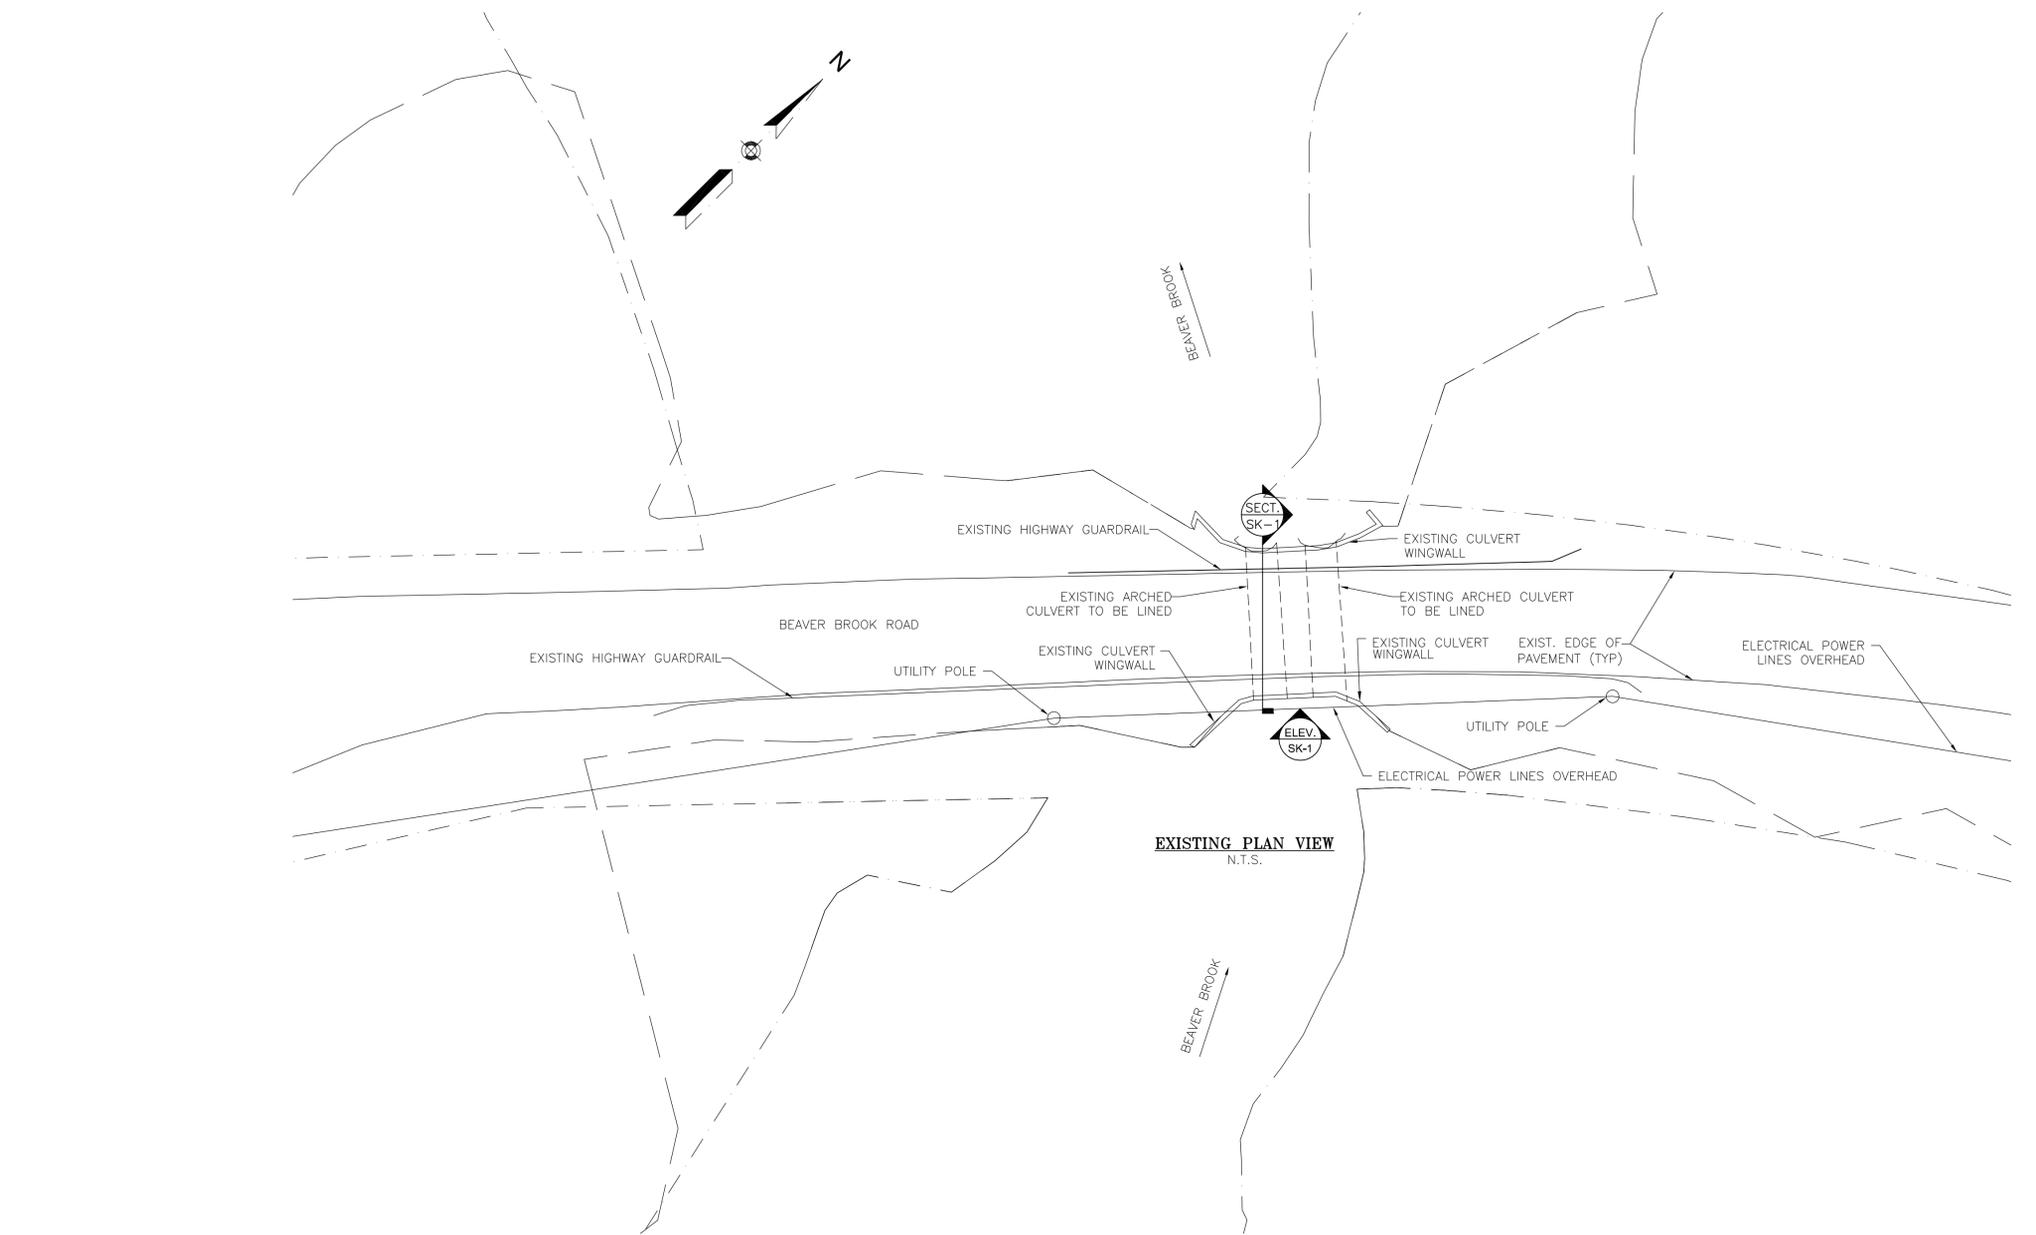
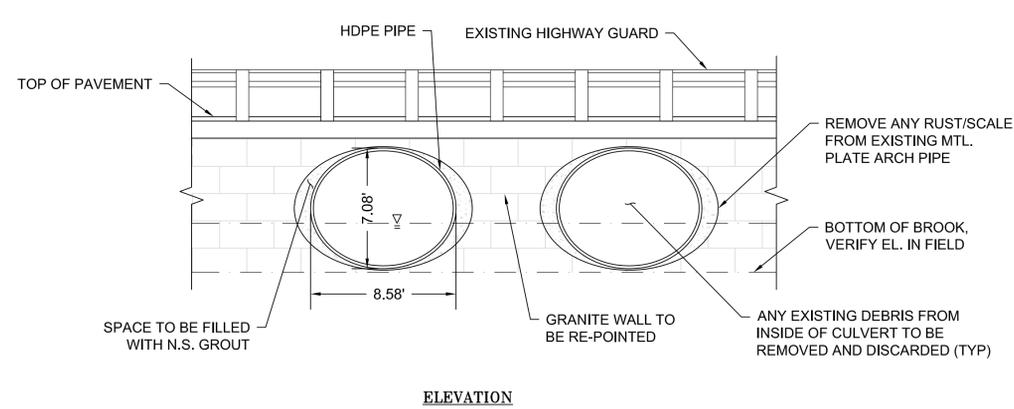
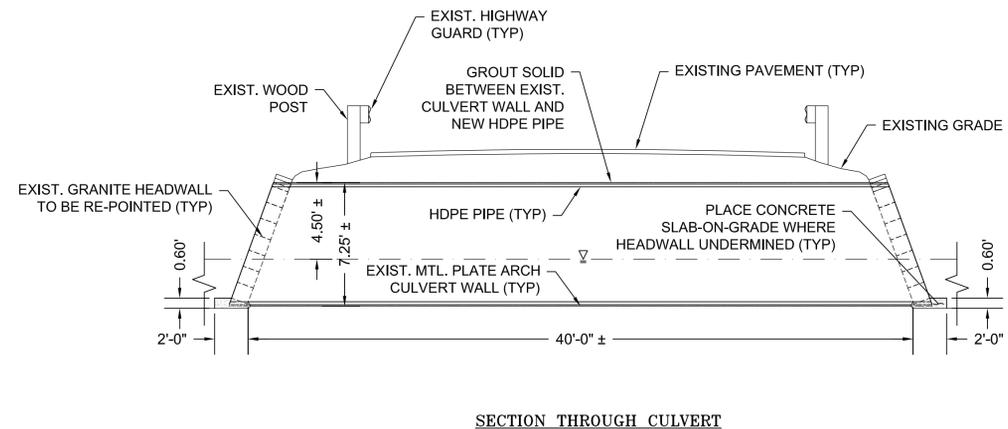
BEAVER BROOK CULVERT REPAIR ALTERNATIVE #1 - HDPE PIPE
N.T.S.

WESTFORD, MA
DEPARTMENT OF PUBLIC WORKS
BEAVER BROOK ROAD CULVERT OVER BEAVER BROOK
EXIST. SITE PLAN AND REPAIR ALTERNATIVE 1 - HDPE PIPE
CADD NO. _____ SCALE: N.T.S.
CONTRACT: _____
JOB NO. 2150087
DR. BY KMC
DSN. BY _____
CHK. BY SRB
APP. BY RAC

Lining the inside of the culvert with HDPE pipe will provide the least amount of repair over its service life. With that being said it also has by far the shortest life cycle at only 50 years. Maintenance and repair would involve cleaning out the culvert of any debris, repairs of voids in the grout lining, and masonry repair of the headwalls. This work is estimated to cost \$1000 every 10 years.

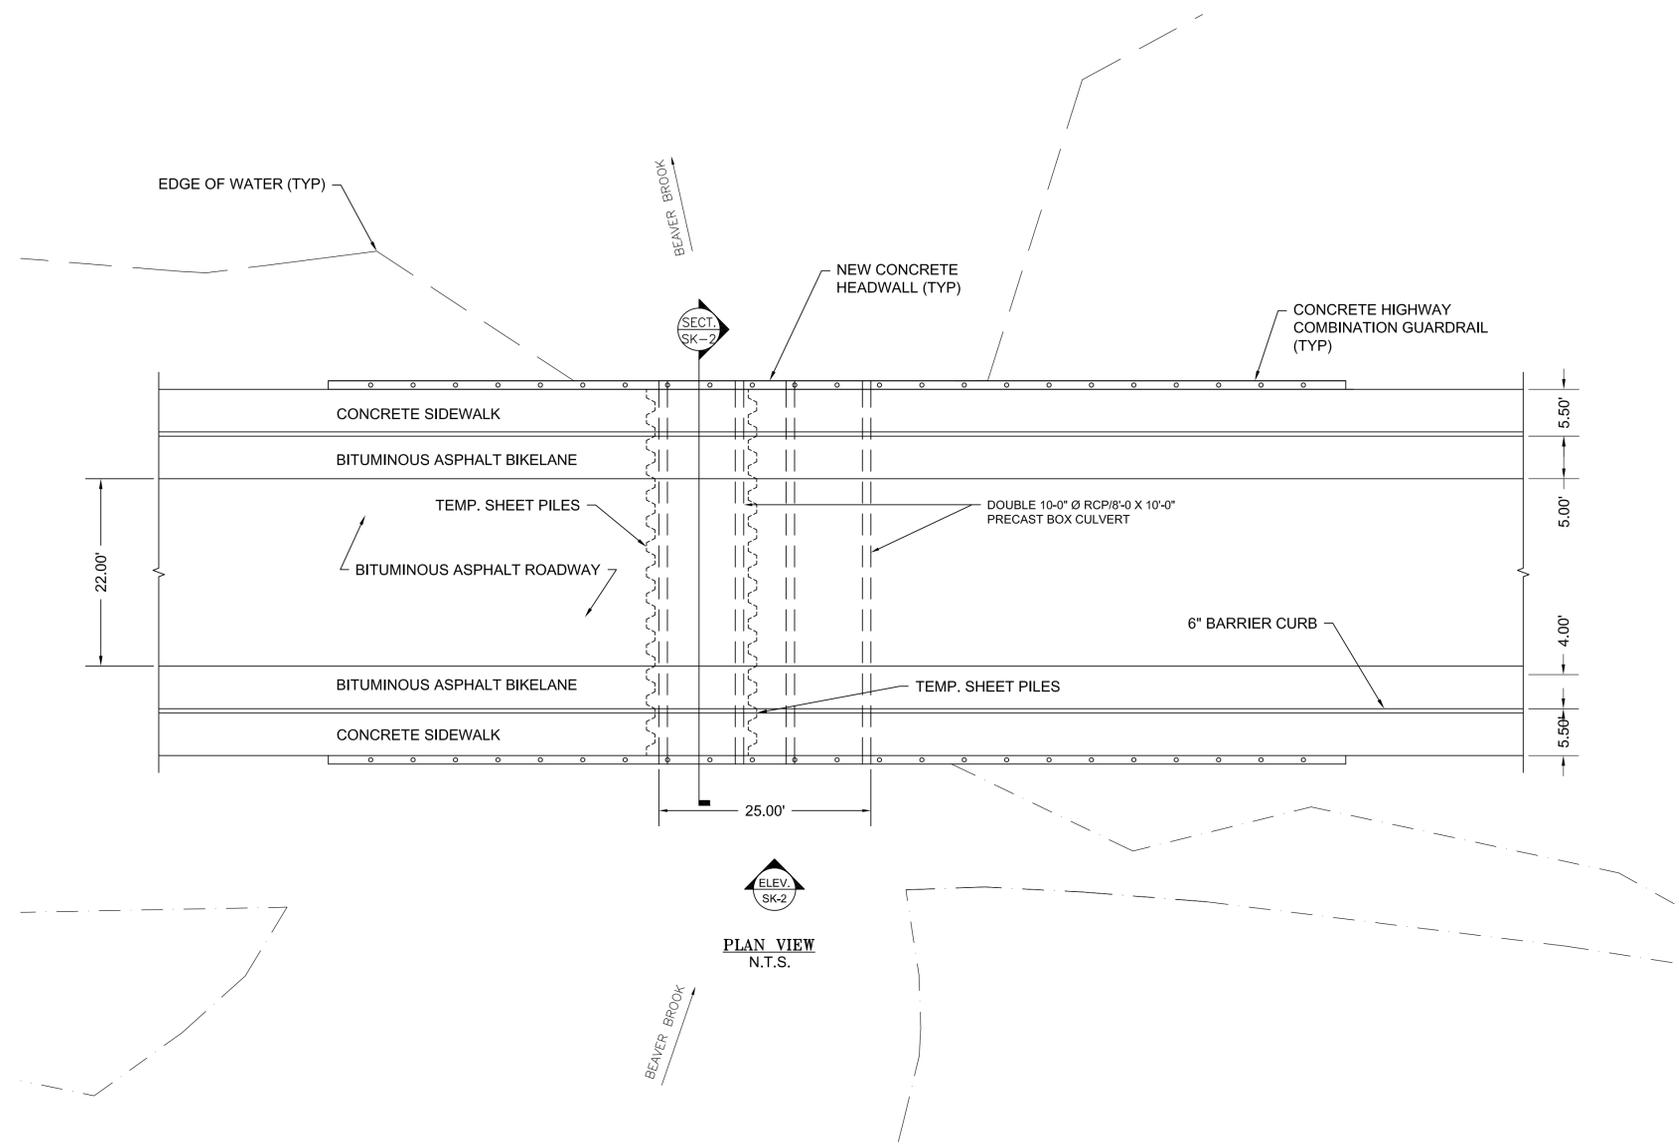
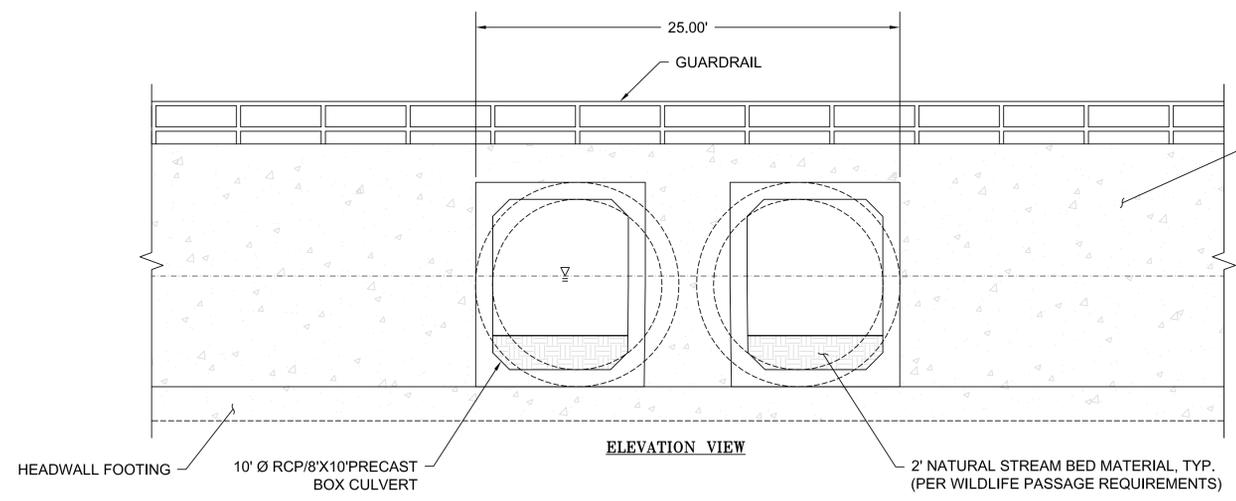
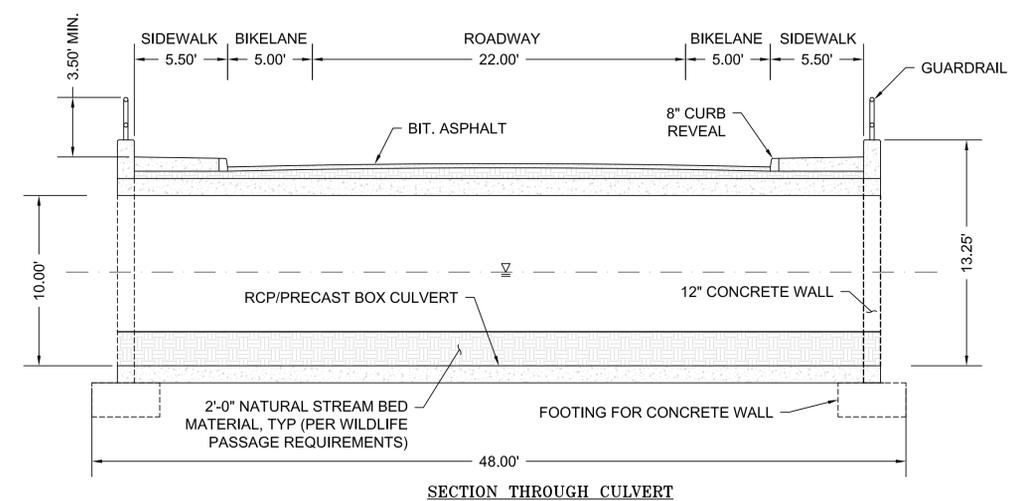
BEAVER BROOK CULVERT REPAIR ALTERNATIVE #2 - RCP/PRECAST BOX CULVERT
N.T.S.

REPAIR ALTERNATIVE 2 - RCP/PRECAST BOX CULVERT

Replacing the culvert with two new reinforced concrete box culverts or RCP pipes will provide a much longer service life than Alternative 1. AASHTO predicts a 75 year life cycle for culverts. This alternative will provide a greater service life but will have higher maintenance costs than Alternative 1. Repairs and maintenance would include cleaning out the structure, repairing spalled and delaminated concrete surfaces, and inspections. Maintenance and repairs are assumed to be completed every 20 years.

The recommended alternative is Alternative 2: Replace the Existing Culverts with Two New Culverts.

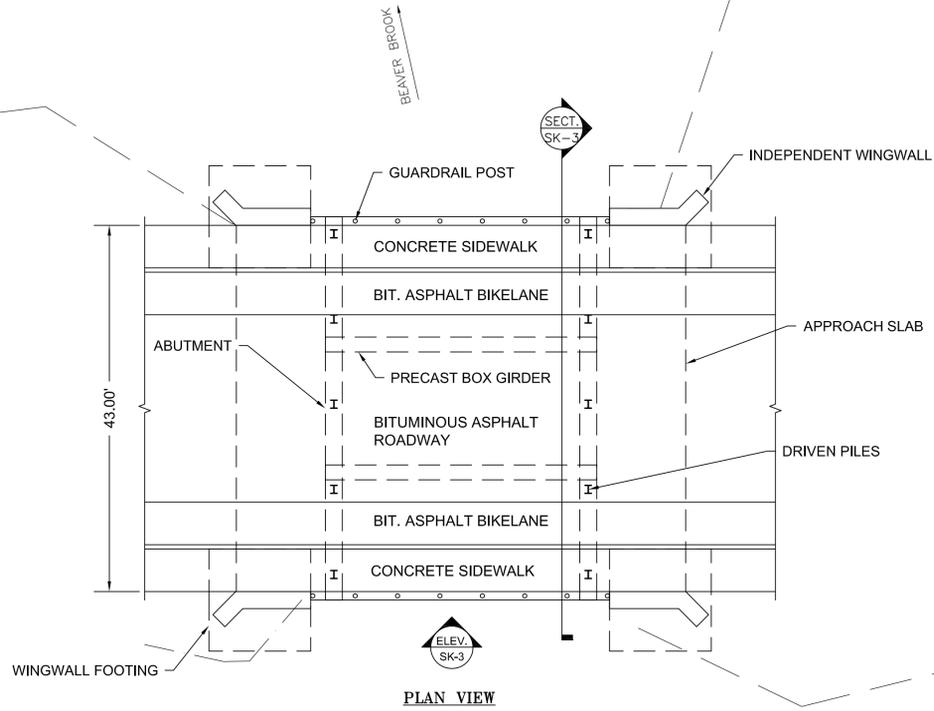
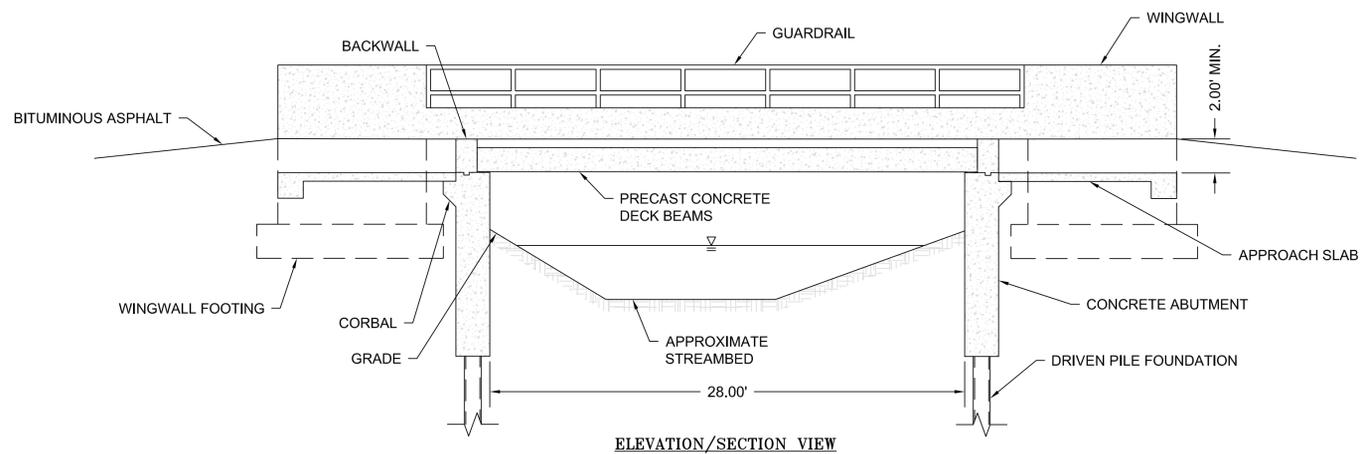
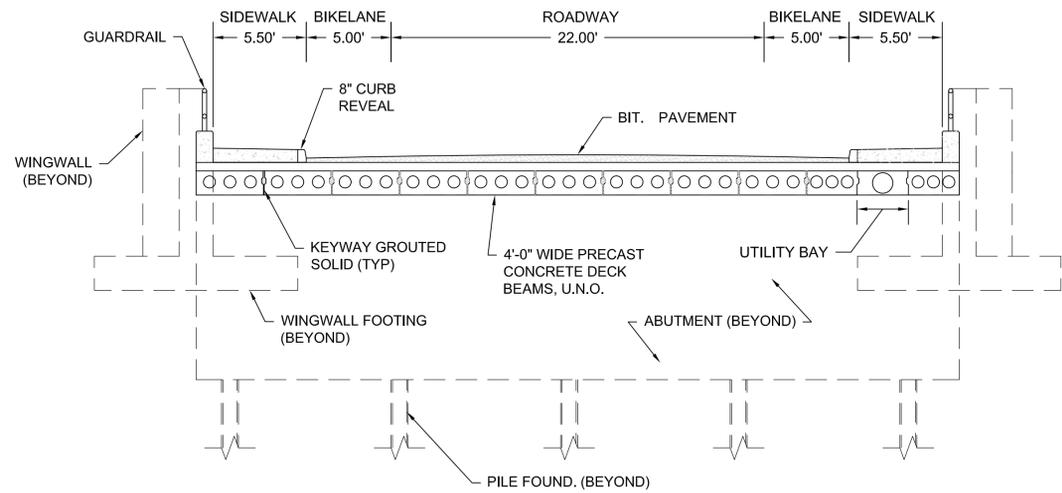
PLAN VIEW

ELEVATION/SECTION VIEW

SECTION VIEW

BEAVER BROOK CULVERT REPAIR ALTERNATIVE #3 - PRECAST BOX BEAM BRIDGE
N.T.S.

WESTFORD, MA
DEPARTMENT OF PUBLIC WORKS
BEAVER BROOK ROAD CULVERT OVER BEAVER BROOK
REPAIR ALTERNATIVE 3 - CONCRETE DECK BEAM BRIDGE
CADD NO. _____ SCALE: N.T.S.
JOB NO. 2150087 CONTRACT: _____
DR. BY KMC DSN. BY SRB CHK. BY SRB APP. BY RAC

Replacing the culvert with a bridge will provide the same life cycle as the culverts at 75 years according to AASHTO. This alternative will require the most maintenance. Maintenance and repairs will include items such as repainting the bridge, repair concrete surfaces, wearing surface replacement, bridge deck repairs, and bridge inspections. These maintenance and repairs are assumed to be completed every 20 years.

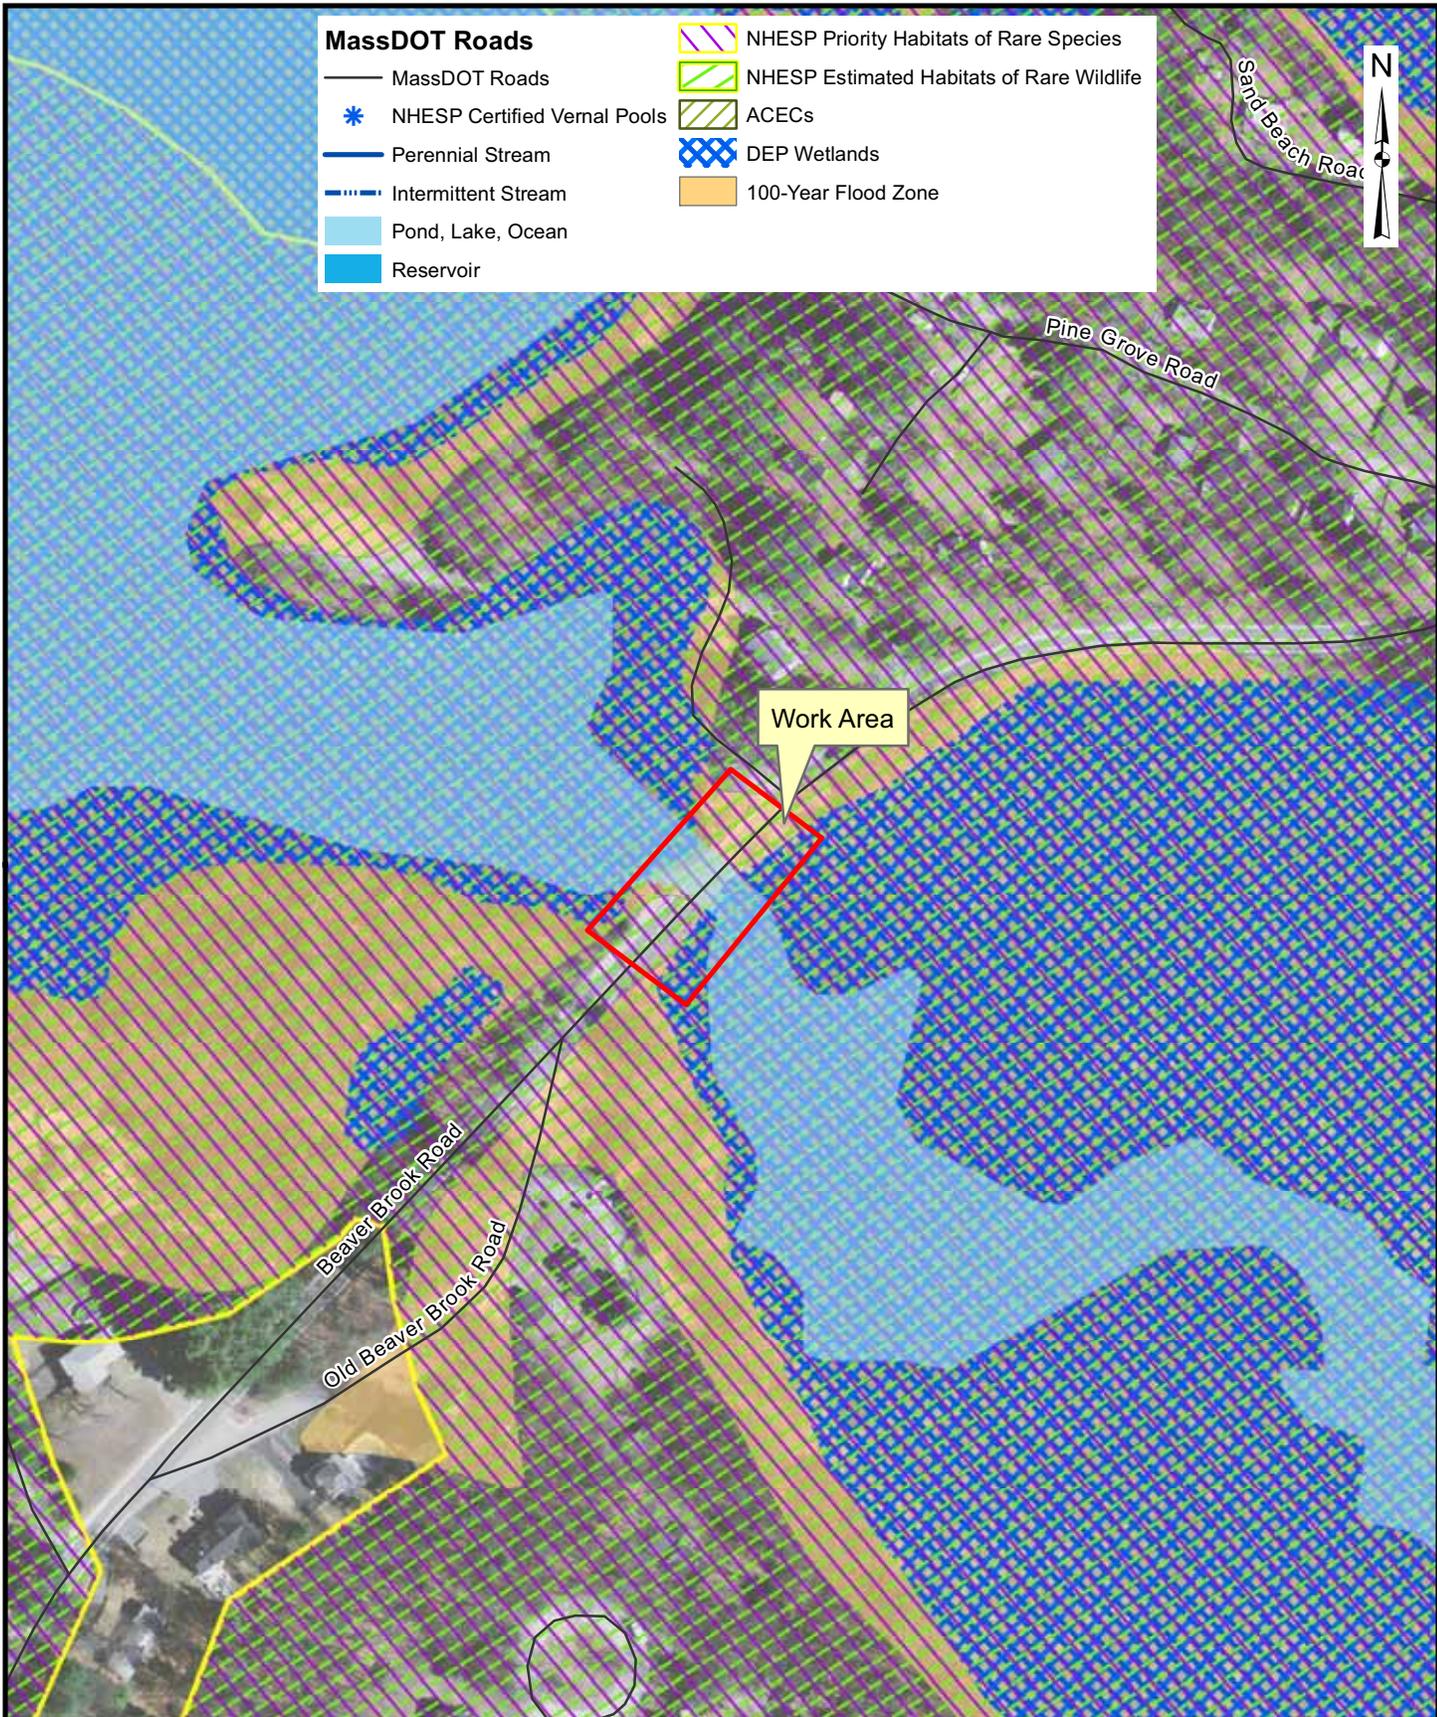
FIGURE 1
Westford, MA
Beaver Brook Culvert Replacement
ENVIRONMENTAL RESOURCES MAP

The bridge site is located within the 100-foot wetland buffer zone, a riverfront area, and NHESP area for rare wildlife. See the Environmental Resource Map (Figure1) in Appendix C.

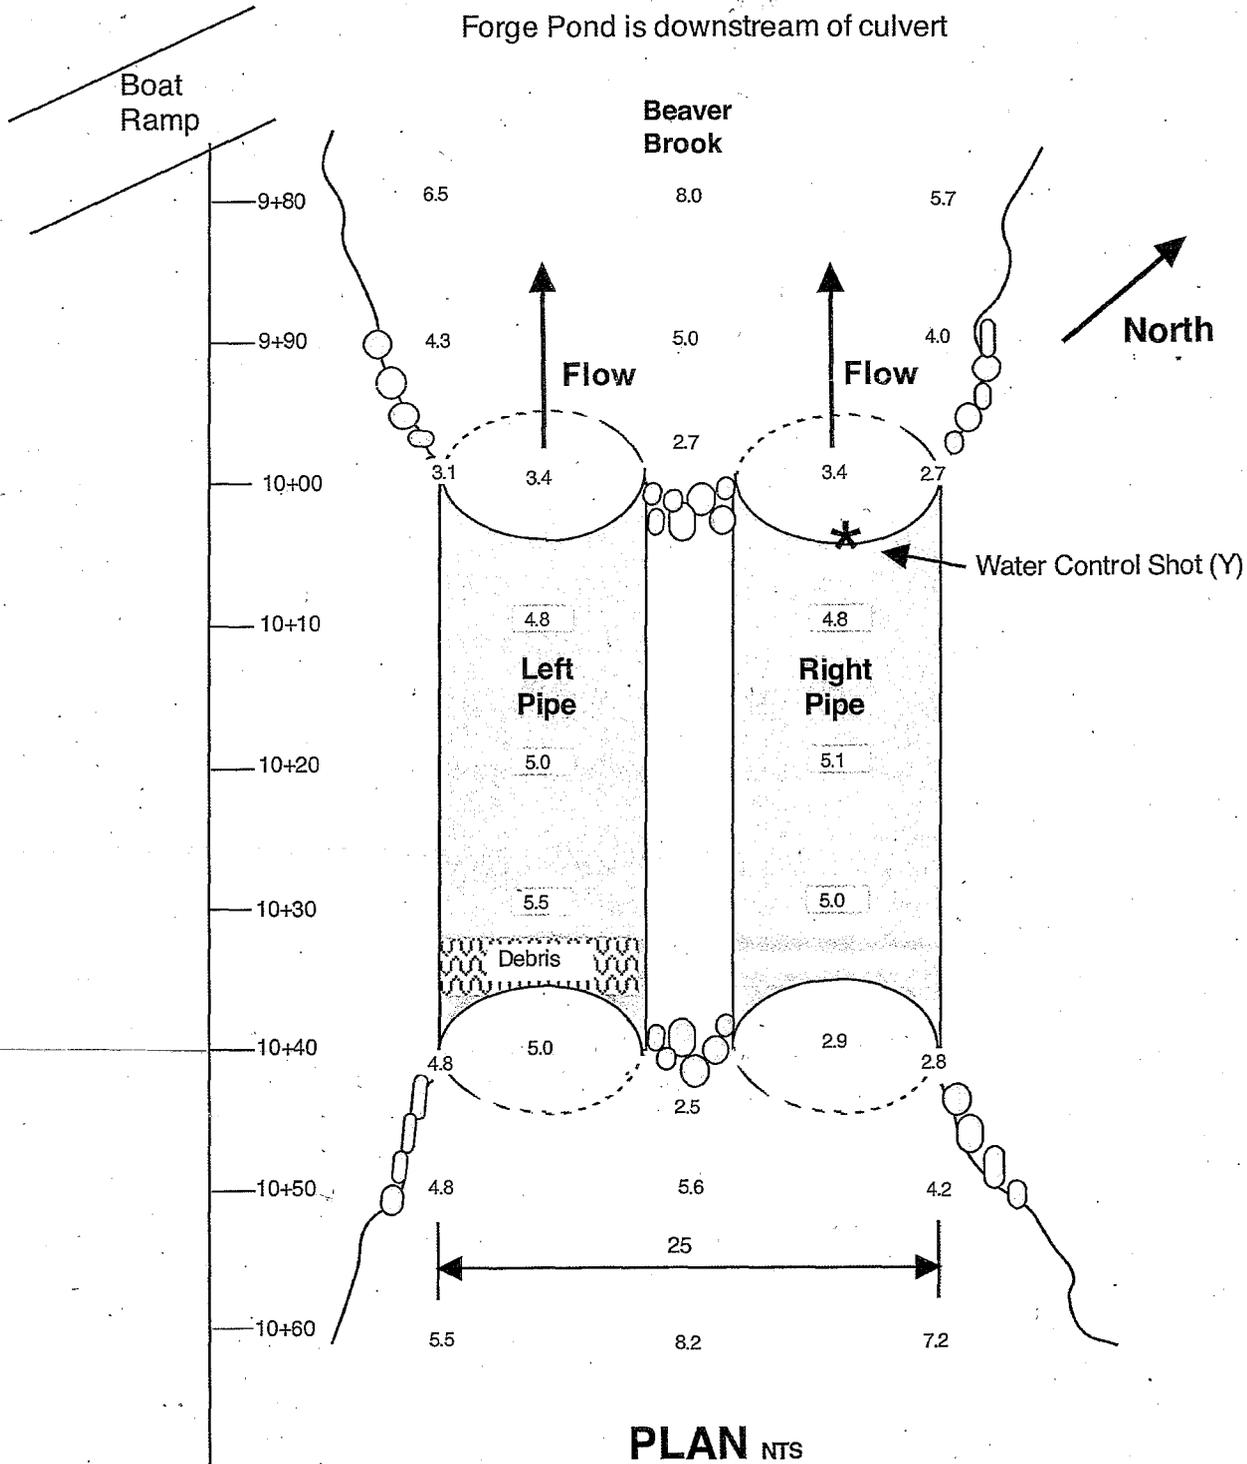
PLAN NTS

Forge Pond is downstream of culvert

Note: All soundings & measurements are in feet and taken from the 1990 Underwater Inspection Report. Water Control Shot taken from top of Right pipe to water.

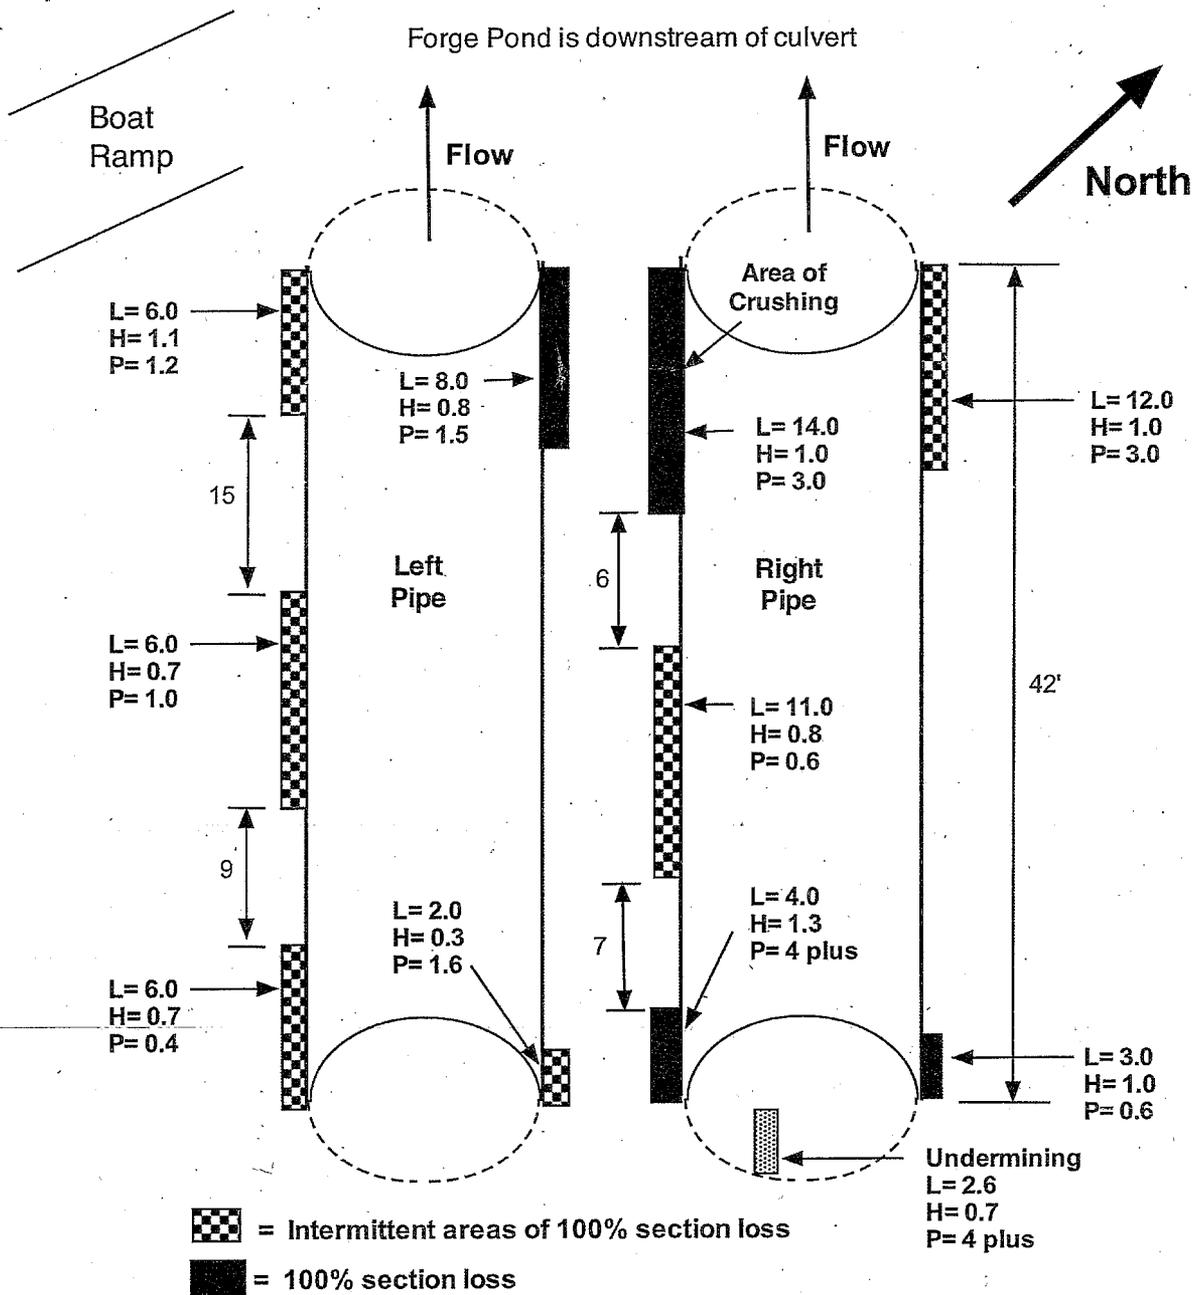
Note: All measurements are in Feet.

L = Length
 H = High
 P = Penetration

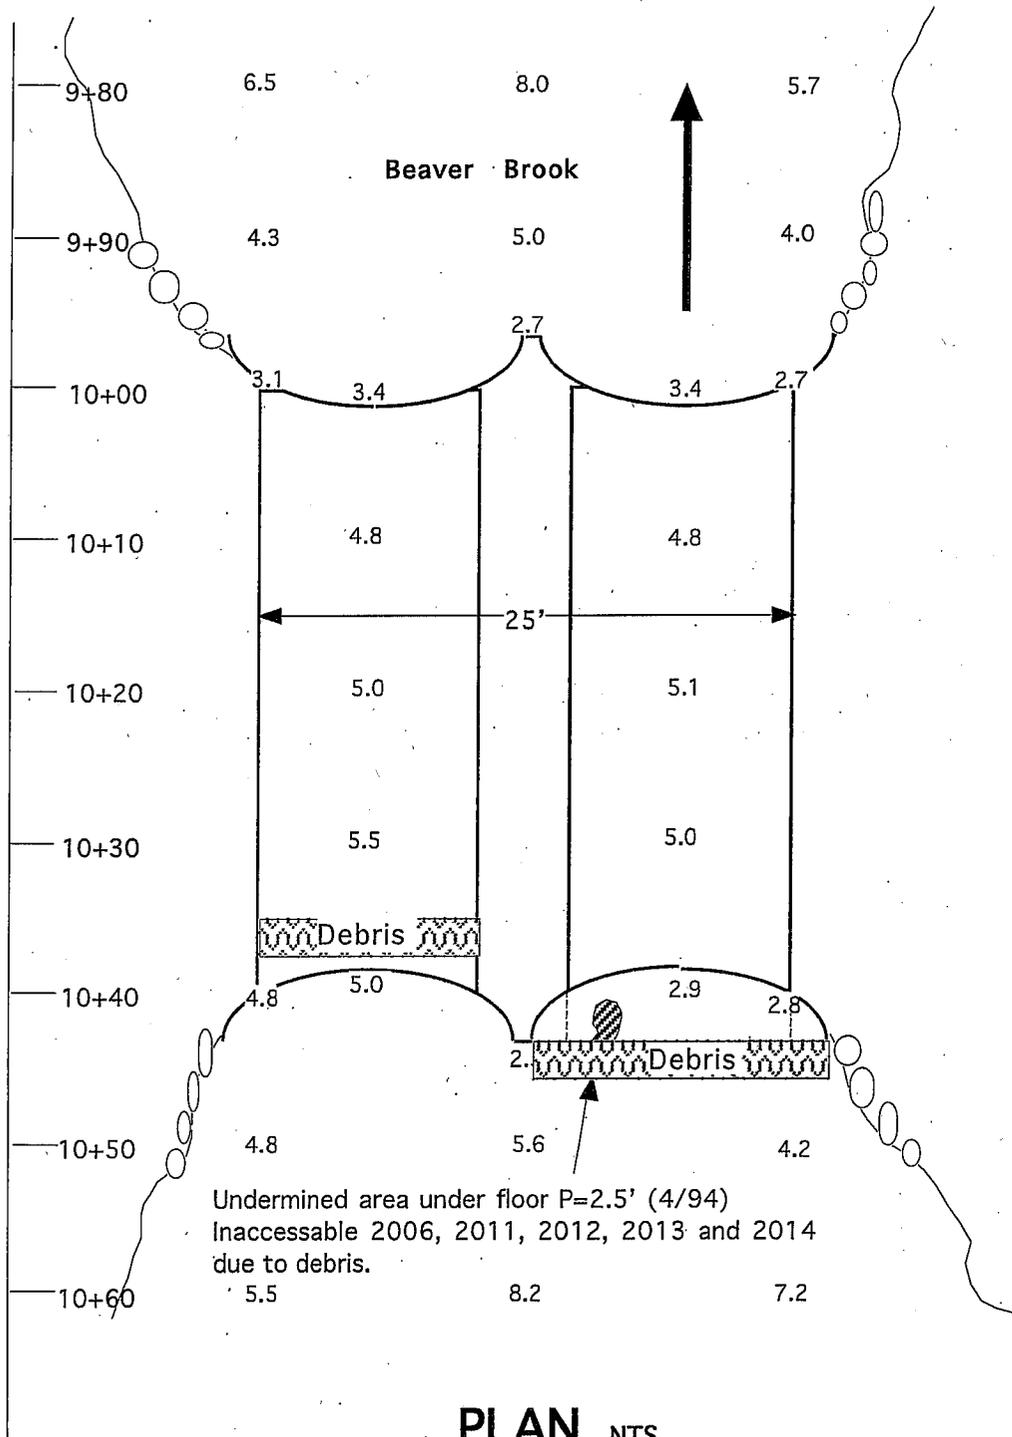
PLAN NTS

Note : All soundings and measurements are in feet and taken from the 1990 underwater inspection report.
