SUPPLEMENTAL DATA REPORT

**Map 22, Parcel 3.3
Boston Road
Westford, MA**

January 2007

Prepared for: The Town of Westford

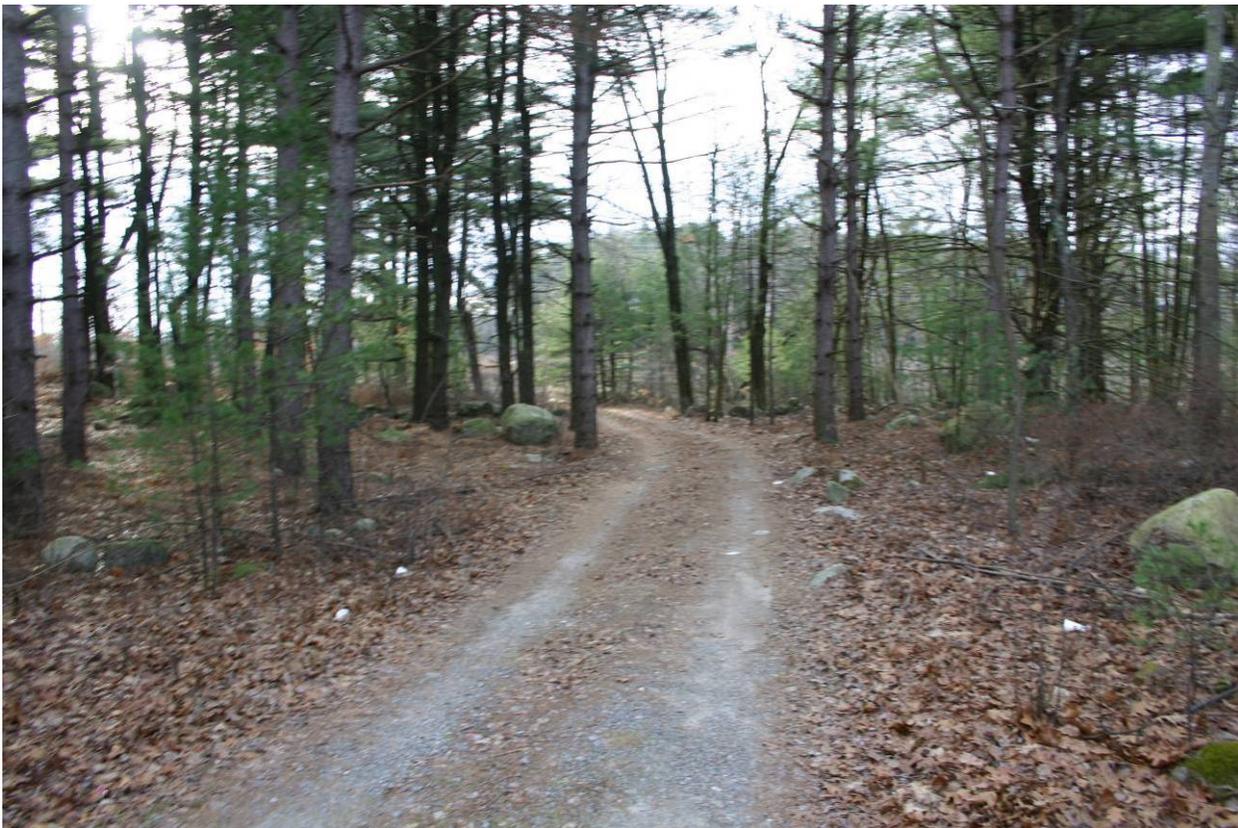
The area north of the power lines contains approximately five and one quarter (5.25) acres of land. Contained in this area are an access road to the abutting Mass. Electric Substation, a stormwater basin for Blake's Hill Road, and a small area of wetlands. The undeveloped areas are wooded. The majority of the trees are coniferous with light underbrush. A well maintained cart path leads from the access roadway to the power line easements.

Figure 1 Cart path heading to power lines from the access road.

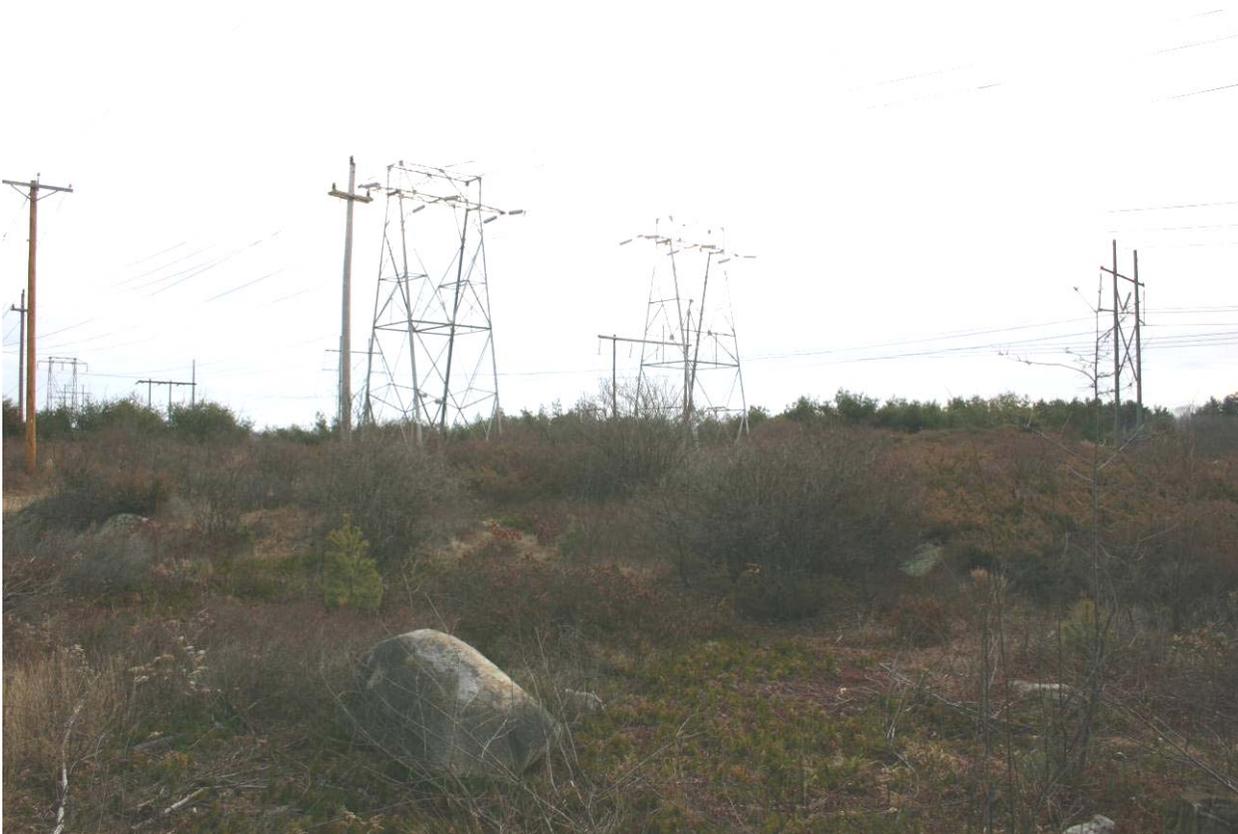
The area under the power lines is free of trees with a ground cover of low brush or junipers. This area contains approximately six and one half (6.5) acres. A finger of the wetlands extends from the rear of the property under the power lines roughly half way to the front of the site. A cart path meanders under the power lines towards the wetlands at the rear of the site.

Figure 2 Power lines adjacent to Boston Road.

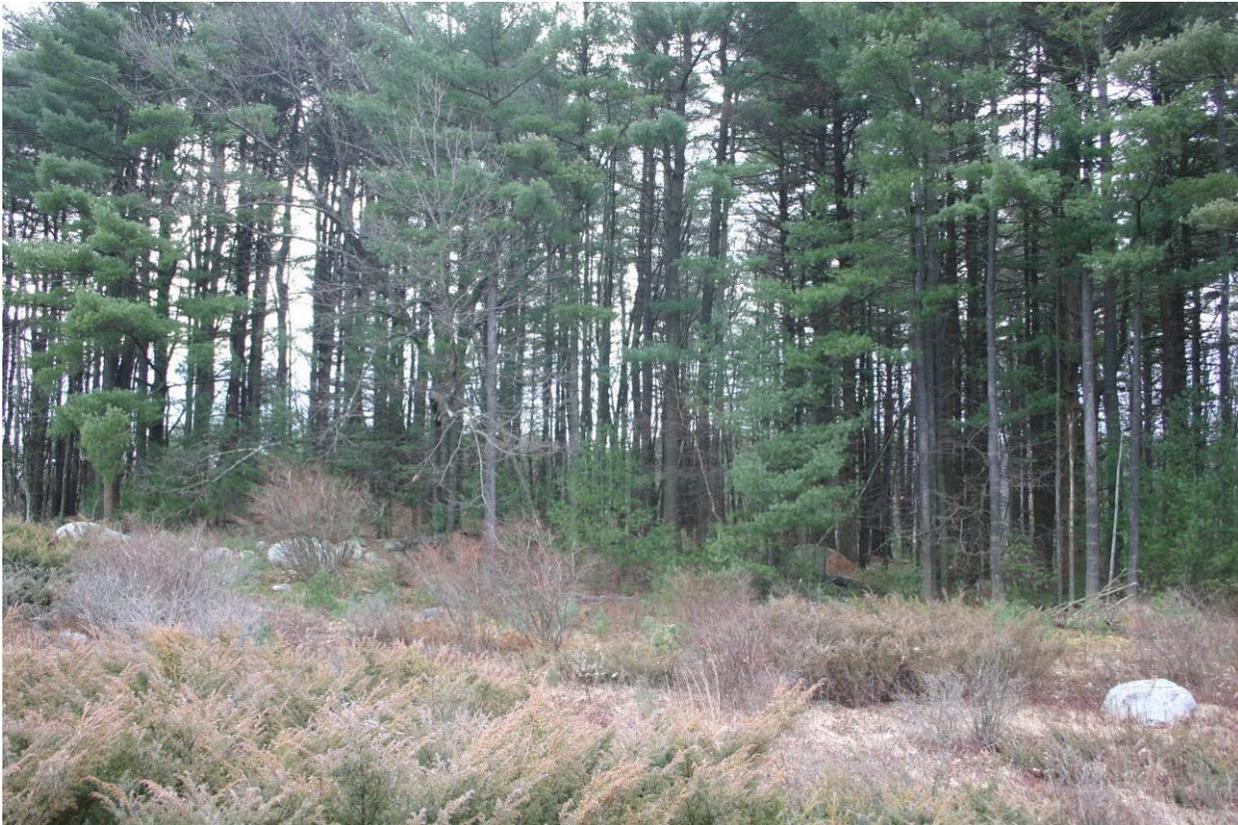
The area south of the power lines contains approximately six (6.0) acres of land. This area is fairly evenly split between wooded areas and wetlands. The existing cart path does not extend past the power lines and as such provides no direct access to this area.

Figure 3 Wooded area beyond the power lines looking south.

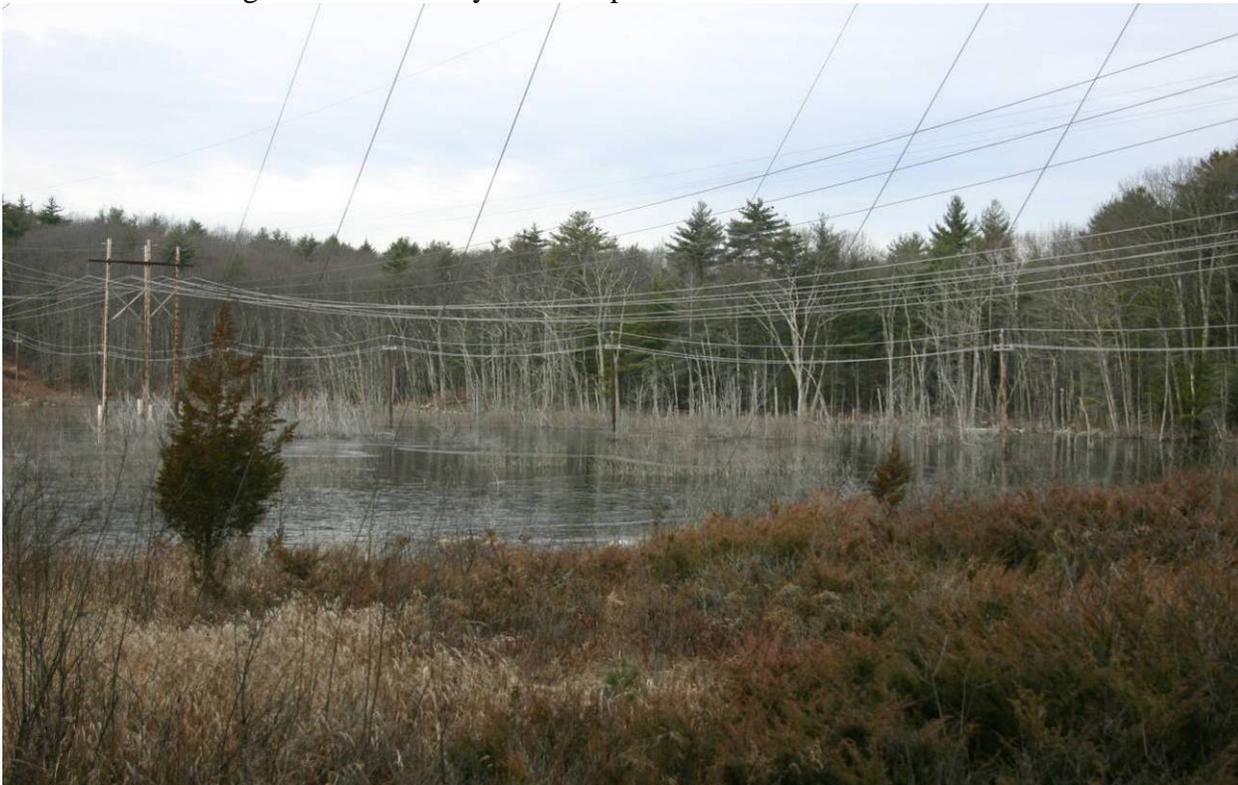
A large wetland is located along the western boundary of the site. Two wetland fingers extend well into the site. The wetland has been flagged according to its vegetation, groundwater indicators and soil indicators in accordance with the Wetland Protection Act and the Town of Westford Non-Zoning Bylaw. The wetlands were flagged by Basbanes Wetland Consulting and field located by LANDTech Consultants, Inc. in November 2006. The wetlands flags and the associated buffer zones are shown on the attached plans. Due to the shape of the wetlands, large areas of the site are contained within the associated buffers zones and as such are subject to the Wetlands Protection Act and the Westford Wetland Non-Zoning Bylaw.

Figure 4 Wetland area at western property line.

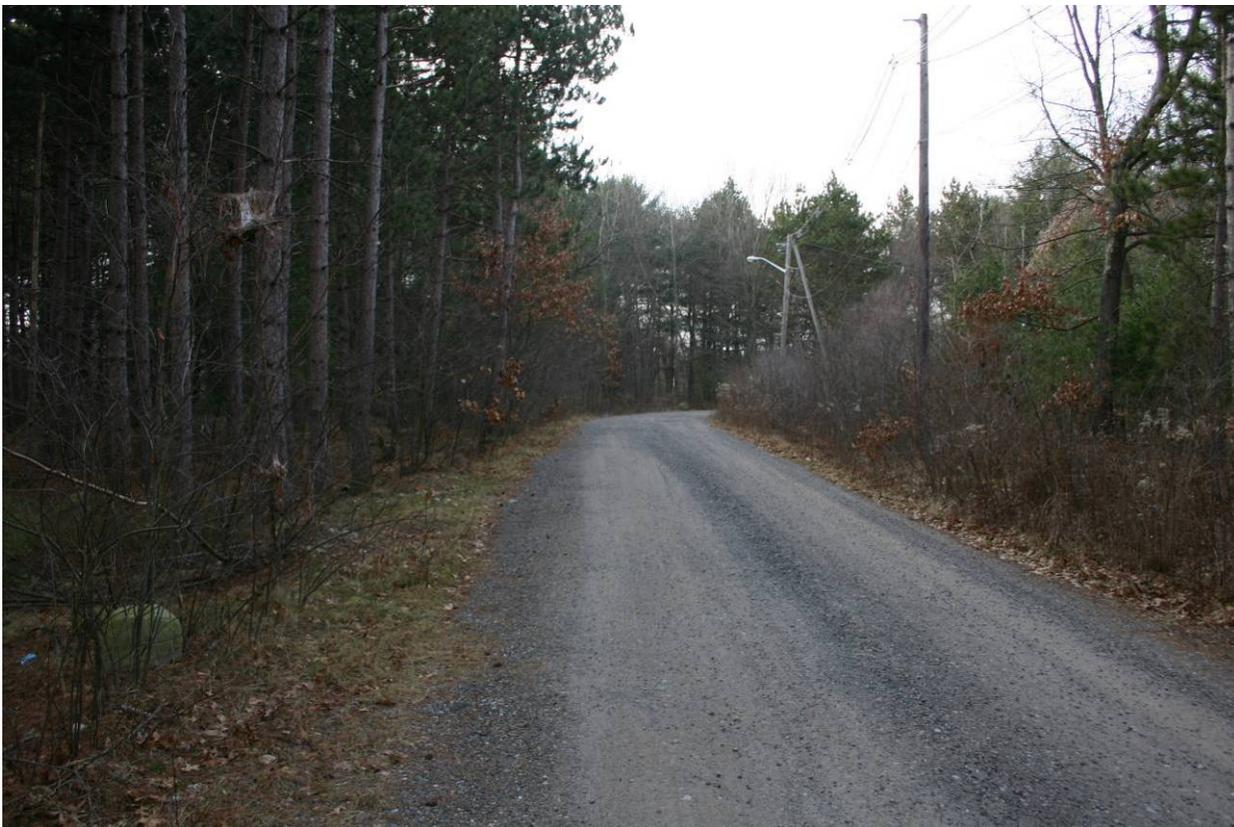
The site has approximately six hundred and twenty-two (622) feet of frontage on Boston Road plus five hundred and ninety-one (591) feet of frontage on Blake's Hill Road. There is currently one curb cut from Boston Road provided for the site. The forty (40±) foot wide curb cut contains a gravel roadway that provides access, via an easement, to the electrical substation located on the adjacent property just west of the site.

Figure 5 Existing Access Road viewed from Boston Road looking west.

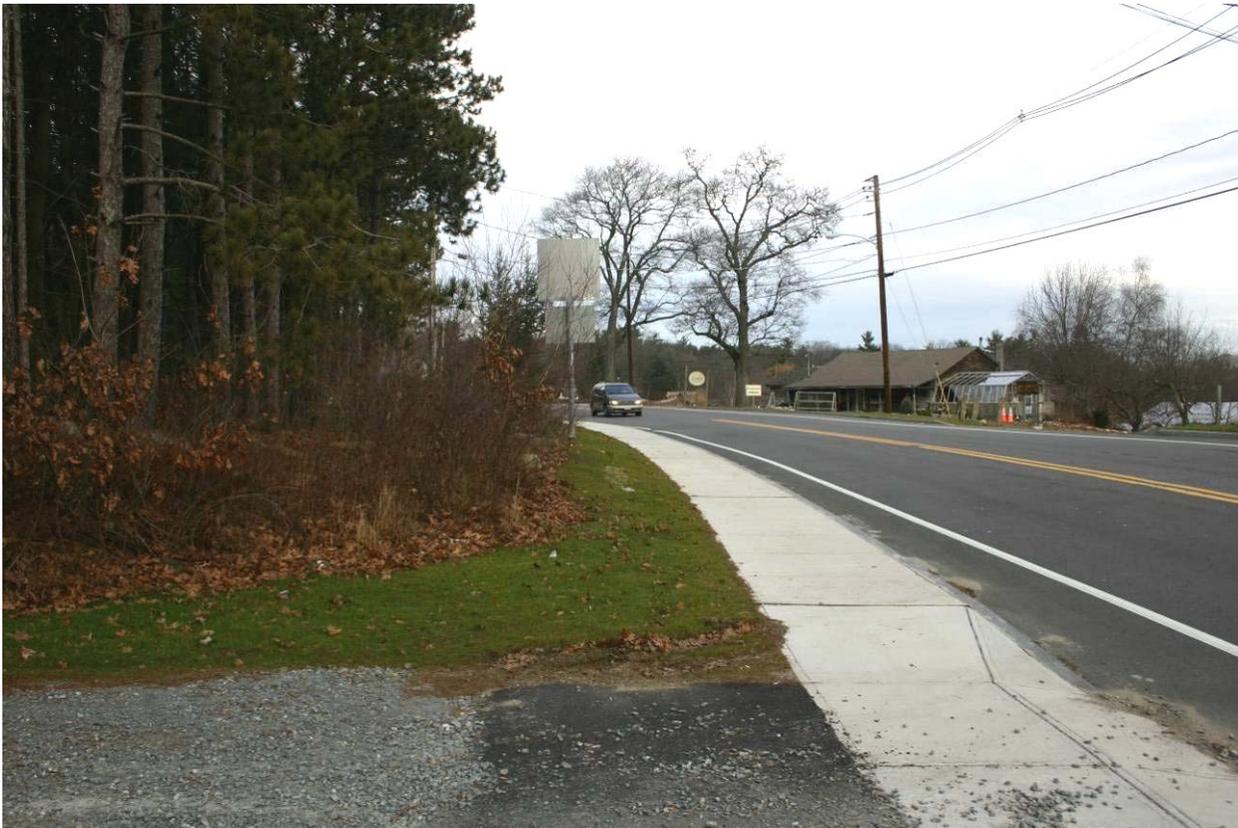
Boston Road provides the existing access for the site and potential for an additional access or expansion of the existing access. The location of the existing access is roughly 130' south of the Blake's Hill Road access. The proximity of these two access points on a busy street provides a high potential for traffic conflicts. In addition the curvature of Boston Road provides limited site distance to the north, making it difficult for a vehicle leaving the site to safely enter traffic on Boston Road. Vegetation removal along Boston Road may increase the site distance to 350 feet, the distance recommended for a secondary street, but not the 500 feet recommended for an intersection with a major street such as Boston Road. The entrance could be relocated to the south, however this will quickly put vehicles leaving the site in conflict with vehicles at the newly constructed traffic light at the exit-ramp of Route 495 and the turning lane for the on-ramp to Route 495. While access directly onto Boston Road may be feasible depending on the scope of the project it would likely be costly and time consuming to design and permit with the Massachusetts Highway Department.

Figure 6. Looking north from the existing access road with limited sight distance.

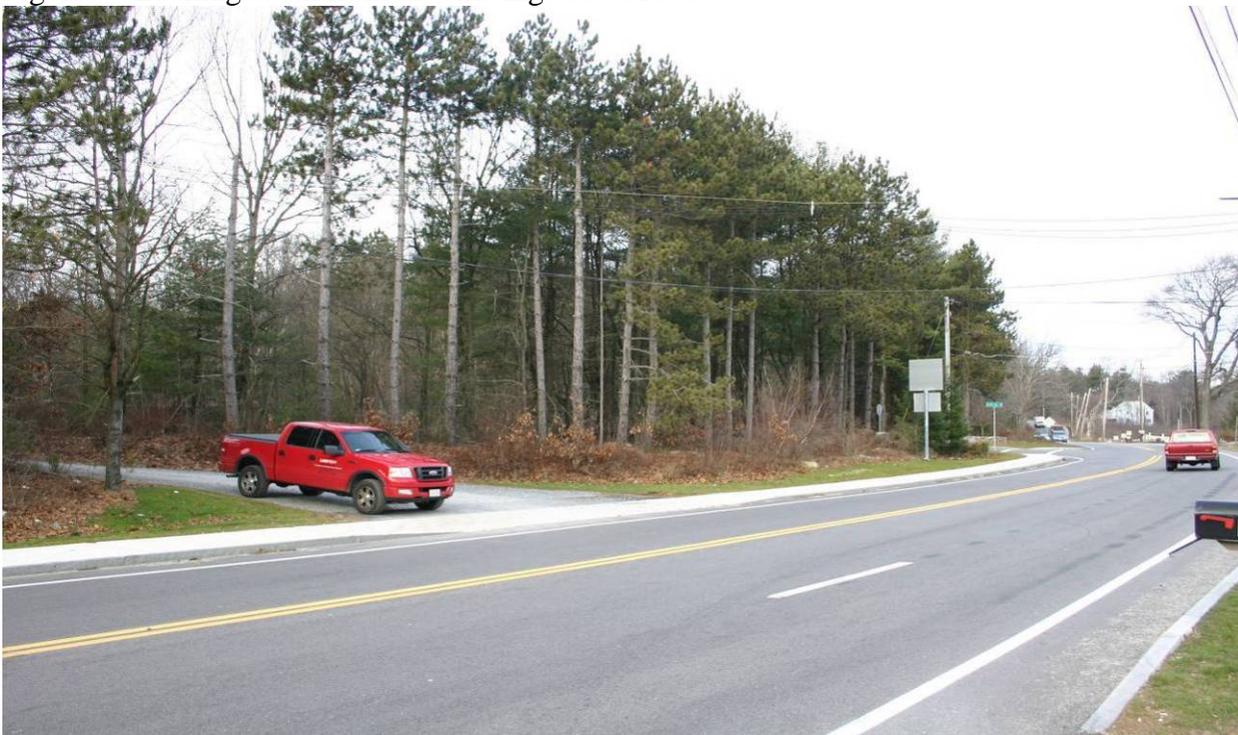
Figure 8. Access road viewed from across Boston Road.

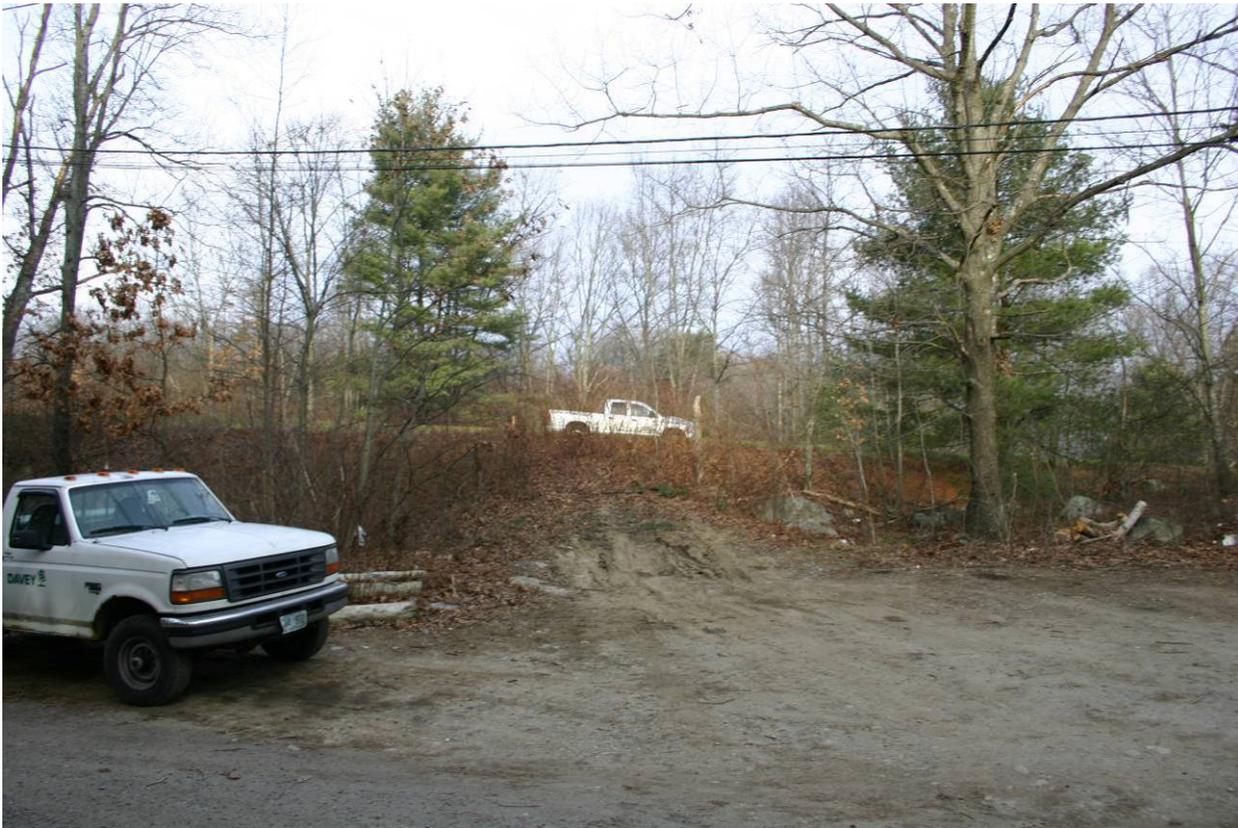
Blake’s Hill Road is a standard paved residential roadway servicing approximately thirty-five (35) residential houses. The roadway begins at Boston Road and slopes upward towards the west. Drainage from the roadway collects and is discharged to a detention basin on the Town’s property approximately 150’ back from Boston Road. Blake’s Hill Road would provide convenient access to a residential development and help to reduce the number of access points on Boston Road. Access would likely need to be within the first 500’ of Blake’s Hill Road due to the increasing difference in elevation between Blake’s Hill Road and the existing site. Near Boston Road the two sites are level, however at the rear of the site Blake’s Hill Road is roughly twenty-five higher in elevation, making a transition between the two difficult. A likely location for an access road would be just west of the detention basin shown on the plans. This area has an existing forty (40) foot wide access easement shown on the plans.

Figure 8. Vehicle(background) on Blake’s Hill Road viewed from the access road
